# MEMORANDUM

JRS ENGINEERING CONSULTANT, LLC

**TO:** Rick Goncalves P.E., CCBWQA TAC Chairman  
Chuck Reid, CCBWQA Manager  
**CC:** Jason Trujillo, CCSP Park Manager  
**FROM:** James R. "Jim" Swanson P.E.  
**DATE:** July 18, 2018  
**SUBJECT:** 2018 Annual Inspection of PRF's at Cherry Creek State Park

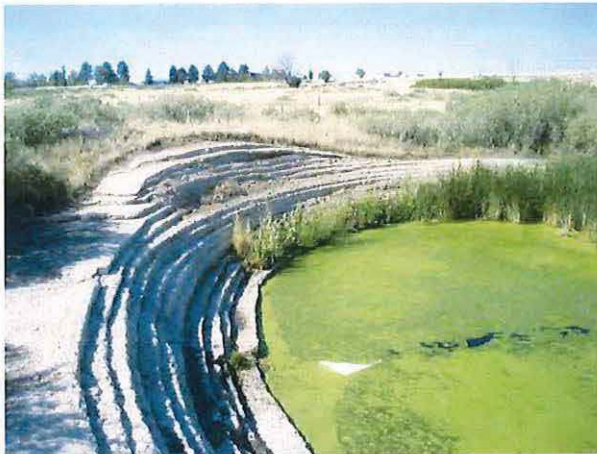
Photo 1 - Typical Structure Deterioration

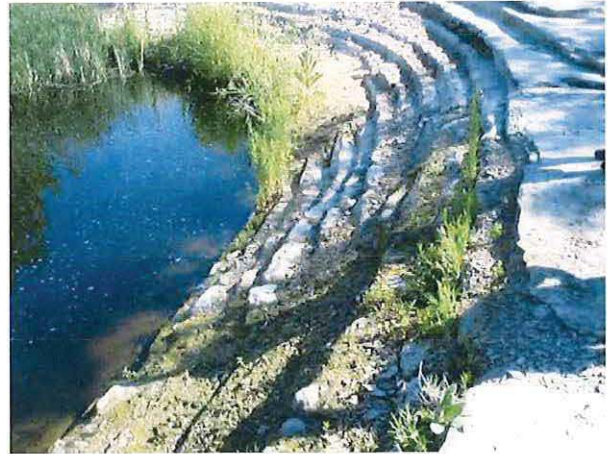
Photo 2 - Typical Seepage Thru Structure

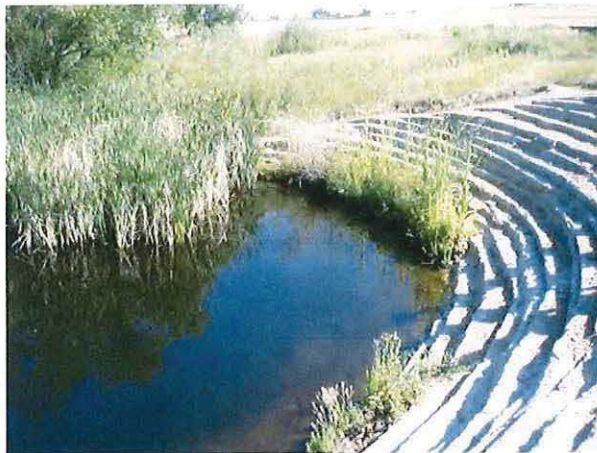
Photo 3 - Typical Weed / Woody Vegetation

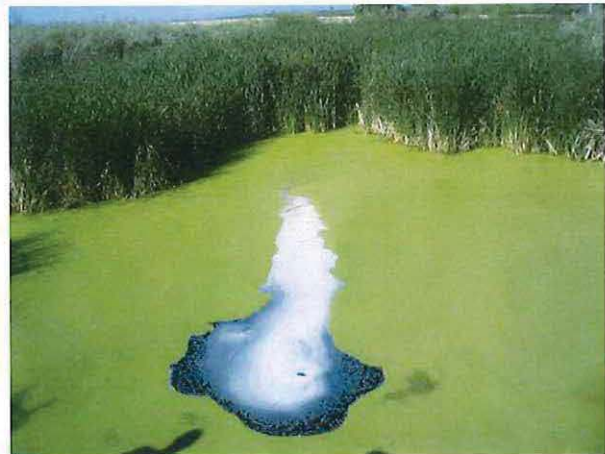
The water surface of Drop Structure Ponds #1 and #2 were each observed with significant duckweed coverage. See Photo 5. The water surface on Drop Structure Ponds #3, #4 and #5 were void of any duckweed. Pond #3 included a small noticeable growth of algae on the surface. The surface of the water quality / detention pond upstream of Aurora Detention Pond Structure (off-site of CCSP) was mostly covered with duckweed.

The presence of duckweed has been normal this past year when compared to previous years. Preliminary research into duckweed suggests that duckweed may not be a water quality concern and may be beneficial to water quality.

Photo 5 – Water Surface at Pond #1

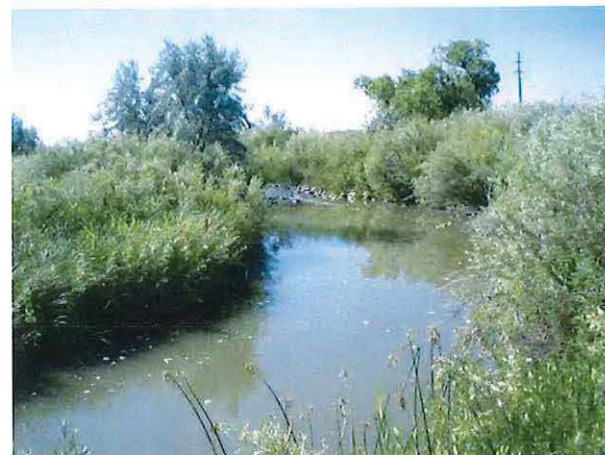
**Cottonwood Creek Reclamation:** There were no signs of erosion or unraveling to the main channel area or structures. Vegetation along the creek is well established. See Photo 6. Vegetation at the south trail low water crossing is encroaching onto the trail and during periods of runoff will flood out the trail. Trimming and mowing is recommended along this area. See Photo 7. Areas of Canada Thistle, and other noxious weed growth were observed and are currently on CCSP's schedule for treatment. See Photo 8.

Photo 6 - Cottonwood Creek Vegetation Cover

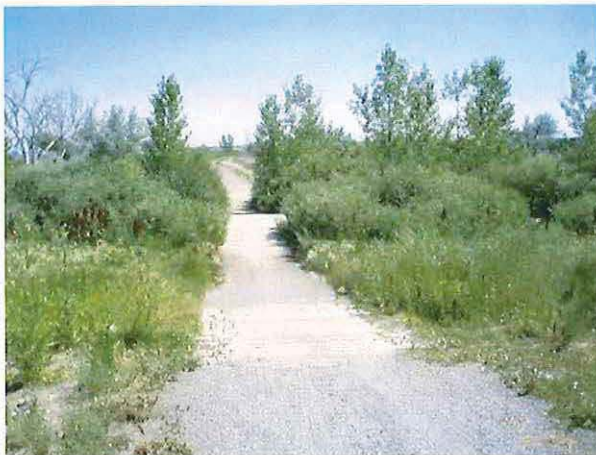
Photo 7 - Cottonwood Creek Low Water Trail Crossing

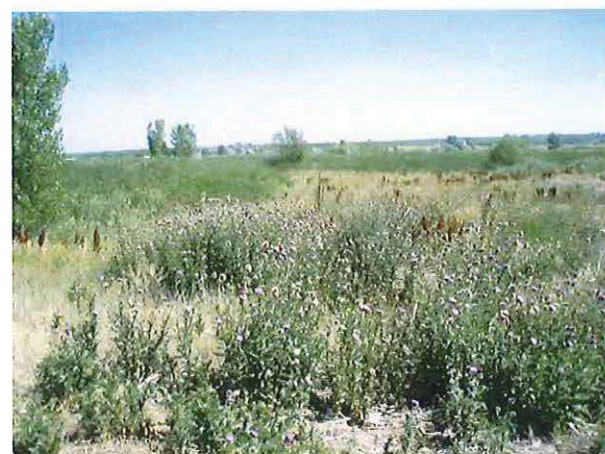
Photo 8 – Canada Thistle Growth along Trail

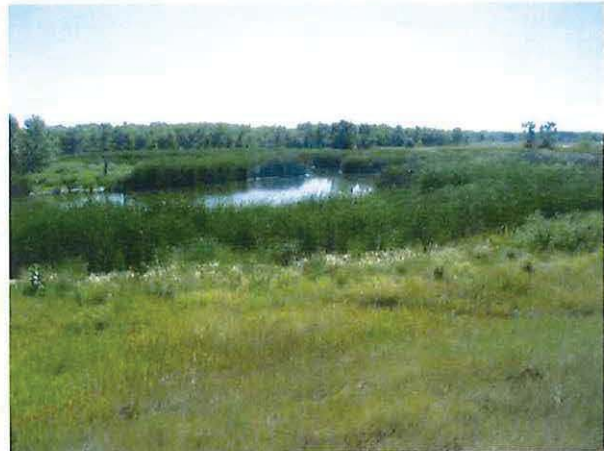
**Cottonwood Wetlands:** Restoration of this PRF was completed in 2012, following the June 2012 flood which deposited silt/sediment along the right bank and damaged the upland seeding. Revegetation efforts, rainfall received and the annual noxious weed control performed has enhanced the vegetation growth at the wetland. See Photo 9. A recently completed shoreline project at the outlet structure has provided a stabilized surface for staff to routinely maintain the bar screen. See Photo 10.

Photo 9 - Cottonwood Wetland Vegetation

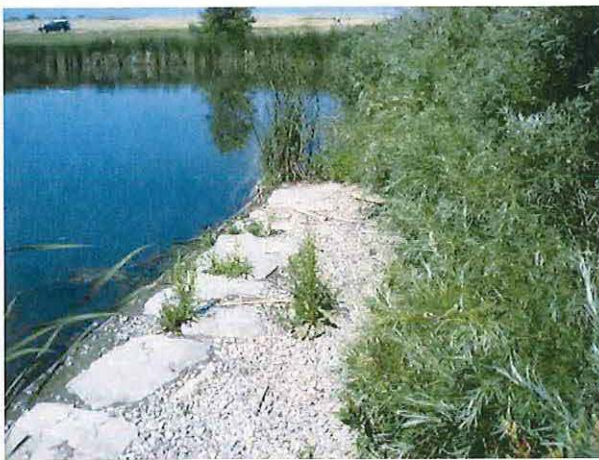
Photo 10 – Cottonwood Wetland Shoreline Stabilization

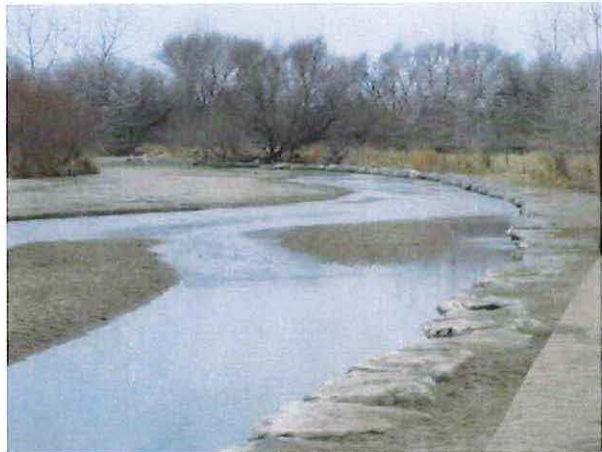
**Cherry Creek at 12-Mile Park Phase I:** Phase I was completed in 2012. It has experienced significant sediment aggradation from the 2014 and 2015 storm events. See Photo 11. Additional bank stabilization along the right bank was included with the Phase II construction completed in the spring of 2014. Noxious weed control has been performed annually since 2014. Channel sediment levels are currently being monitored. Photos 12 and 13 show the Phase 1 stream right bank breach caused by the sediment aggradation following the June 11, 2015 storm event. Cherry Creek flow was observed spilling out of the channel at the downstream end of Phase I early in 2017. This spill area is being monitored and will require a capital grading, erosion control and revegetation project to stabilize the eroded bank area.

Photo 11 - 12-Mile Park, Phase I, Sediment Aggradation, - looking downstream.

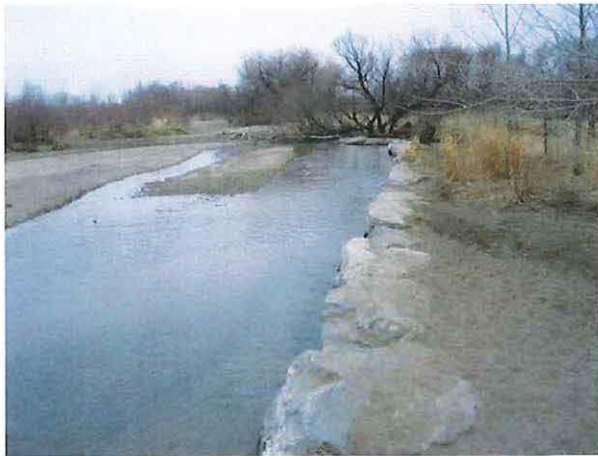
Photo 12 - 12-Mile Park, Phase I Channel Sediment Aggradation

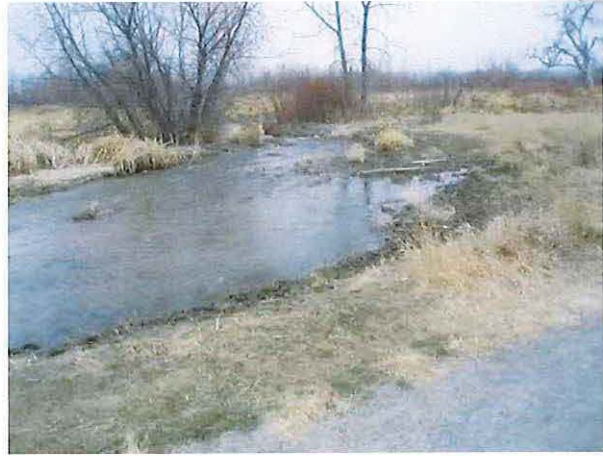
Photo 13 - 12-Mile Park, Phase I, Bank Breach Spill from Channel entering Wetland

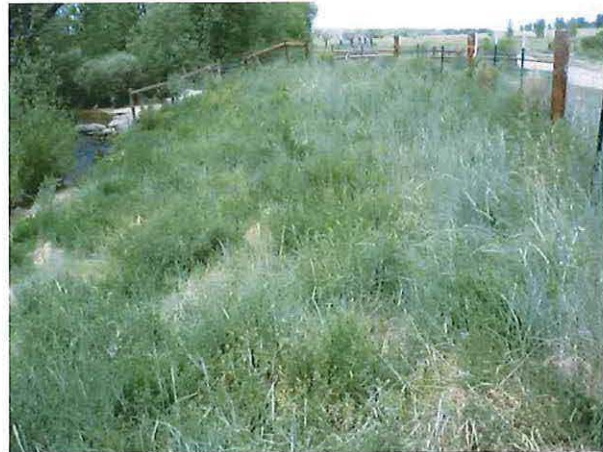
**Cherry Creek at 12-Mile Park Phase II:** Phase II was completed in 2014 and is experiencing high pedestrian / dog activity. Vegetation on the side slopes down to the creek bank, protected by the permanent fencing along the top of slope and the sides of each access point, is well established, see Photo 14. The vegetated areas outside the fence, between the fence and the trail was revegetated in May of this year, prior to the late May rainfall. See Photo 15. Signs were posted to inform Park users of the ongoing revegetation efforts. See Photo 16.

Photo 14 - 12-Mile Park, Phase II, Vegetated Channel Bank

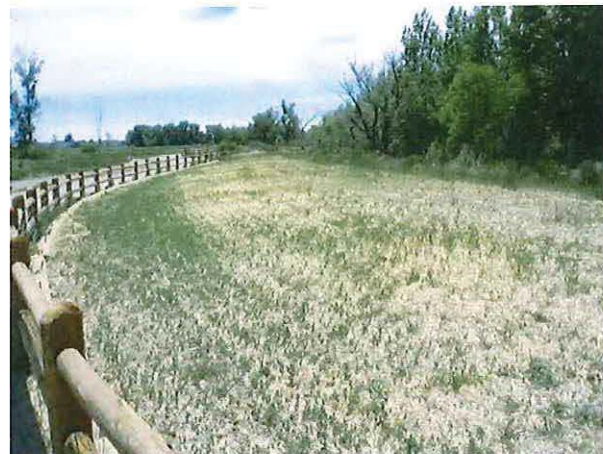
Photo 15 - 12-Mile Park, Phase II, Vegetated Area between Permanent Fence and Trail

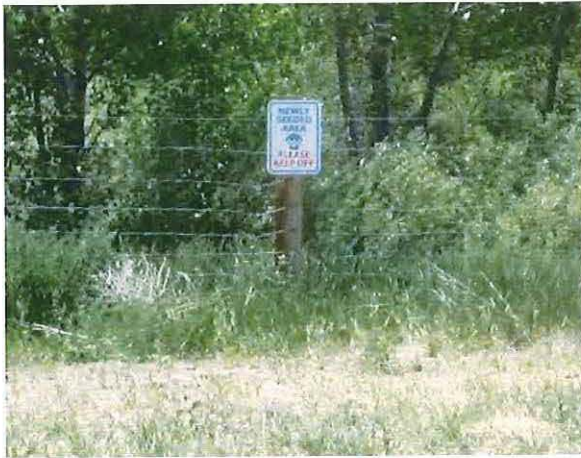
Photo 16 – 12-Mile Park, Phase II, CCBWQA  
Revegetation Signage

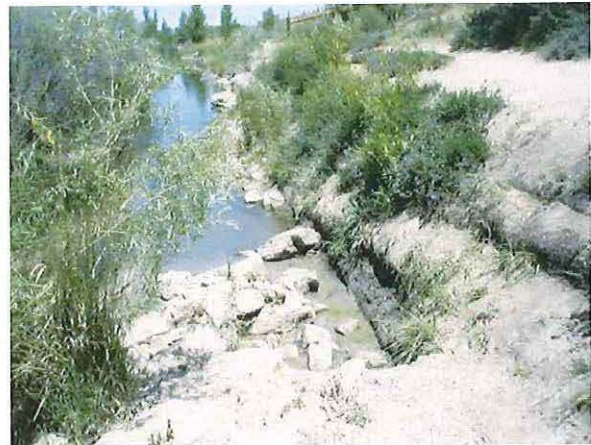
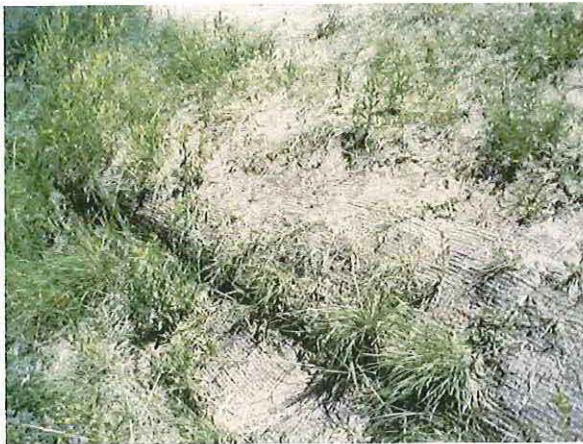
Recent Cherry Creek flow pattern changes have lowered the water level in the side channel between Access #6 and #8 at the south end of the Phase II project allowing dog and pedestrian access to the lower bank. This area was stabilized with soil wraps and is unraveling from the dog and pedestrian traffic. Temporary fencing and revegetation is required to close off the area and allow the revegetation to fill in the area. See Photos 17 and 18.

Photo 17 – 12-Mile Park, Phase II, Soil Wrap Bank  
Stabilized Area

Photo 18 – 12-Mile Park, Phase II, Soil Wrap Bank  
Stabilized Area

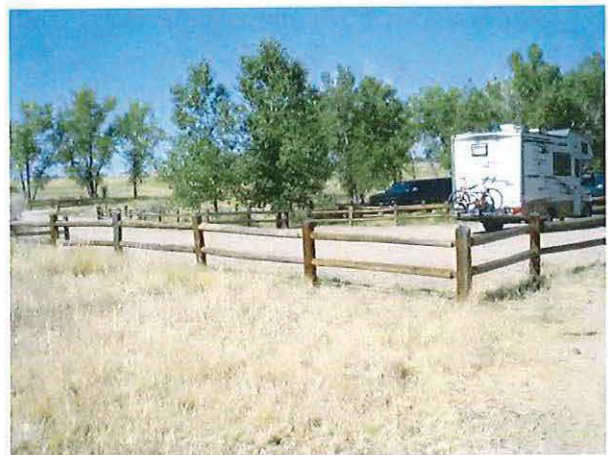
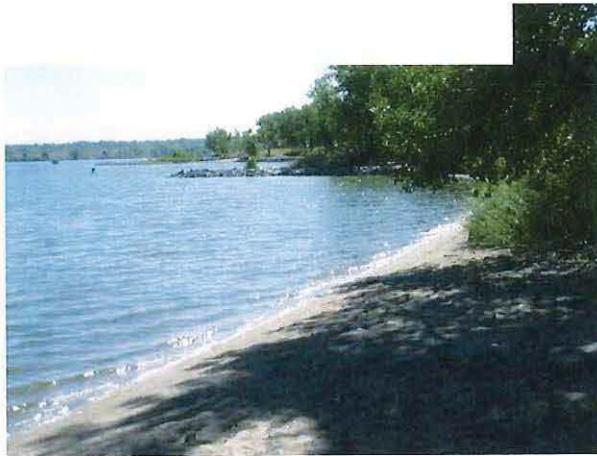
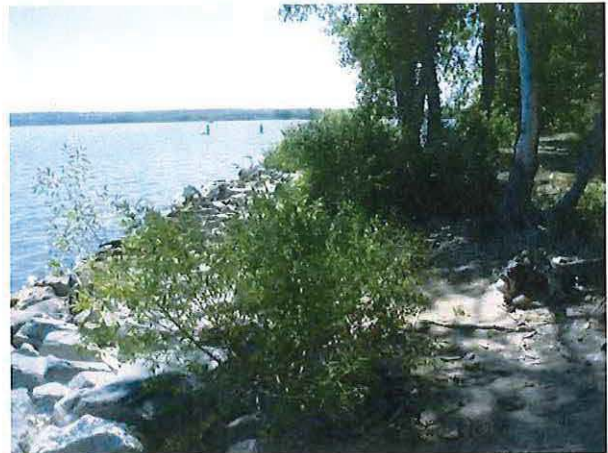
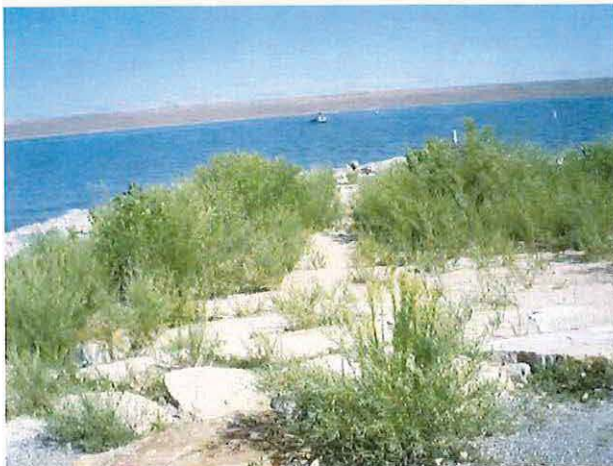
Construction of this PRF was completed in 2013. The shoreline stabilization work including restoration work performed following the 2015 flooding was successfully completed and is performing as designed. Weed control and tree trimming on the new cottonwood trees is an ongoing maintenance requirement. The constructed jetty at the north end of the Lake Loop Parking Area has silted in and is currently supporting a health stand of willows and other vegetation. See Photos 19, 20, 21 and 22.

Photo 19 - Mountain - Lake Loop Parking Lot Vegetation  
& Cottonwood Trees

Photo 20 - Mountain - Lake Loop Shoreline

Photo 21 - Mountain - Lake Loop Shoreline

Photo 22 - Mountain - Lake Loop Jetty Vegetation

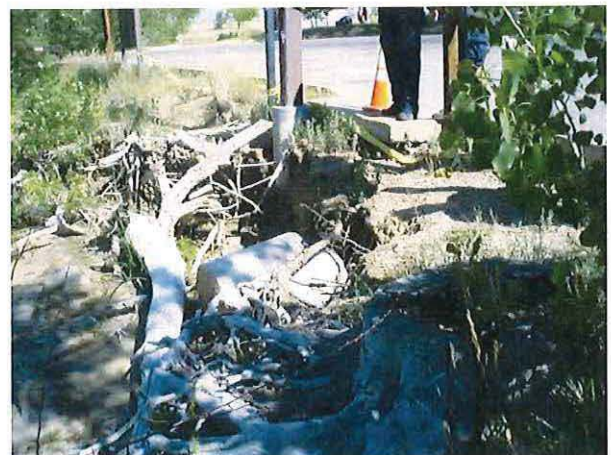
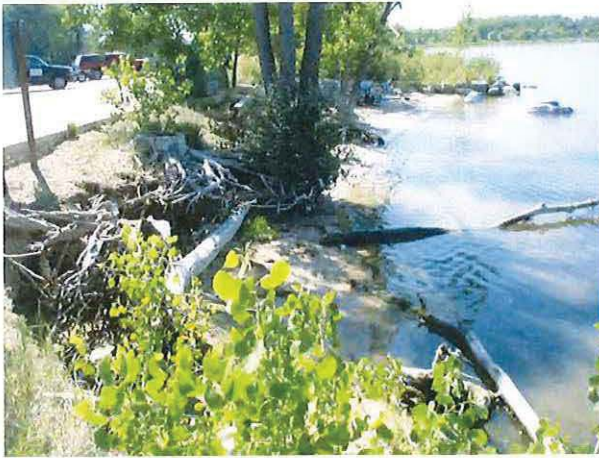
**East Boat Ramp:** Previous shoreline stabilization work at this PRF appears to be functioning as designed; however, an area of shoreline adjacent to the boat ramp and previous shoreline stabilization area is unraveling and threatening adjacent infrastructure and trees. It appears wave action has caused this area to unravel. See Photos 23 and 24. The curb cuts, where stormwater drains into the vegetated areas requires minor maintenance and will continue to be observed for additional silt build-up and flow short circuiting. See Photo 25.

Photo 23 - East Boat Ramp Shoreline Erosion

Photo 24 – East Boat Ramp Shoreline Erosion

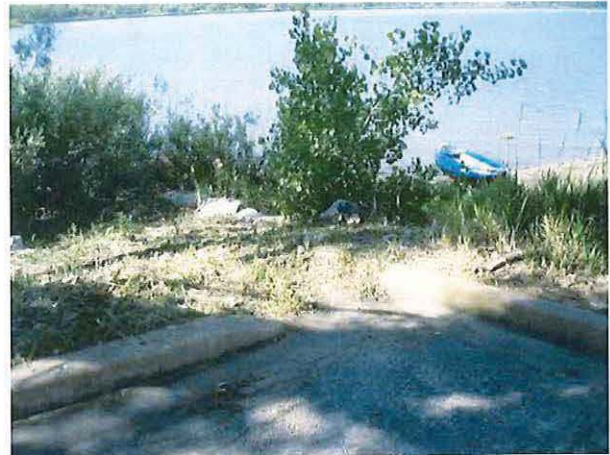
Photo 25 – East Boat Ramp Curb Cut Drainage

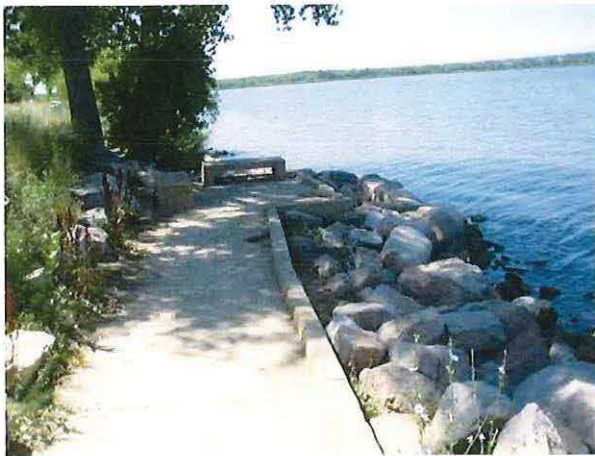
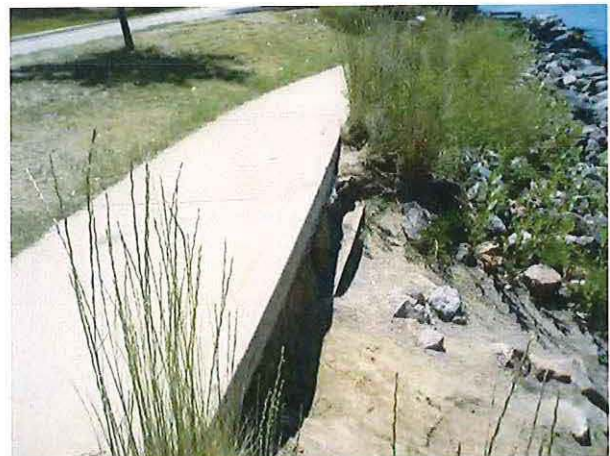
**East Shade Shelter:** The shoreline stabilization at the fishing pod of this PRF appears to be functioning as designed. The concrete handicap access to the water provides convenient access to the water's edge while serving as shoreline stabilization. The shoreline along the walk walkway is unraveling and requires repair. See Photos 26 and 27.

Photo 26 - Access Walk & Fishing Pod

Photo 27 – Shoreline Erosion along Walkway

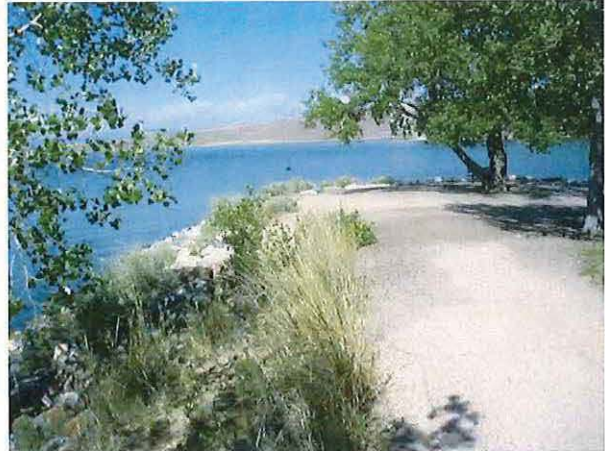
**Dixon Grove:** No erosion or revegetation concerns were observed. See Photo 28.

Photo 28 – Dixon Grove

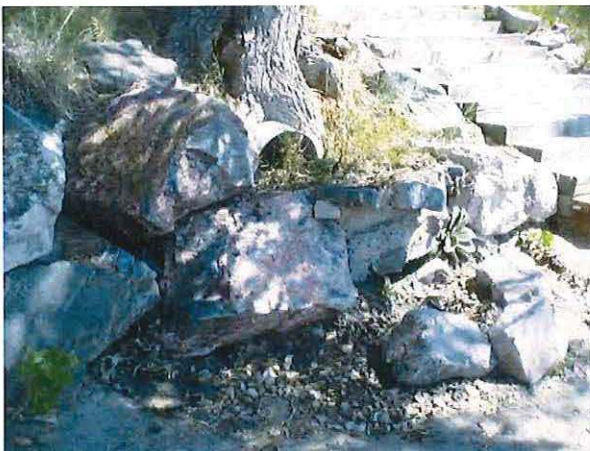
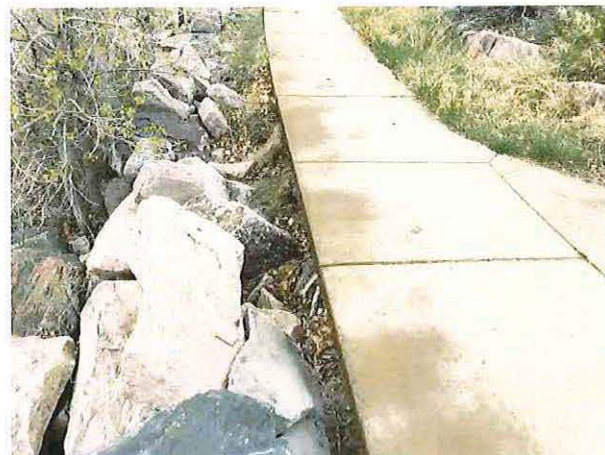
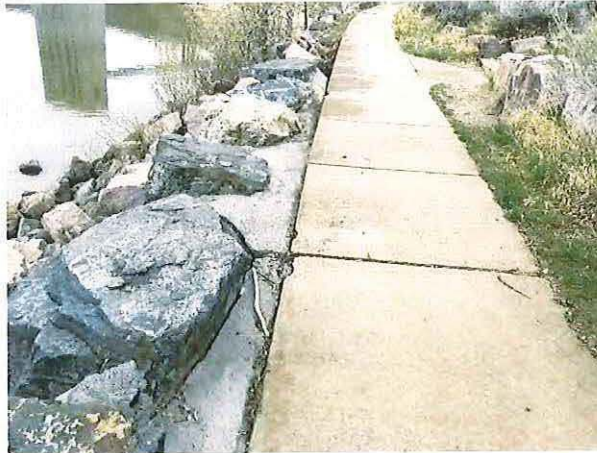
**Tower Loop:** Portions of the shoreline stabilization at this PRF appear to be functioning as designed; however, recent wave action has overtopped the rip rap protection and has undercut a portion of the access sidewalk adjacent to the north stairway. Other access areas are in need of routine maintenance. See Photos 29, 30 and 31.

Photo 29 - Tower Loop Parking Lot Drainage Outfall

Photo 30 - Tower Loop Shoreline Erosion at Access Walk

Photo 31 - Tower Loop Shoreline Erosion at Access Walk

A shoreline area extending approximately 120 feet to the south was being used for fishing and is experiencing a moderate amount of bank erosion. This area will be added to the 10-year capital improvement program.

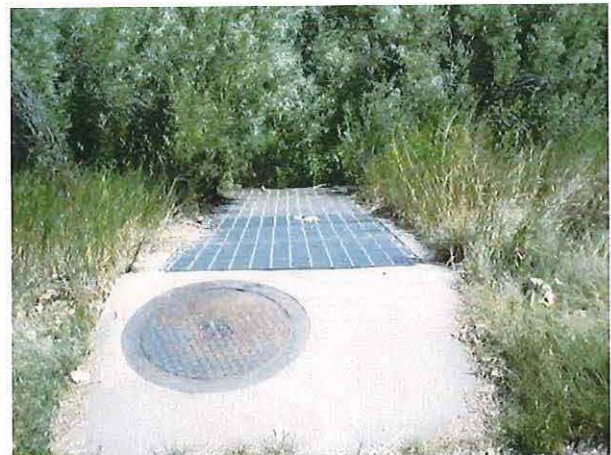
**Quincy Drain:** No erosion or revegetation concerns were observed. See Photo 32.

Photo 32 – Quincy Drain

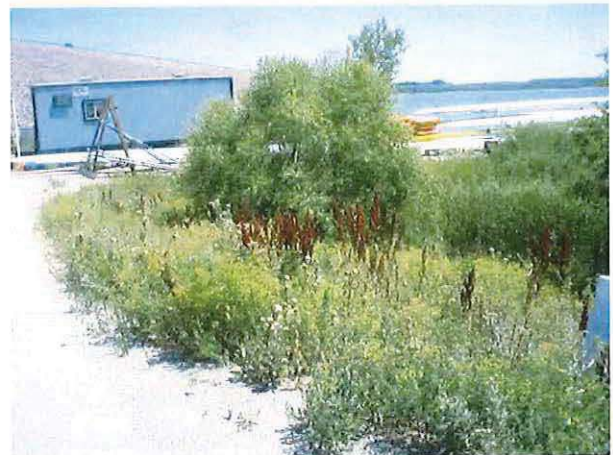
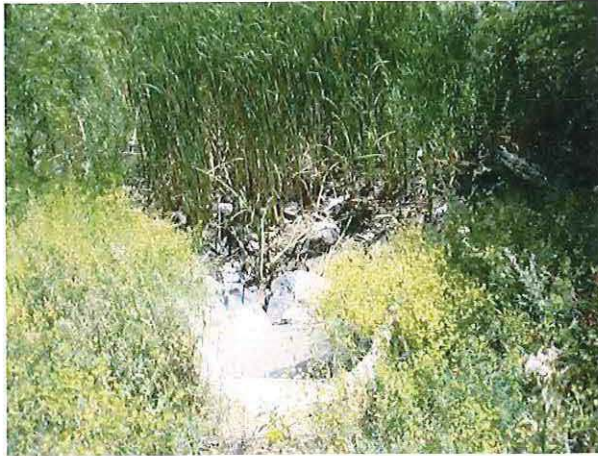
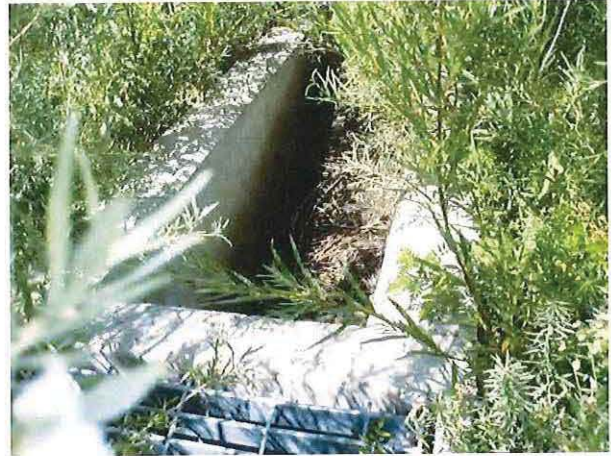
**West Boat Ramp Parking Lot Improvements:** Construction of this PRF was completed in 2014. All maintenance for this PRF is the responsibility of CCSP. Routine maintenance including weed control (mowing and spray application), outlet structure cleaning (box and screen) and clearing willows and woody vegetation from the detention pond is needed. See Photos 33, 34 and 35.

Photo 33 – WBR Vegetation along Top of Berm

Photo 34 – WBR Pipe Inlet Flared End Section

Photo 35 – WBR Outlet Structure
