MEMORANDUM

DATE: August 28, 2019

FROM: Richard G. Borchardt PE, CFM

SUBJECT: 2019 Annual Inspection of Pollution Reduction Facilities (PRFs) at CCSP

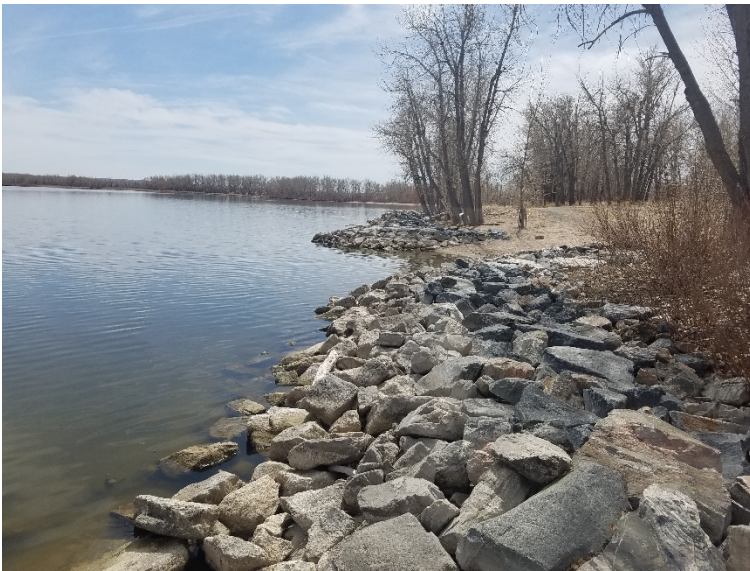
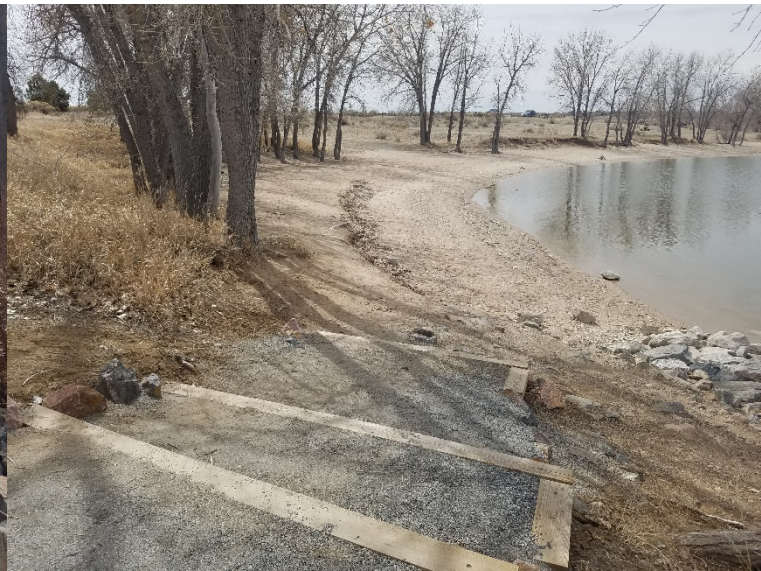
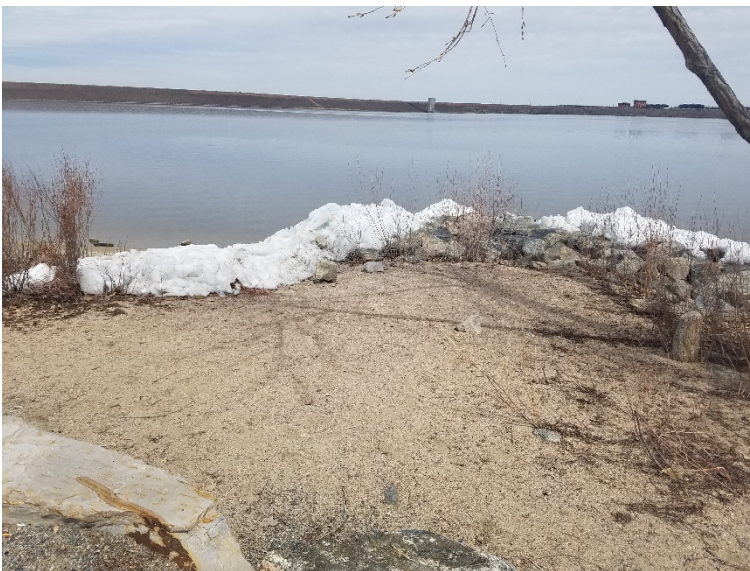
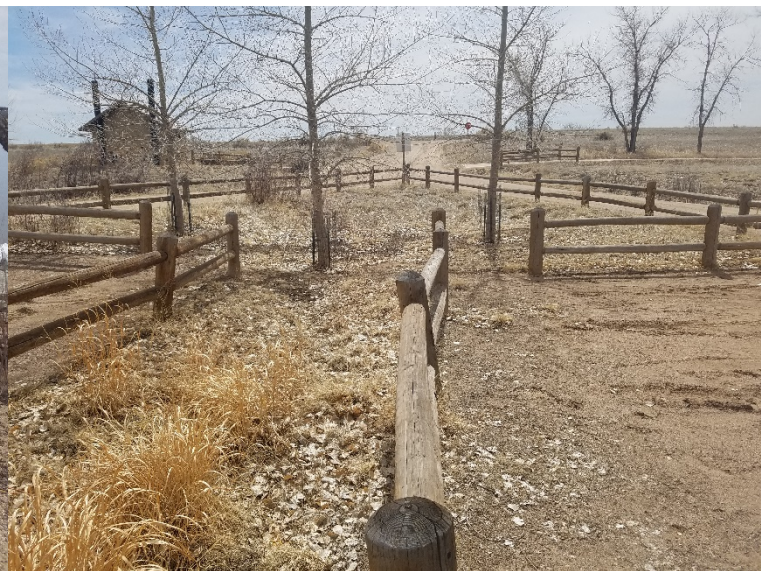
Mountain and Lake Loop: Construction of this PRF was completed in 2013. Additional shoreline stabilization and restoration work was performed following the 2015 flooding; it was successful. No significant concerns or problems were identified with PRF. This project appears to be functioning effectively as a shoreline stabilization (**Photos 1 and 2**). A layer of course sand has deposited over rock of one of the Jetties (**Photo 3**). This PRF provides a BioRetention Area that treats access road and parking (**Photo 4**); this area is well vegetated and appears stable.

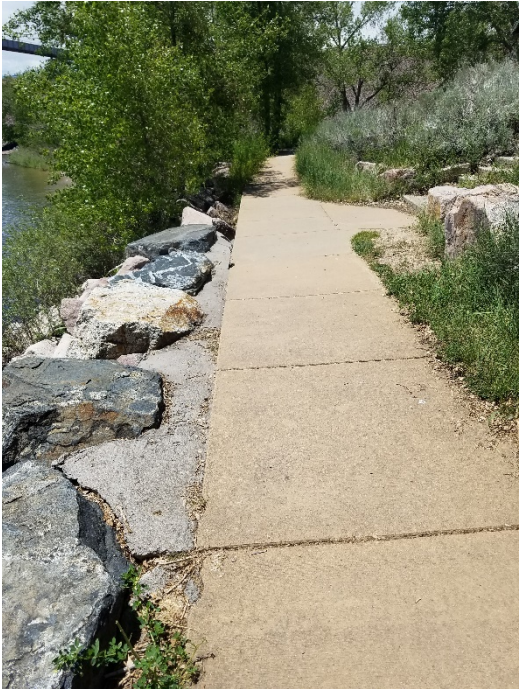
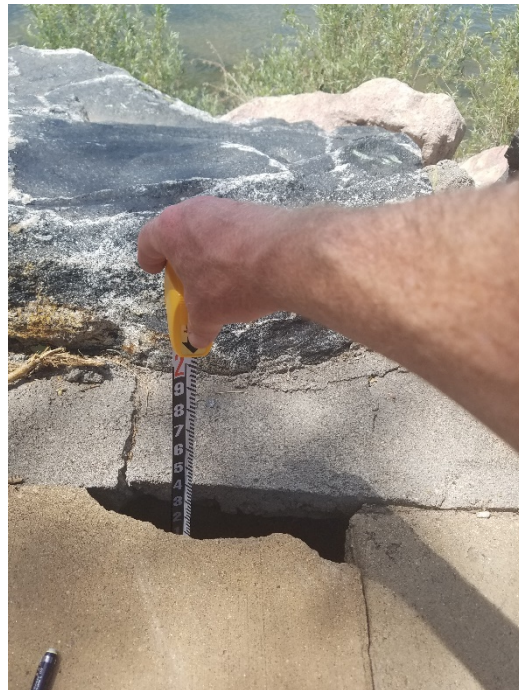
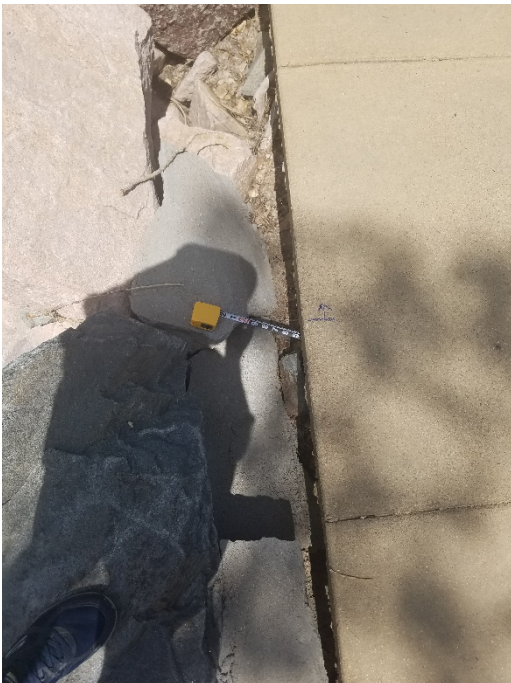
Tower Loop: No new concerns or problems were identified in 2019 on this PRF. Repairs from 2018 Annual Inspection (**Photos 5-7**) are scheduled for end of 2019. New for 2019, erosion was noted at Boulders near fishing area (**Photo 8**), and it is suggested that monitoring be done with future inspections.

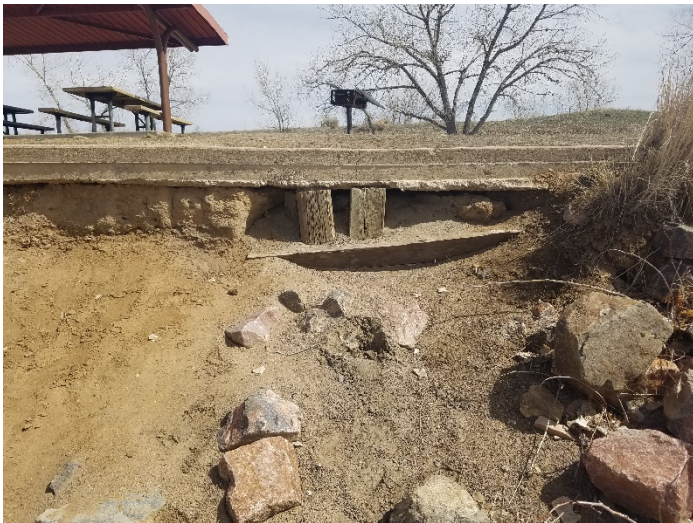
Photo 9

East Shade Shelters: Maintenance identified in 2018 inspection (**Photo 9**); resulted in shoreline protection being budgeted and scheduled for end of 2019 or early 2020. Shifting riprap shown near steps in 2018 inspection (**Photo 10**) was monitored in 2019; suggest continued monitoring of this area. New for 2019, additional shoreline erosion was noted (**Photos 11-12**) continued monitoring of this area is suggested.

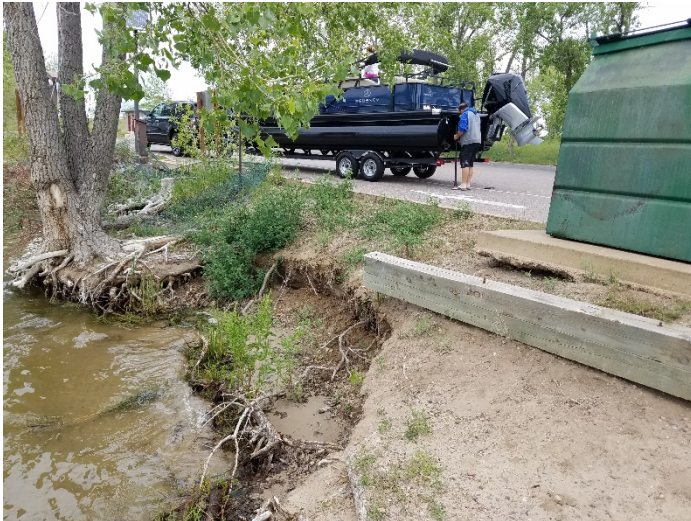
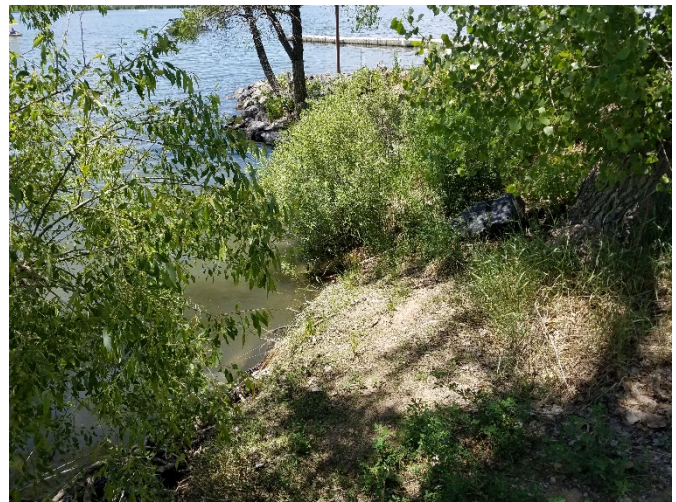
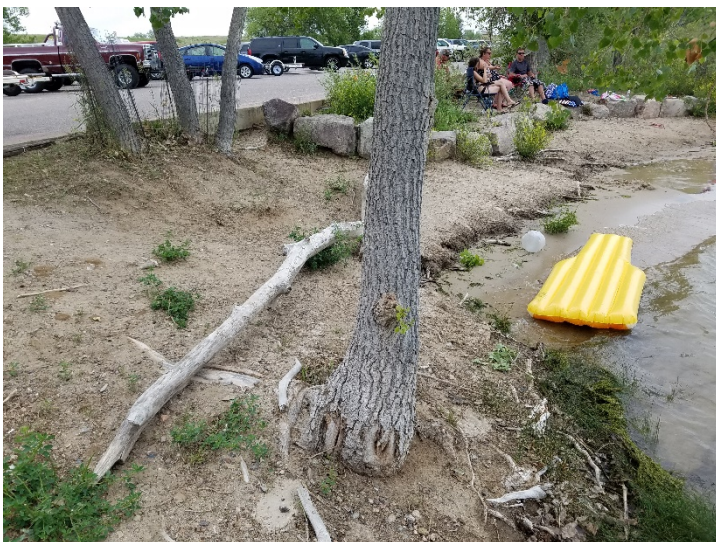
East Boat Ramp: Maintenance identified in 2018 inspection (**Photos 13-15**); resulted in budgeting for shoreline protection which is scheduled for end of 2019 or early 2020. New for 2019, additional shoreline erosion was noted (**Photo 16**) to south of previous shoreline stabilization projects; continued monitoring of this area is suggested.

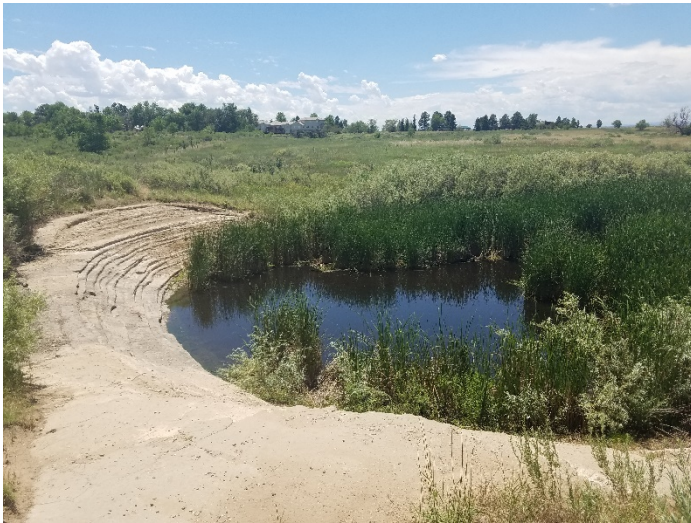
Photo 17

Shop Creek: Minor deterioration of the top of the roller compacted concrete drop structures #2 and #3 was noted (**Photo 17**) similar to 2018 inspection; continued monitoring of this area is suggested. CCSP performs regular maintenance by cleaning the trash racks, mowing/removing vegetation around the trash racks, and removing woody vegetation in areas that could impact the soil cement structures (**Photo 18**). Trash racks require frequent cleaning for proper operation. The Mile High Flood District is coordinating and scheduling a sediment removal for upstream pond outside of state park (**Photo 19**)¹. Weed control for noxious weeds is needed and a maintenance project is being developed for consideration by Authority’s TAC and Board.

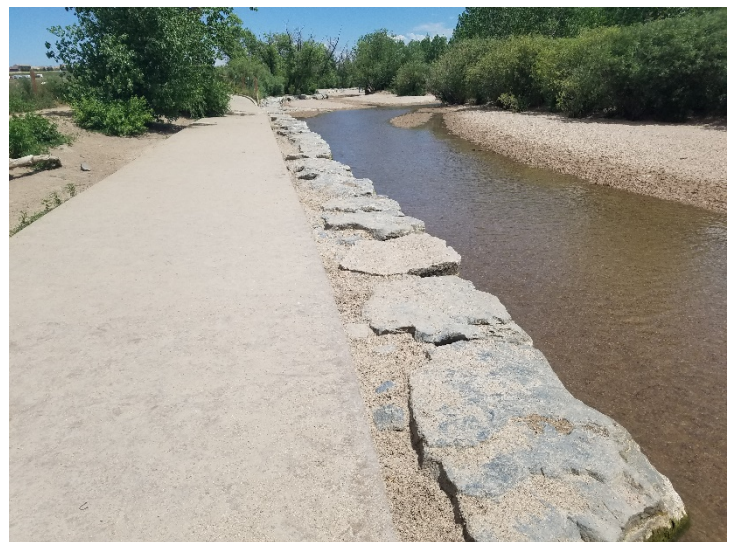
Photo 24

Cherry Creek 12-mile Park Phase I: Phase I was completed in 2012. It has experienced significant sediment aggradation from the 2014 and 2015 storm events. Maintenance identified in 2018 inspection (**Photo 24**); resulted in budgeting for fencing and revegetation which is scheduled for end of 2019. New for 2019, stream sediment levels appear to have a visible improvement over 2018 inspection; continued monitoring is suggested (**Photos 21-22**). Noxious weed control has been performed annually since 2014, and a maintenance effort is being prepared to continue treatment (**Photo 23**); for consideration by Authority's TAC and Board in 2020. Social trails are being formed along bank closed to Dog Off Leash Area; continued monitoring is suggested.

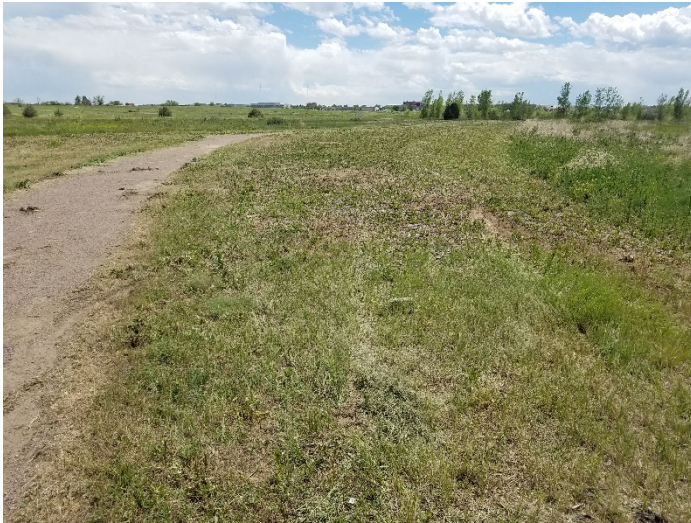
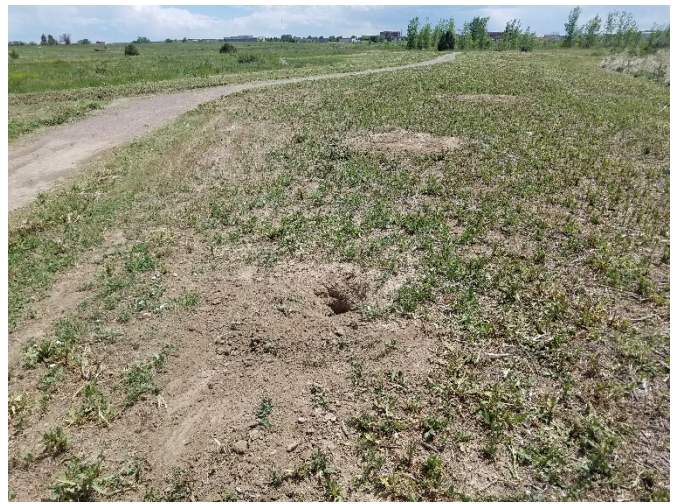
Cottonwood Creek Stream Reclamation: Noxious weed control identified in 2018 inspection was performed by the CCSP and the Authority (**Photos 29-30**), continued maintenance and monitoring of this area is suggested. There were no signs of erosion or unraveling to the main channel area or structures (**Photos 31-32**). A maintenance effort for continuing weed control, mowing, and fencing is being developed for consideration by Authority's TAC and Board in 2020.

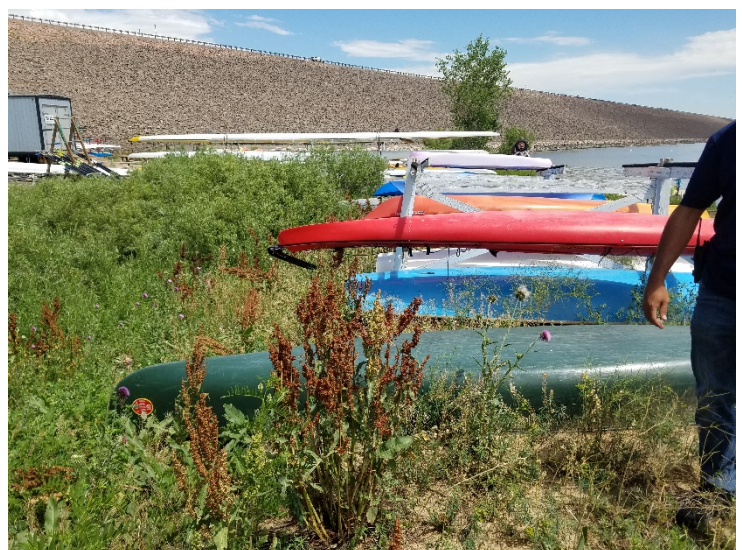
Photo 36

West Boat Ramp: Construction of this PRF was completed in 2014. All maintenance for this PRF is the responsibility of CCSP. Routine maintenance including noxious weed control (mowing and spray application), outlet structure cleaning (box and screen) and clearing willows and woody vegetation from the detention pond and over pipe outfall is needed (**Photos 33-35**). The Marina is storing equipment and materials in spillway area (**Photo 36**); CCSP will follow-up with Marina to relocate these items.

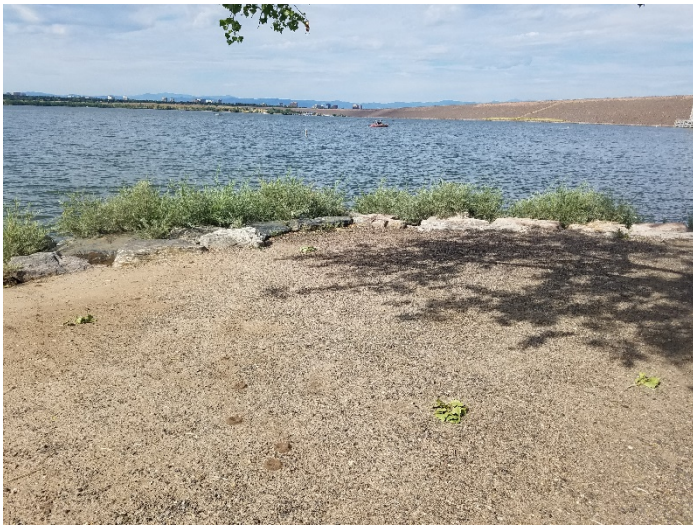
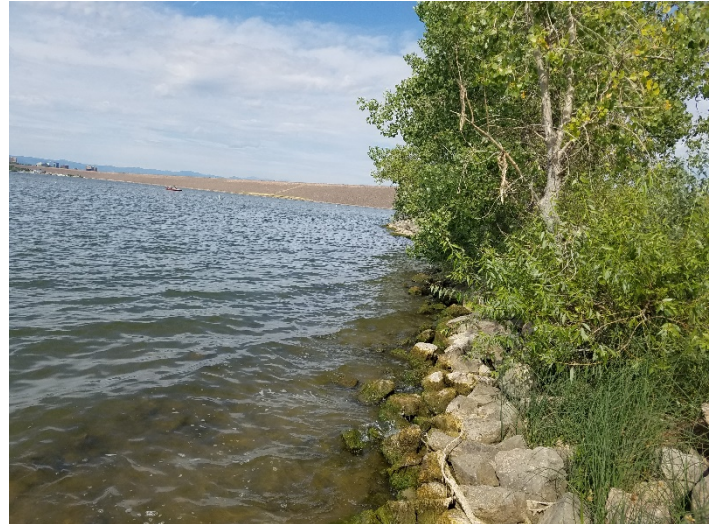
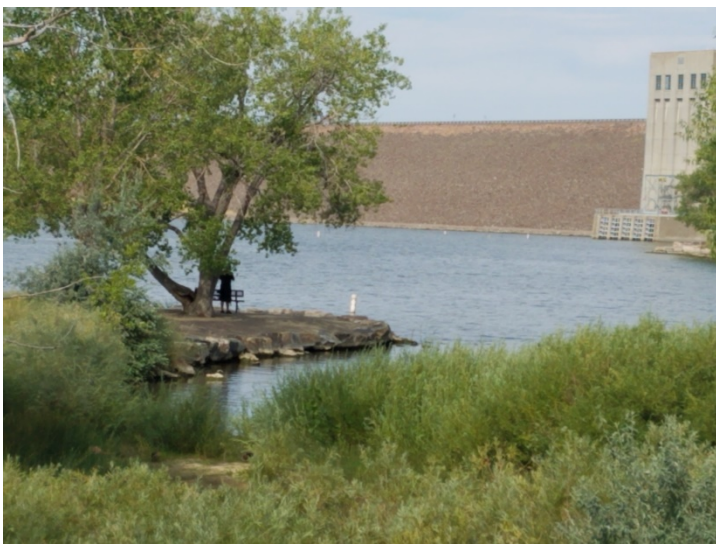
Dixon Grove: No concerns were noted with the original project (**Photos 37-39**). An area to the south of the previous shoreline project shows some erosion (**Photo 40**); continued monitoring of this area is suggested.

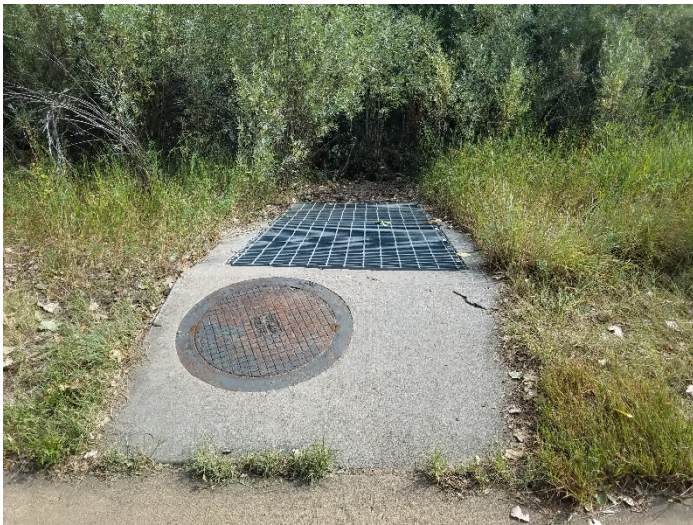
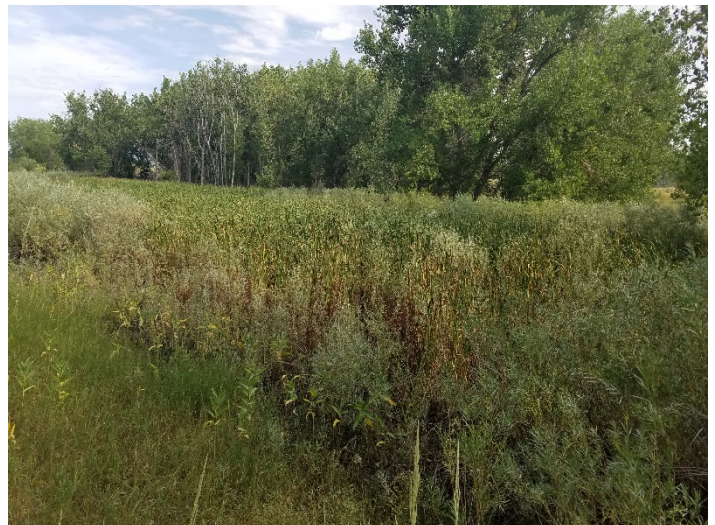
Quincy Drainage: No erosion or revegetation concerns were observed around the detention basin (**Photos 41-42**). CCSP is doing routine maintenance on dead and downed trees (**Photo 43**). Erosion was observed on Quincy Drainage upstream of the detention basin to the Perimeter Road (**Photo 44**).

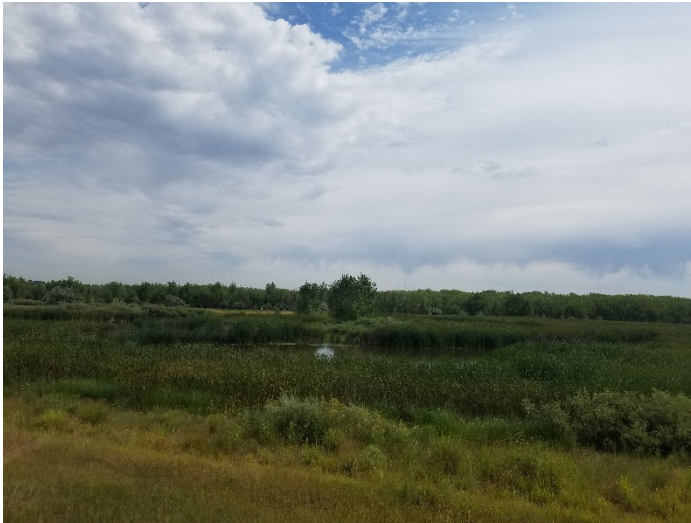
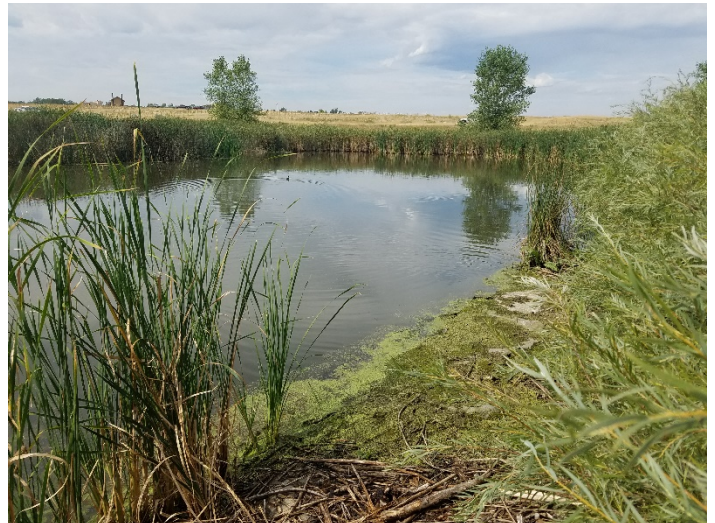
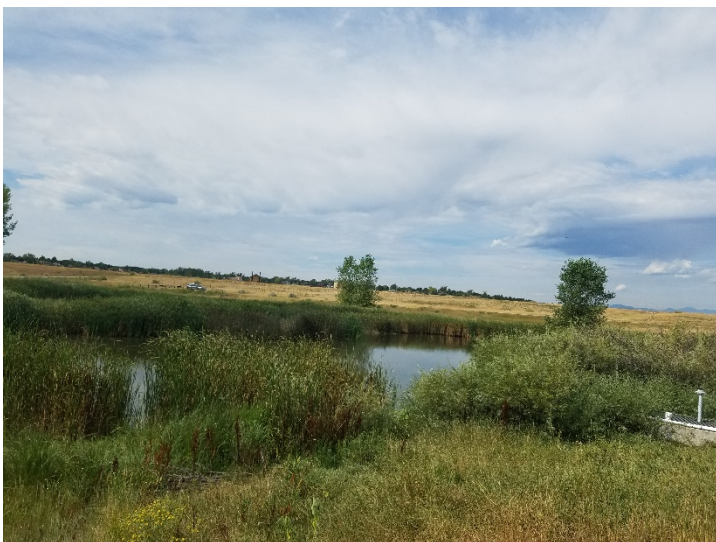
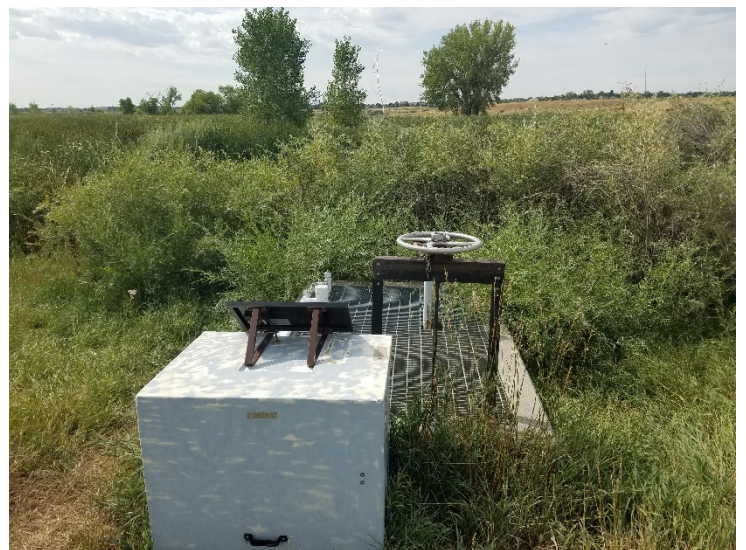
Cottonwood Wetlands: No erosion or revegetation concerns were observed (**Photos 45-48**).
