R I F F L E S T O R I P P L E S

DATE: September 14, 2020 (Updated with TAC Comments on 10/8/20)

SUBJECT: 2020 Annual Field Observation of Pollution Reduction Facilities (PRFs) at CCSP

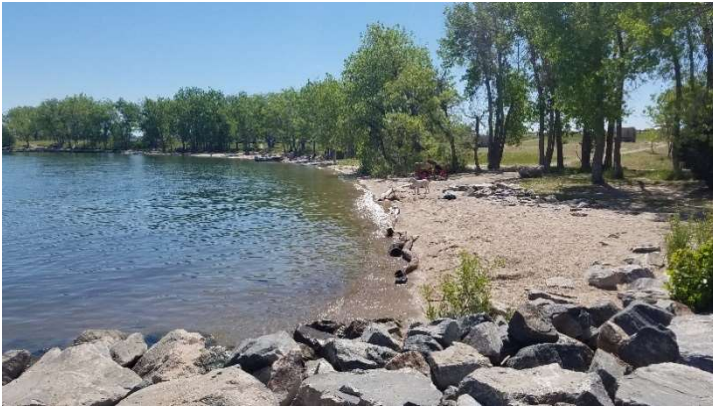
Photo 1

Mountain and Lake Loop (Reservoir Water Surface Elevation = 5550.2): Construction of this PRF was completed in 2013. Additional shoreline stabilization and restoration work was performed following the 2015 flooding. This project appears to be functioning effectively as shoreline stabilization (**Photos 1 and 2**). There is some erosion near a trail access (**Photo 3**) and a maintenance project is included in this report for TAC and Board consideration. This PRF provides a BioRetention Area that treats access road and parking (**Photo 4**); this area is well vegetated and appears stable.

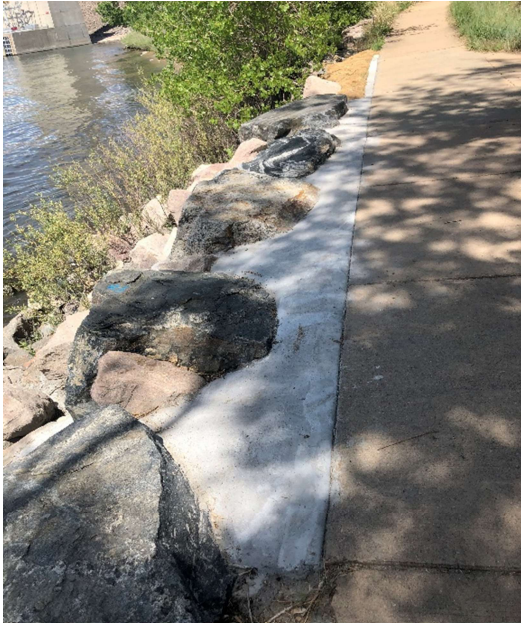
Photo 5

Tower Loop (Reservoir Water Surface Elevation = 5550.2): Repairs from 2018 Annual FO (**Photos 5**) were completed on April 20, 2020. New for 2020, the crusher fines behind grouted boulders are lower than top edge of grout (**Photo 6**); maintenance of crusher fines will be brought to attention of CCSP. There is erosion occurring where the existing shoreline protection stops (**Photo 7**); a second phase of shoreline protection is planned in the current Capital Improvement Program. Ducks are monitoring the water quality and the effectiveness of an existing boulder Jetty (**Photo 8**).

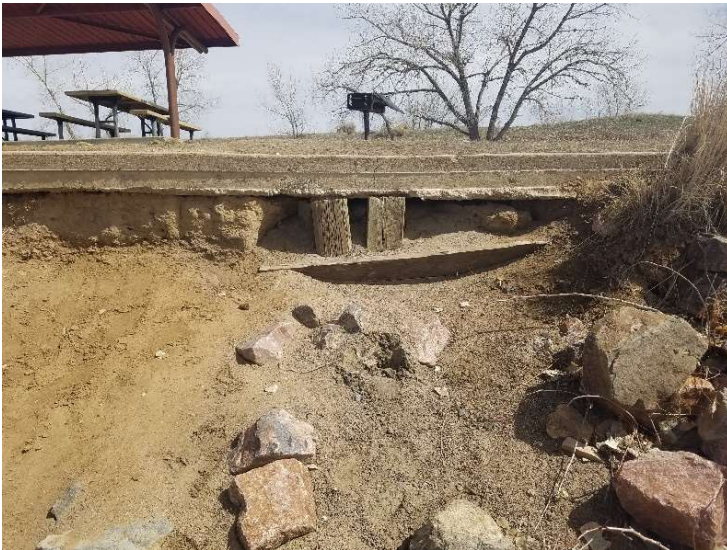
Photo 9

East Shade Shelters: Erosion was noted in the 2018 FO (**Photo 9**) resulted in shoreline protection being scheduled for 2020. Shifting riprap shown near steps in 2018 observation (**Photo 10**) was monitored in 2019. The 2020 repair has been submitted for review and approval by the United States Army Corps of Engineers (USACOE) and CCSP; repair will be scheduled for construction after approval is received. Additional shoreline erosion was noted in 2019 (**Photos 11-12**) continued monitoring of this area is suggested.

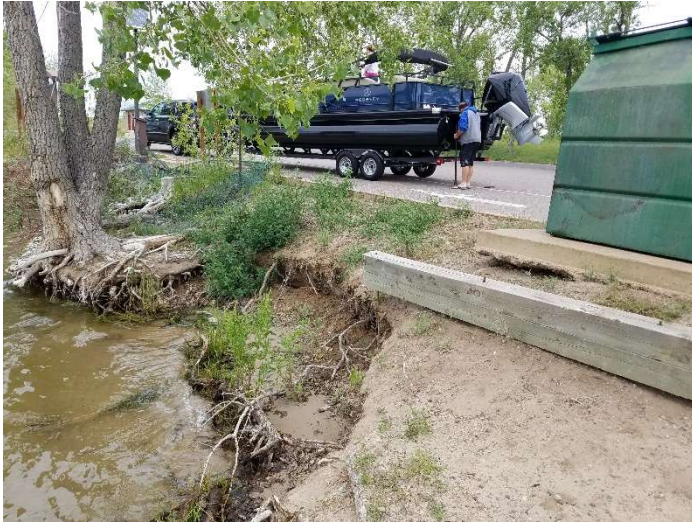
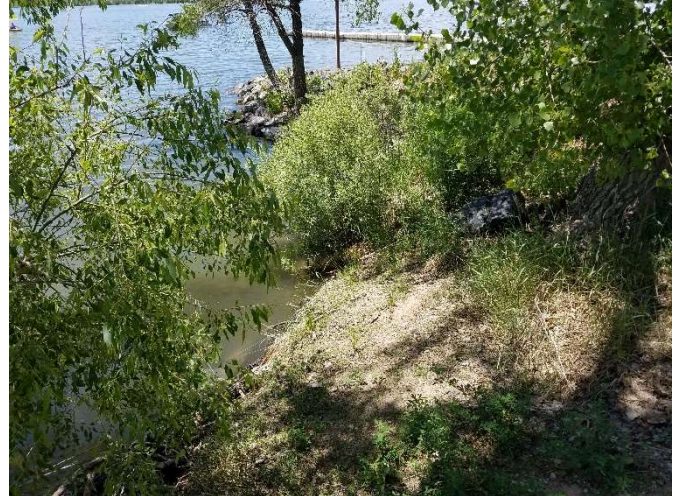
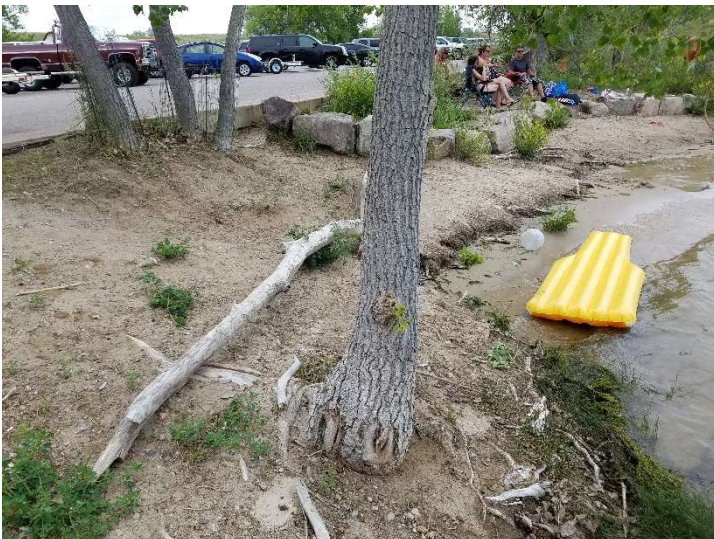
East Boat Ramp: Maintenance identified in 2018 FO (**Photos 13-15**) resulted shoreline protection being scheduled for 2020. The 2020 repair has been submitted for review and approval by the United States Army Corps of Engineers (USACOE) and CCSP; repair will be scheduled for construction after approval is received. First observed in 2019, additional shoreline erosion was noted (**Photo 16**) to south of previous shoreline stabilization projects; continued monitoring of this area is suggested.

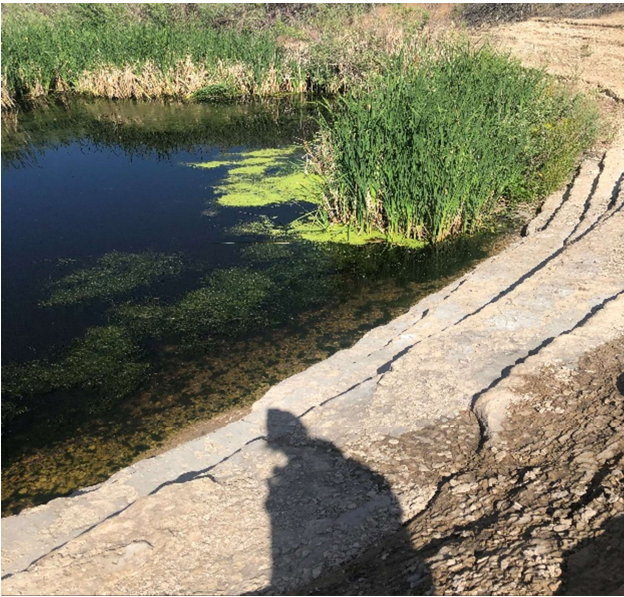
Photo 17

Shop Creek: Minor deterioration of the top of the roller compacted concrete drop structures #2 and #3 (**Photo 17**); continued monitoring of this issue is suggested. CCSP performs regular maintenance by cleaning the trash racks and mowing and removing vegetation around inlets. Vegetation intrusion in inlets was noted drop structures #1 and #2 (**Photo 18**); maintenance of these inlets will be brought to the attention of CCSP. The Mile High Flood District has completed a sediment removal for upstream pond outside of state park (**Photo 19**)¹. Weed control (**Photo 20**) started in 2020 and the continuation of this program is included in this report for consideration by the TAC and Board.

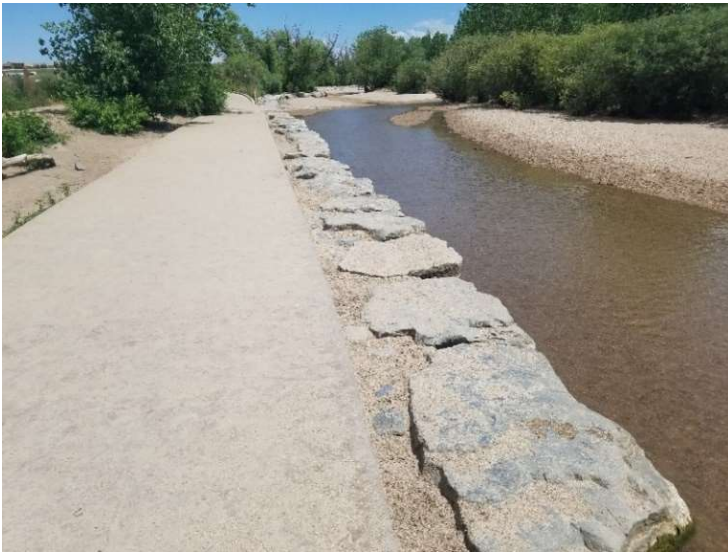
Photo 21

Cherry Creek 12-mile Park Phase I: Phase I was completed in 2012. It did experience significant sediment aggradation from the 2014 and 2015 storm events which appears to have resolved with the breach. Maintenance identified in 2018 FO (**Photo 21**); resulted in budgeting for fencing and revegetation which was completed on August 24, 2020 (**Photo 22**). Bank erosion and social trails were noted in 2019 FO (**Photo 23-24**); planning and permitting have started for this repair. Noxious weed control and mowing was done by CCSP in 2020 and should be continued by CCSP.

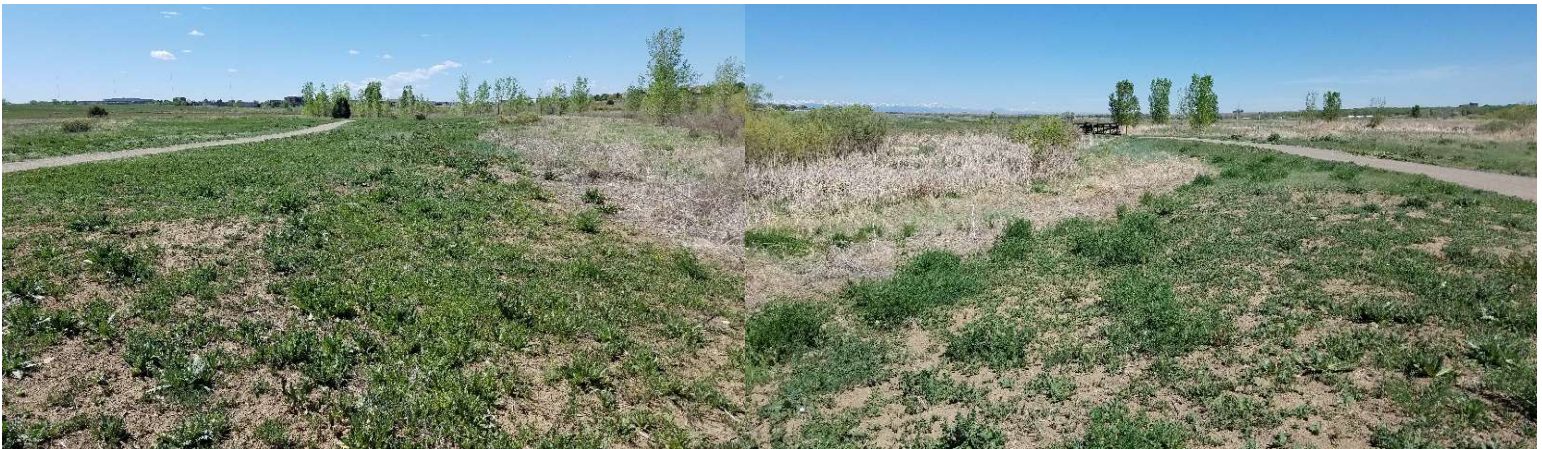
Cottonwood Creek Stream Reclamation: Noxious weed control was performed by the CCSP and the CCBWQA (**Photos 28-29**) in 2020. The east bank of a riffle structure is experiencing some erosion of topsoil over the riprap (**Photo 30**), and continued monitoring of this issue is suggested. The main channel area and structures appear to be functioning (**Photos 31**). Additional weed control for noxious weeds is included in this report for consideration by the TAC and Board.

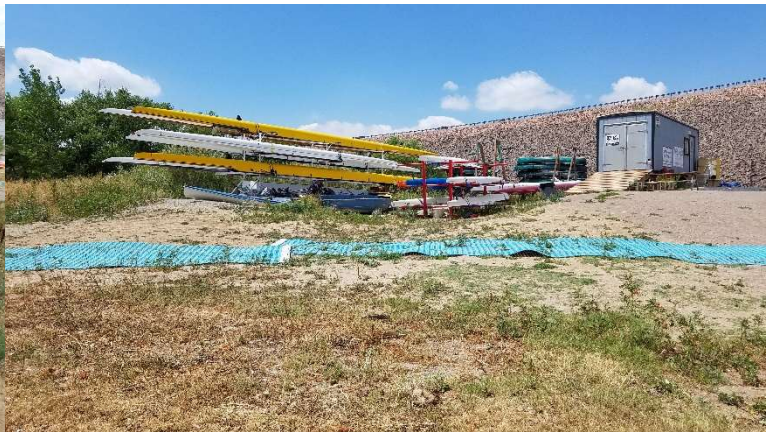
Photo 34

West Boat Ramp (Reservoir Water Surface Elevation = 5549.4): Construction of this PRF was completed in 2014. All maintenance for this PRF is the responsibility of CCSP. Routine maintenance that was noted in 2019 FO and has been completed: cleaning of the outlet structure box and screen and clearing of woody vegetation (**Photo 31**) and removal of tree over pipe outfall is needed (**Photos 32**). Weed control is still needed (**Photo 33**) and should be continued by CCSP. Marina continues to store equipment and materials in spillway area (**Photo 34**); CCSP staff will continue to work with the Marina to relocate these items.

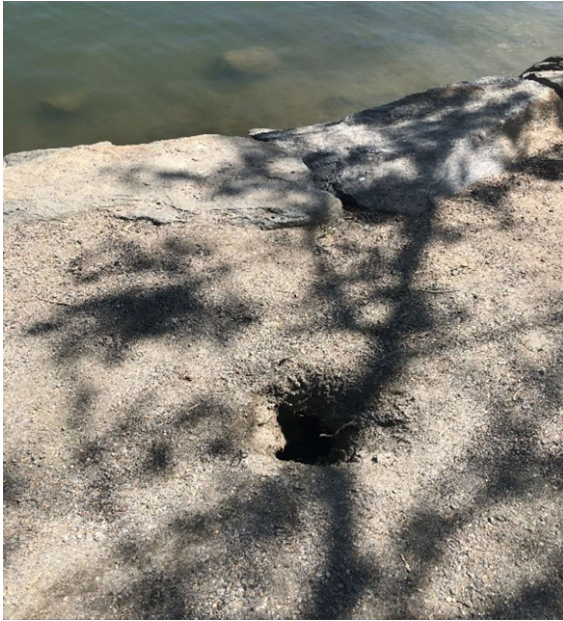
Photo 35

Dixon Grove (Reservoir Water Surface Elevation = 5550.2): A hole developed near the edge on the Shoreline (**Photo 35**); CCSP staff were notified and repair was made (**Photo 36**). A gap between a boulder and the grout has formed (**Photo 37**), continued monitoring of this issue is suggested. Starting with the 2019 FO, an area to the south of the existing shoreline protection shows some erosion (**Photo 38**), a second phase of shoreline protection will be included in the upcoming Capital Improvement Program for consideration by TAC and Board. The riprap installed along the shoreline appears to be working (**Photo 39**).

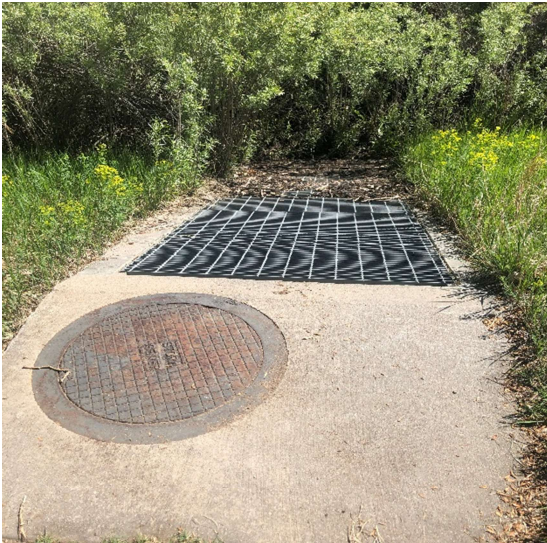
Photo 41

Quincy Drainage: No erosion or revegetation concerns were observed around the detention basin (**Photos 41-42**). CCSP is doing routine maintenance on dead and downed trees (**Photo 43**). Erosion was observed on Quincy Drainage upstream of the detention basin to the Perimeter Road (**Photo 44-45**).

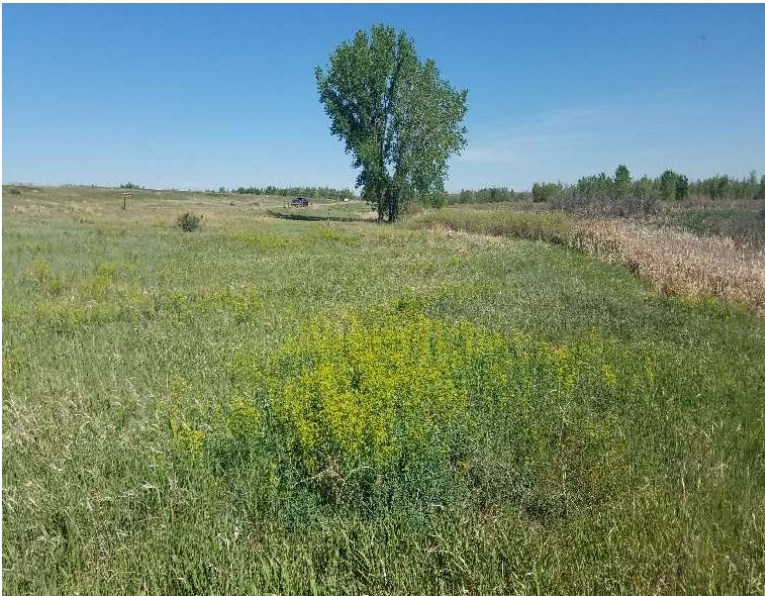
Photo 45

Cottonwood Wetlands: Noted Leafy spurge on the west bank (**Photo 45**). The stakes and wires that were supporting the trees when planted are now constricting them; it is suggested that these stakes and wire be removed since they are no longer needed (**Photo 46**). No concerns were observed with pond and outlet structure (**Photos 47-48**). A maintenance effort for control of noxious weeds is included in this report for TAC and Board consideration.
