**DATE:** October 28, 2021

**FROM:** Richard G. Borchardt PE, CFM

**SUBJECT:** 2021 Annual Field Observation of Pollution Reduction Facilities (PRFs) at CCSP

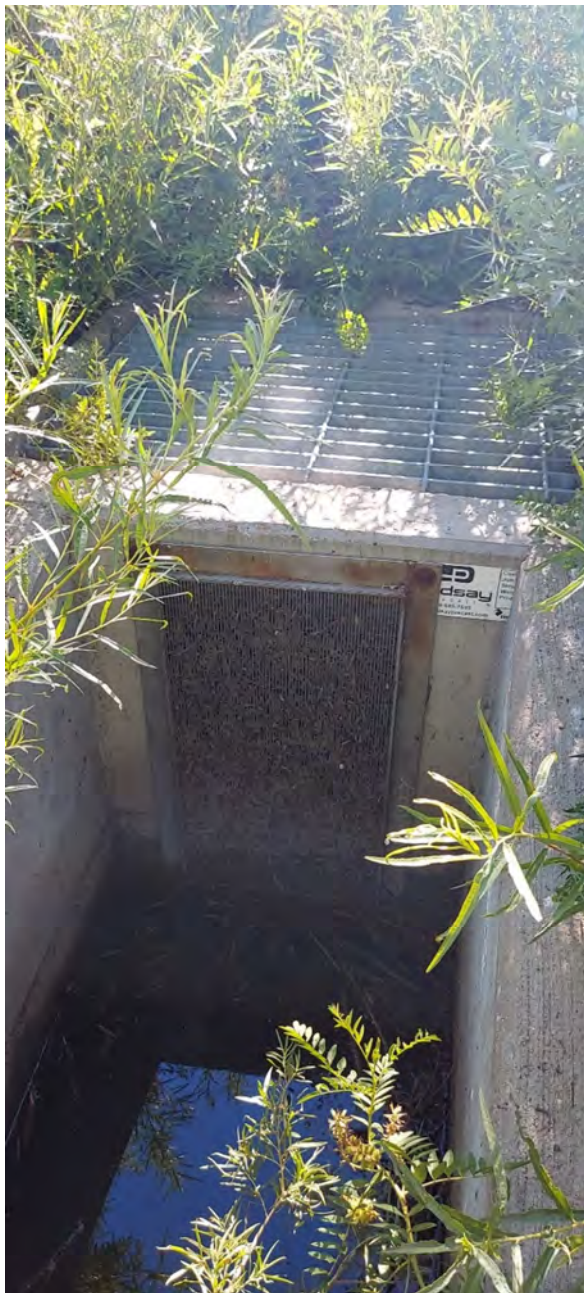
Photo 1

Construction of this PRF was completed in 2014. All maintenance for this PRF is the responsibility of CCSP. Routine maintenance cleaning of the outlet structure box and screen and clearing of woody vegetation that was completed by CCSP staff between the 7/7/21 (**Photo 1**) and 8/25/21 (**Photo 2**) FOs. Marina continues to store equipment and materials in spillway area (**Photo 3**); CCSP staff will continue to work with the Marina to relocate these items. Some pooling of water in outlet structure was observed. Noxious weeds (Leafy Spurge, Musk and Canadian Thistle, etc.) are present. Lower Branches of Trees (Cottonwood and Peach-Leaf Willow) could benefit from trimming.

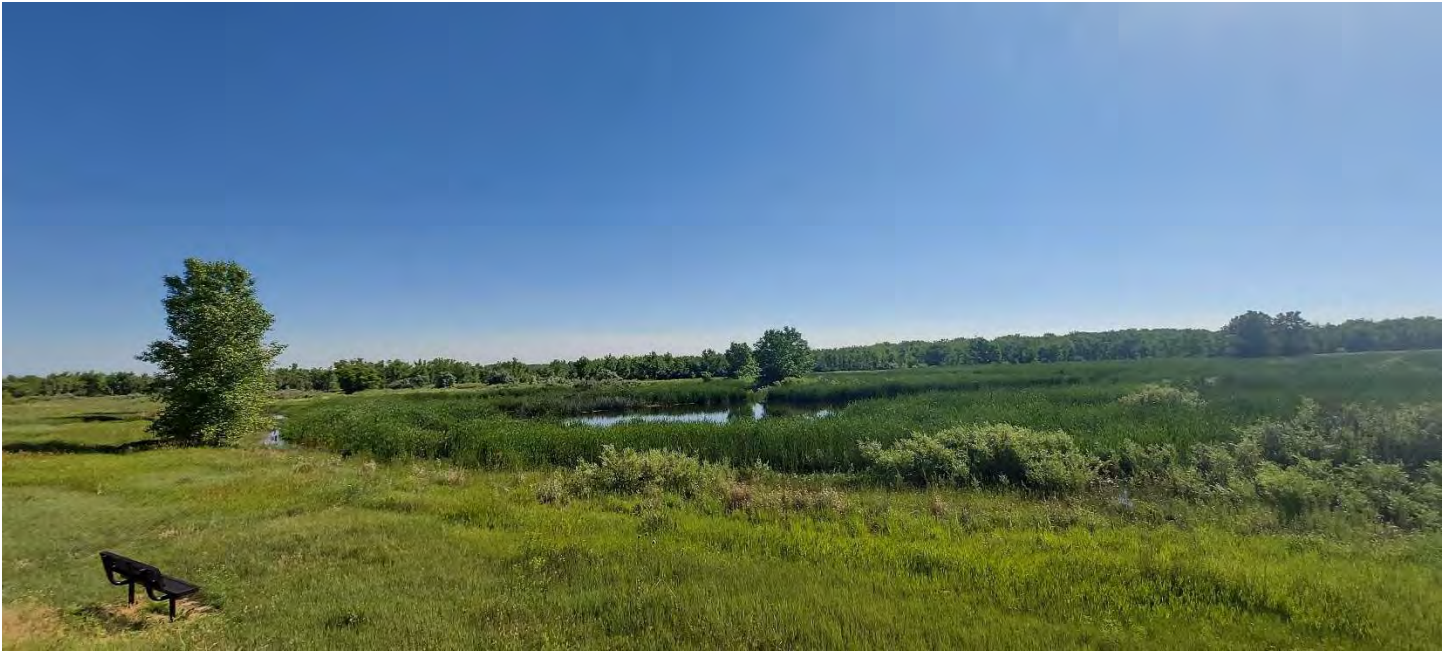
Photo 4

Cottonwood Wetlands: Weed Control efforts by CCBWQA and CCSP appear to be working. Continued Weed control is still needed, as noxious weeds (Leafy Spurge, Musk and Canadian Thistle, etc.) are present. (**Photos 4 and 5**). Some woody vegetation was observed around outlet (**Photo 6**) and water level was up (**Photo 7**) from recent storm, so lower grates of outlet structure were under water and not observed.

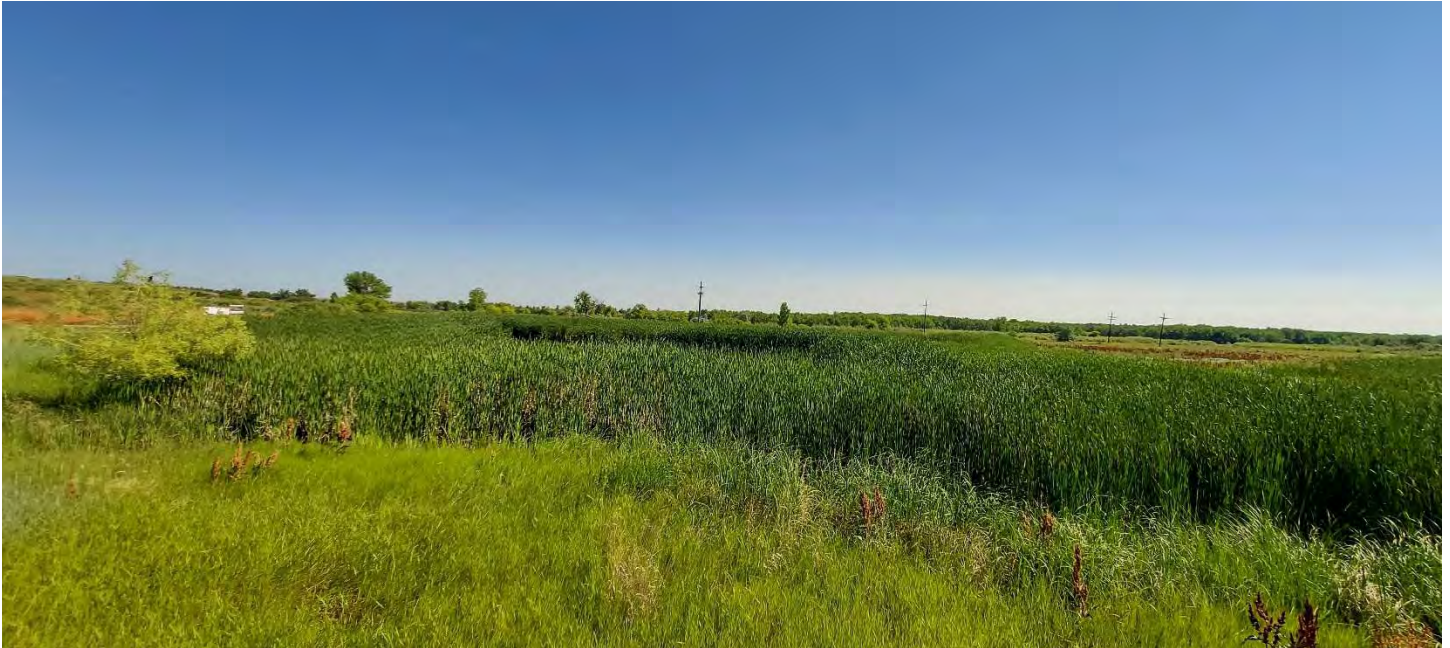
Photo 8

Cottonwood Creek Stream Reclamation: Riparian and wetland vegetation along stream banks is thriving (**Photos 8 and 11**). Xcel Gas Line installation is disturbing adjacent upland vegetation to the stream (**Photo 9**). Weed Control efforts by CCBWQA and CCSP appear to be working. Continued Weed control is still needed, as noxious weeds (Leafy Spurge, Musk and Canadian Thistle, etc.) are present consider expansion of weed control to include Russian Olive Tree Removal (**Photo 10**).

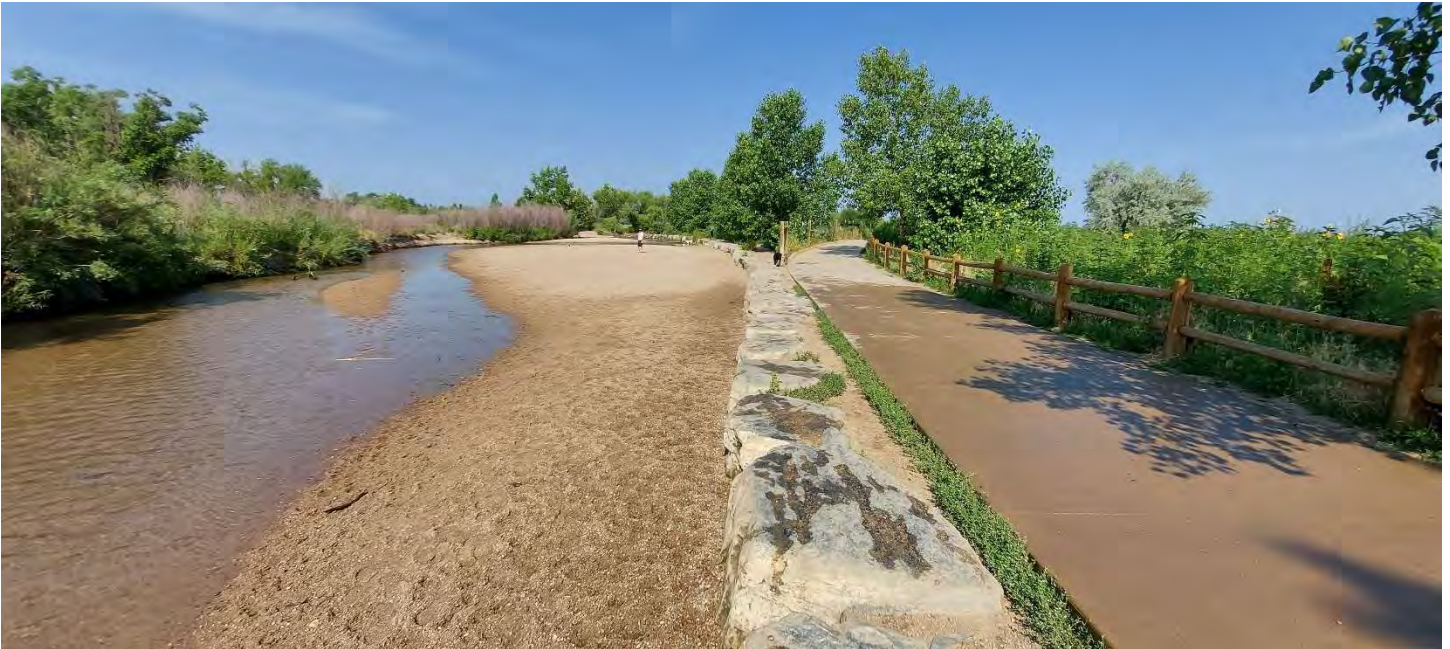
Photo 12

Cherry Creek 12-mile Park Phase I: 2019 revegetation effort in fenced area is filling in (**Photo 12**). Phase I was completed in 2012 and it experienced significant sediment aggradation from the 2014 and 2015 storm events, appeared to have improved in 2020, now bed erosion is taking place with water now appearing at bottom of boulder edging and soil between trail and boulders is eroding leaving exposed riprap (**Photo 13**); the Cherry Creek 12-mile park 3 project currently under design will help provide grade control and prevent further bed erosion at the north end of Phase 1. Additional evidence of bank erosion is taking place (**Photos 14 and 15**).

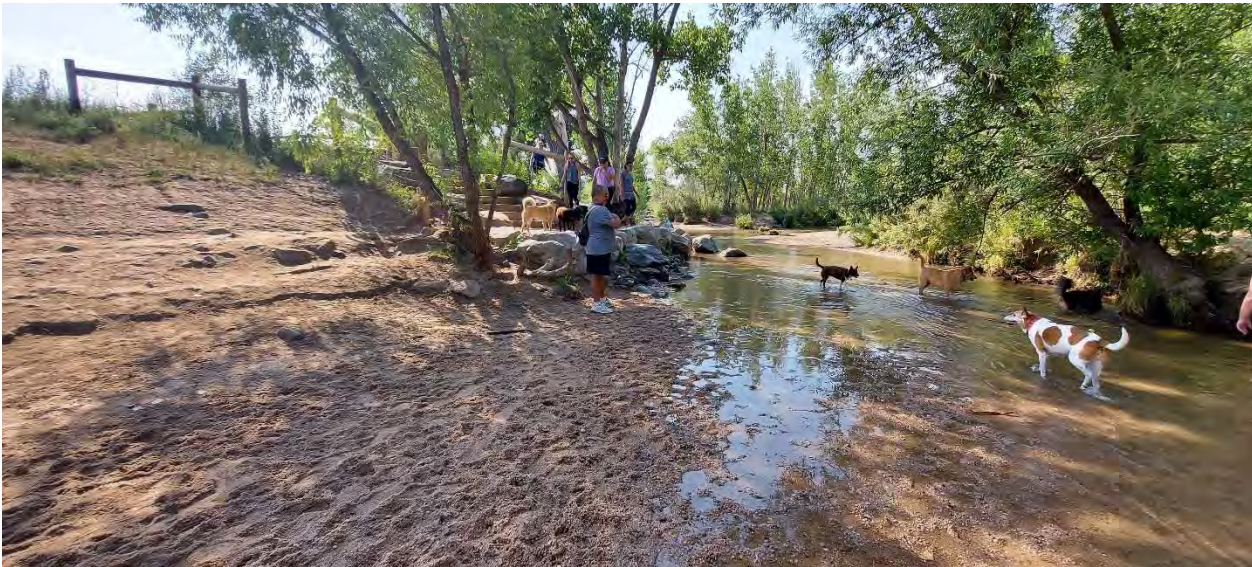
Photo 16

Cherry Creek 12-mile Park Phase II: Phase II was completed in 2014 and is experiencing high pedestrian and dog activity. It did experience significant sediment aggradation from the 2014 and 2015 storm events, appeared to have resolved itself in 2020, and now appears to be experiencing bed erosion (**Photos 16**). Noted in 2019 and 2020 FO, traffic into along the banks of the Creek has denuded the vegetation and continued in 2021 (**Photo 17**). Area behind Boulder Edging is eroding, the Boulders have tipped, and a maintenance effort planned for 2021 has been deferred due to the increased bed and bank erosion that was observed (**Photo 18**) the extents may necessitate a larger Capital Project at some point. Social trails and bank protection were observed on side channel on south end of phase 2 (**Photo 19**), could be done as maintenance effort or part of the afore mentioned larger Capital Project. Noxious weed control and mowing was done by CCSP in 2021 and should be continued by CCSP, as additional noxious weeds are present (musk thistle in **Photo 20**).

- c. No tree or shrub replacement were identified for 2022.
4. The Cherry Creek 12-mile Park phases 1 and 2 projects is experiencing bed and bank erosion. While the Cherry Creek 12-mile Park phase 3 is expected to provide grade control towards the north end of the phase 1 project, the additional bed and bank erosion is a concern and may eventually necessitate a larger rehabilitation project at some point. The high use by dogs and people continue to denude the vegetation in the area; rill erosion has been observed and several eroded travel paths around willows have formed (**Photo 28**). It suggested that this project be evaluated and prioritized with the other projects in the Cherry Creek Reservoir to Cherry Creek State Park Boundary Study.

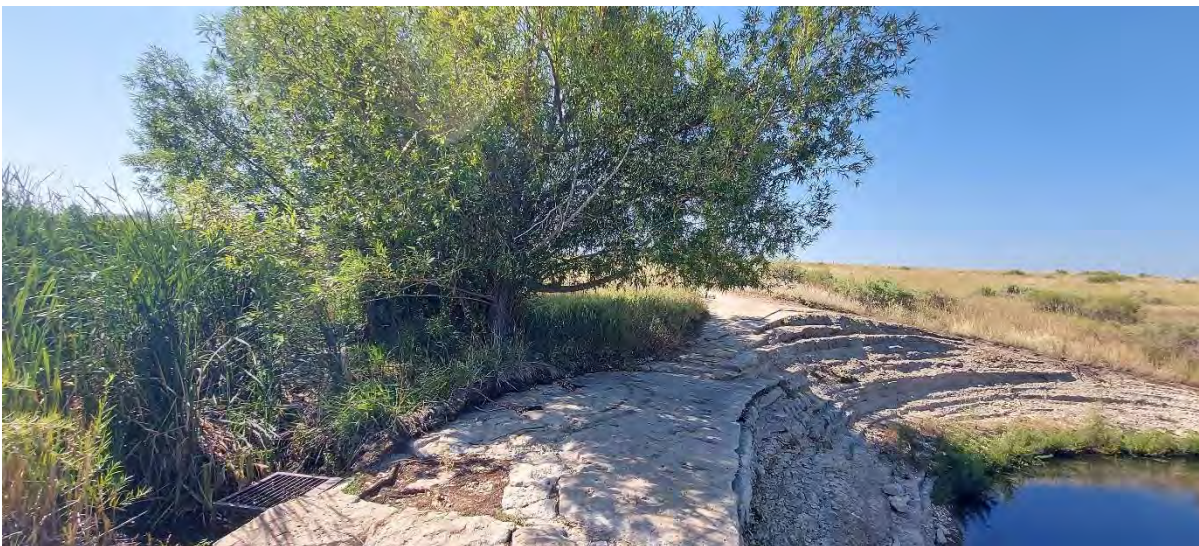
**Photo 21**

Shop Creek: Tree root intruded into roller compacted concrete drop structures #3 (**Photo 21**); CCSP staff will remove tree. CCSP performs regular maintenance by cleaning the trash racks and mowing and removing vegetation around inlets. Inlet box grate on upstream of drop structure #5 (**Photo 22**) has pulled away from structure breaking off a chunk of concrete. In addition, broken bolts for 2 grates were noted during follow-up visit with CCSP Staff. Maintenance work is needed to repair grates to replace broken bolts and pulled away concrete. Weed control activities were going on during 7/16/21 visit (**Photo 23**), it was started in 2020. Continuation of this weed control is included as several noxious weeds (Leafy Spurge, Musk and Canadian Thistle) are still present (**Photo 24**).

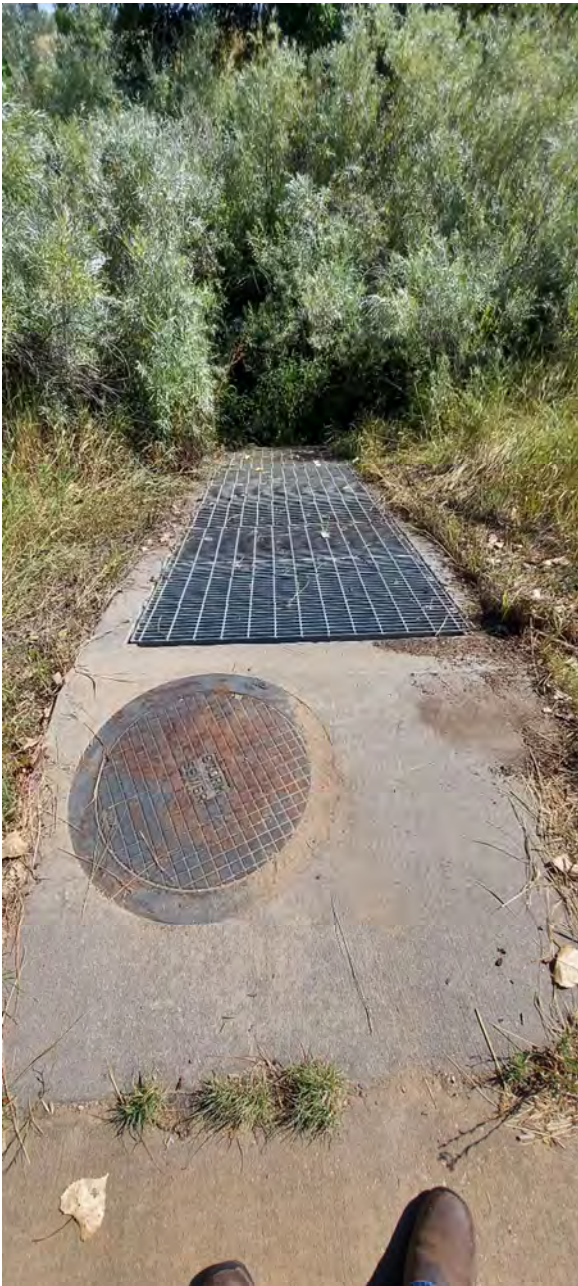
**Photo 25**

Quincy Drainage: CCSP Staff cleans outlet structure (**Photo 25**). No erosion was observed around the detention basin (**Photo 26**). Noxious weeds (Leafy Spurge) were observed on bank (**Photo 27**).
