RIFFLES TO RIPPLES

**DATE:** November 1, 2022 (Revised to include TAC input on November 4, 2022)

**SUBJECT:** 2022 Annual Field Observation of Pollution Reduction Facilities (PRFs) at CCSP

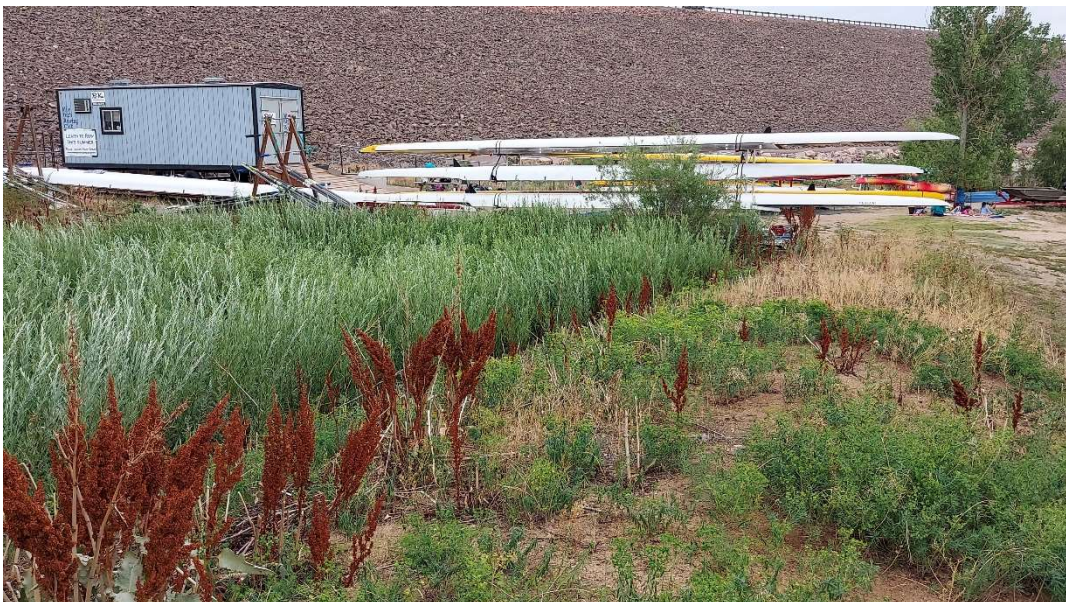
**Photo 2 - 7/28/22**

West Boat Ramp (Reservoir Water Surface Elevation = 5547.7 on 7/28/22): Construction of this PRF was completed in 2014. All maintenance for this PRF is the responsibility of CCSP. Routine maintenance is needed to clear woody vegetation (**Photo 1**). At the 8/2/22 meeting with CCSP, CCSP staff marked limits of the spillway with paint and will coordinate with Marina and associated groups to relocate items currently stored there to another location (**Photo 2**). Maintenance that was identified for CCSP is cutting and clearing of vegetation around outlet and relocating stored items outside of spillway.

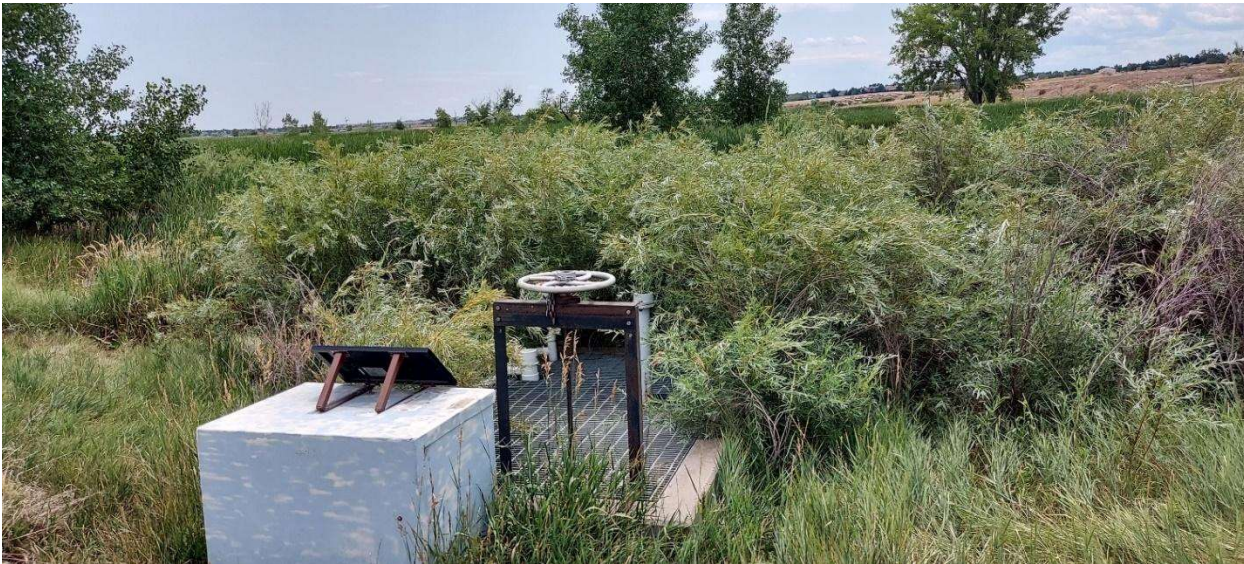
**Photo 3 – 8/1/22**

**Cottonwood Wetlands:** Some woody vegetation was observed around outlet (**Photo 3**). This vegetation was subsequently cut and removed with the wetland harvesting effort. Some aquatic vegetation and algae were observed in water (**Photo 4**) and maintenance bench above outlet grate had cattail debris covering it (**Photo 5**); the outlet grate and bench were subsequently cleaned with the wetland harvesting. Several standing dead trees were noted around the PRF (**Photo 6**). The educational signs appear to be in functional shape (**Photos 7 and 8**). The post-storm visit was done on August 26, 2022; no damage was observed from the post-storm visit and a higher water surface was observed (**Photos 9 and 10**). Stressed vegetation and compaction of soils was observed on the access along the embankment (**Photos 11-14**); decompaction and reseeded will likely benefit the recovery of the native grasses and protection of embankment during overtopping events. The maintenance identified for CCBWQA's consideration is cleaning of the outlet grate and decompaction and revegetation of the access along the embankment.

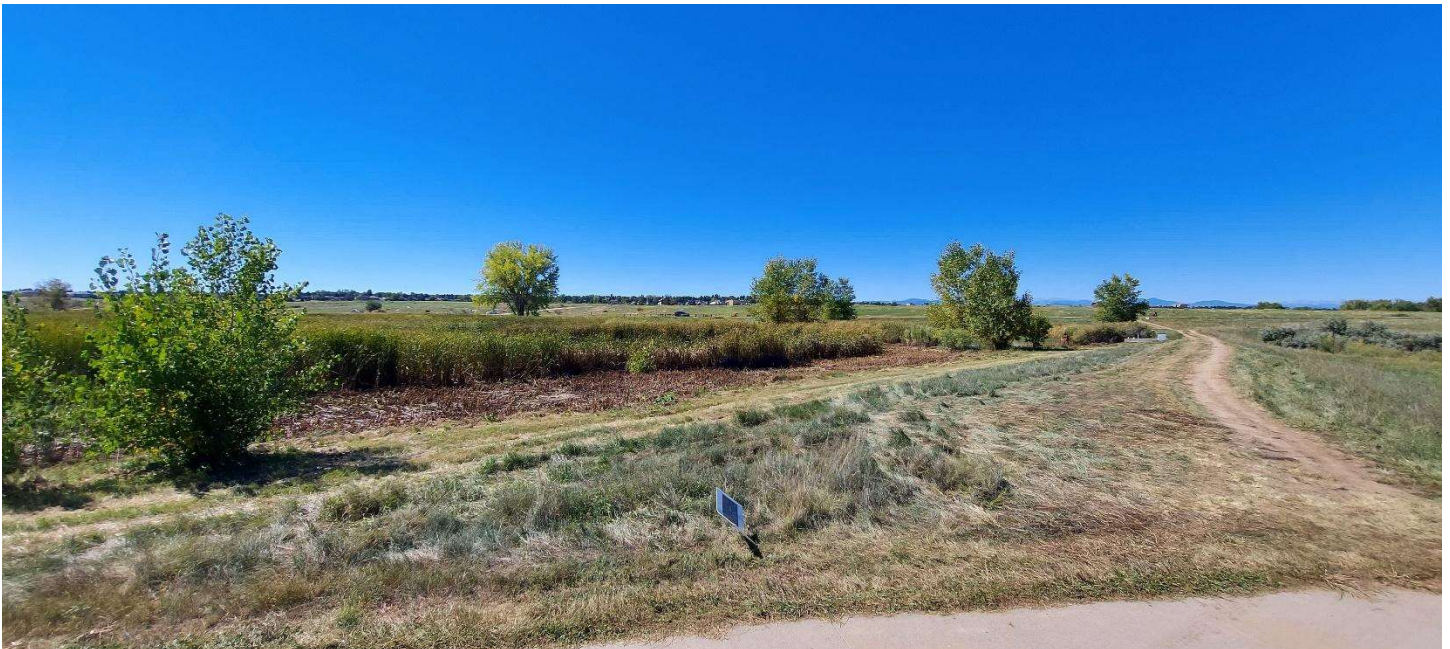
**Photo 12 – 10/10/22 (after heavy use in 2022)**

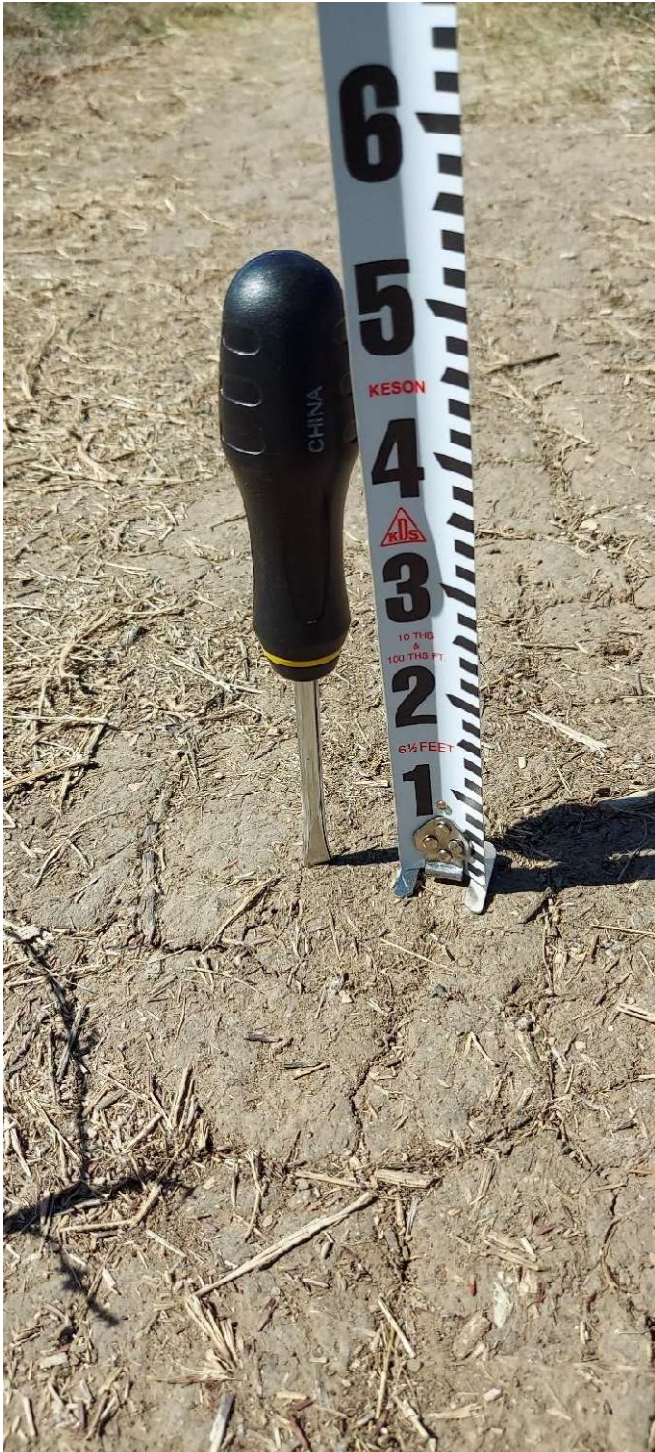
Photo 13 – 10/10/22 (Compaction test along access)

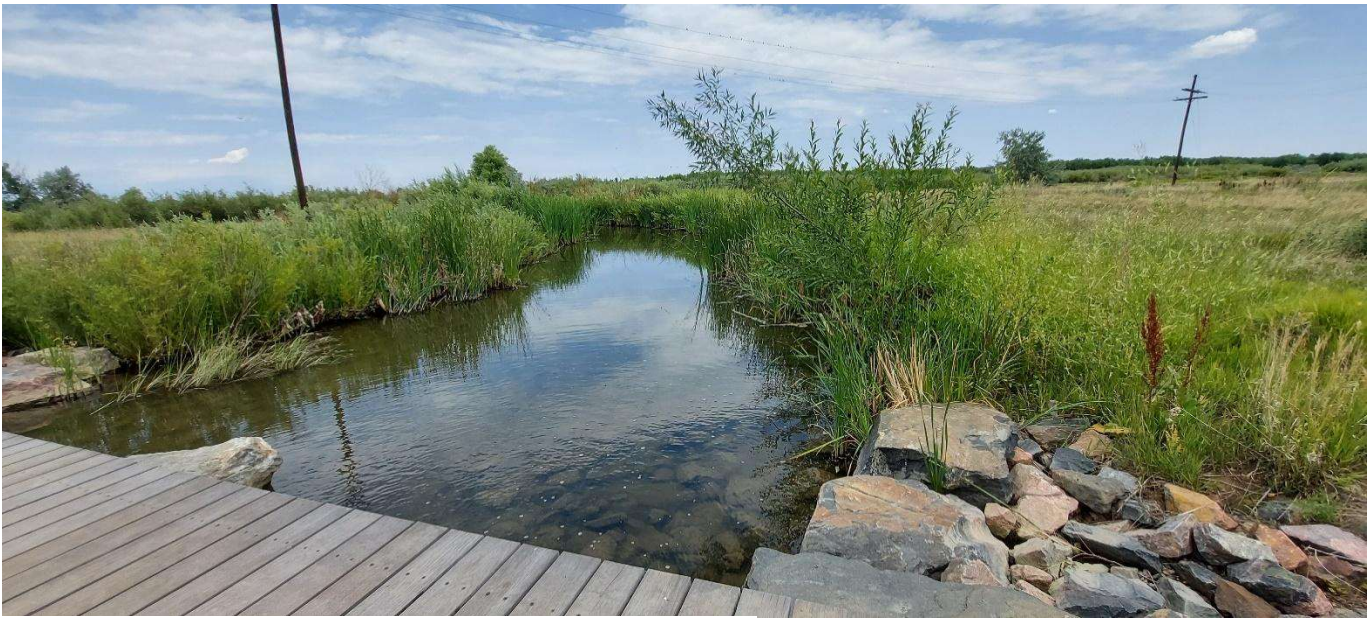
**Photo 15 – 8/1/22**

Cottonwood Creek Stream Reclamation: Riparian and wetland vegetation along stream banks is thriving (**Photo 15**). Riffle drops are functioning with some Russian olives, a Colorado noxious weed list B species, present (**Photo 16**). Common reed, a Colorado noxious weed watch-list species, was observed (**Photo 17**). Several downed trees were noted from beaver activity (**Photo 18**). The post-storm visit was done on August 26, 2022; no damage was observed from the post-storm visit and evidence of high-water debris was observed (**Photos 19 and 20**). No maintenance was specifically identified; however, continued monitoring and coordination with CCSP staff on noxious weeds is suggested.

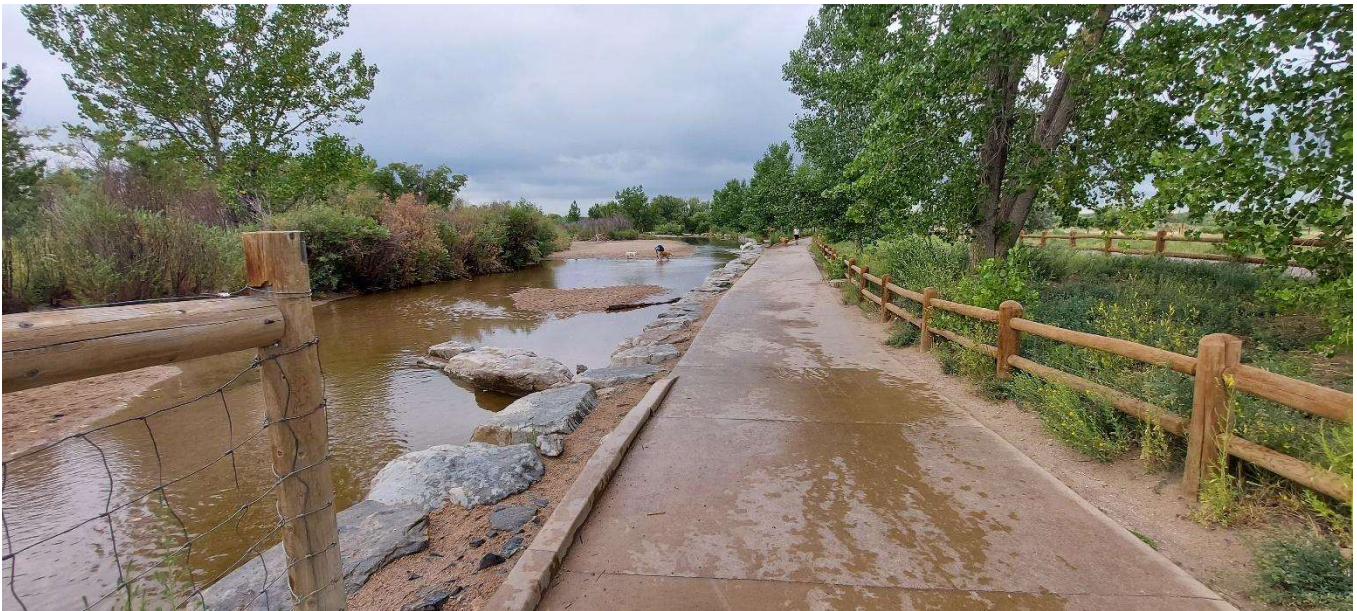
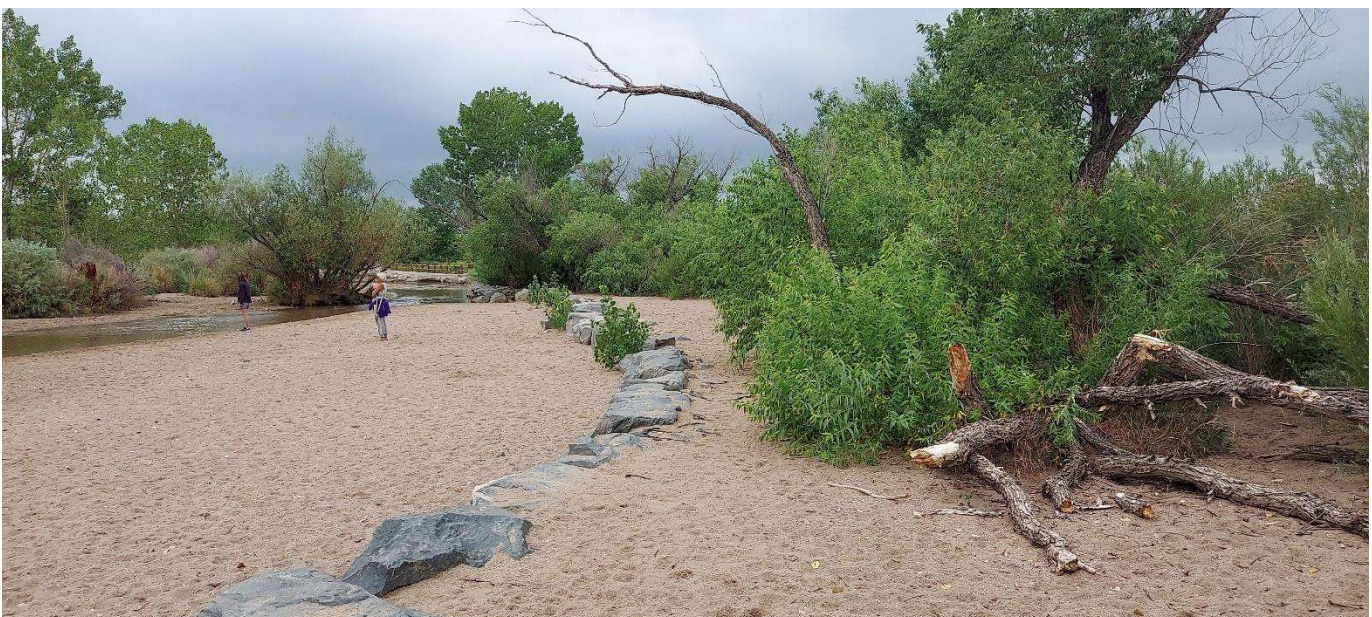
Cherry Creek 12-mile Park Phase I: Phase I was completed in 2012. Bed erosion was noted in 2021 Annual Field Observation. A grade control structure was installed downstream with the Cherry Creek 12-mile Park Phase III project which appears to be helping (**Photos 21 and 22**). Additional bank erosion was observed (**Photo 23**) and the August storm event appears to have accelerated it (**Photo 24**). Bank and bed erosion appear to be active further upstream and away from the grade control structure installed with the Cherry Creek 12-mile Park Phase III project (**Photo 25**). No maintenance was identified; however, a capital project for stream reclamation may be needed. Continued planning is suggested to identify work needed, overall priorities, and costs for Cherry Creek between Lake View Drive and the CCSP Boundary.

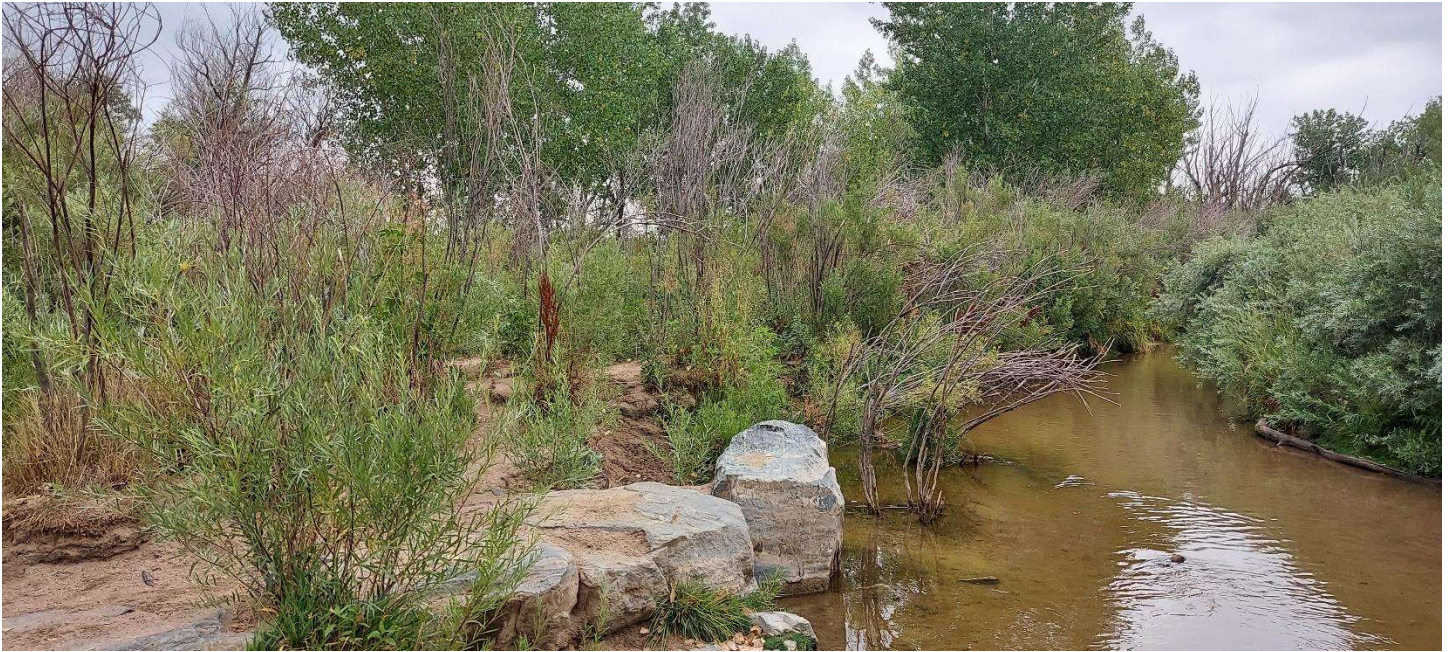
**Photo 23 (Bank Erosion on 7/28/22)**

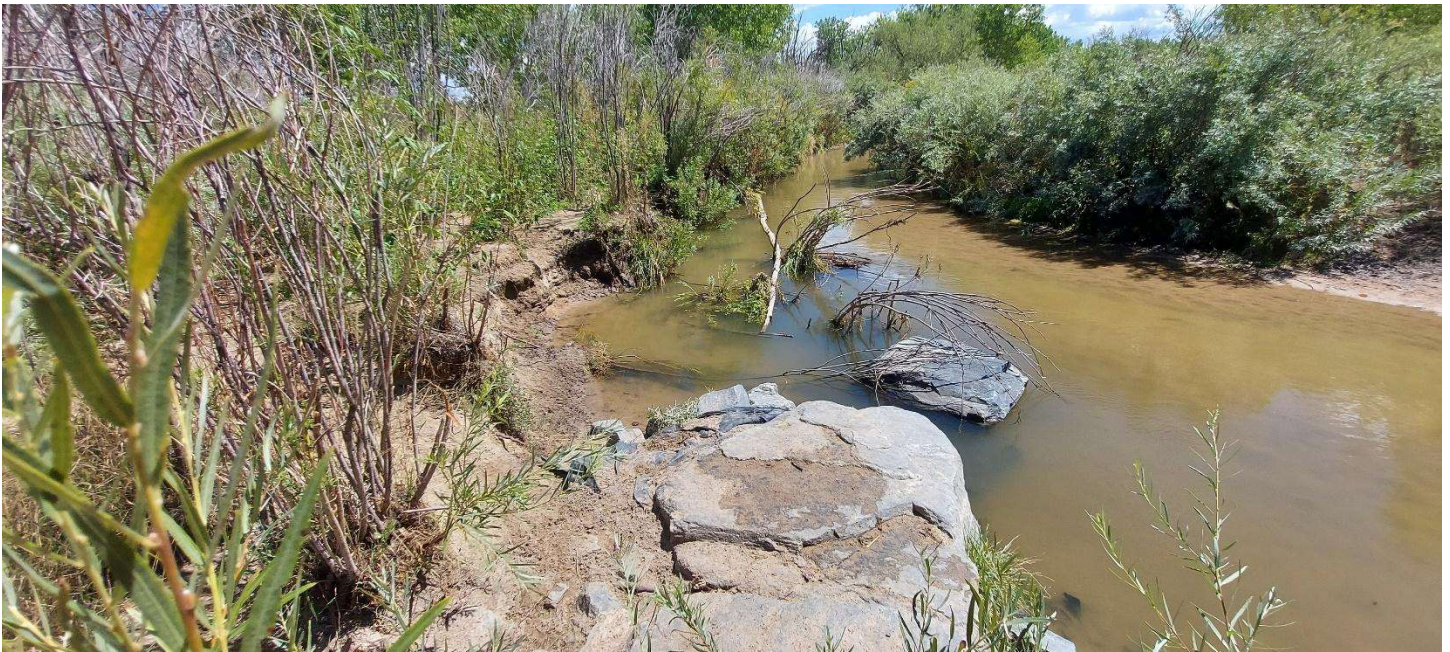
**Photo 24 (Bank Erosion at post-storm visit on 8/23/22)**

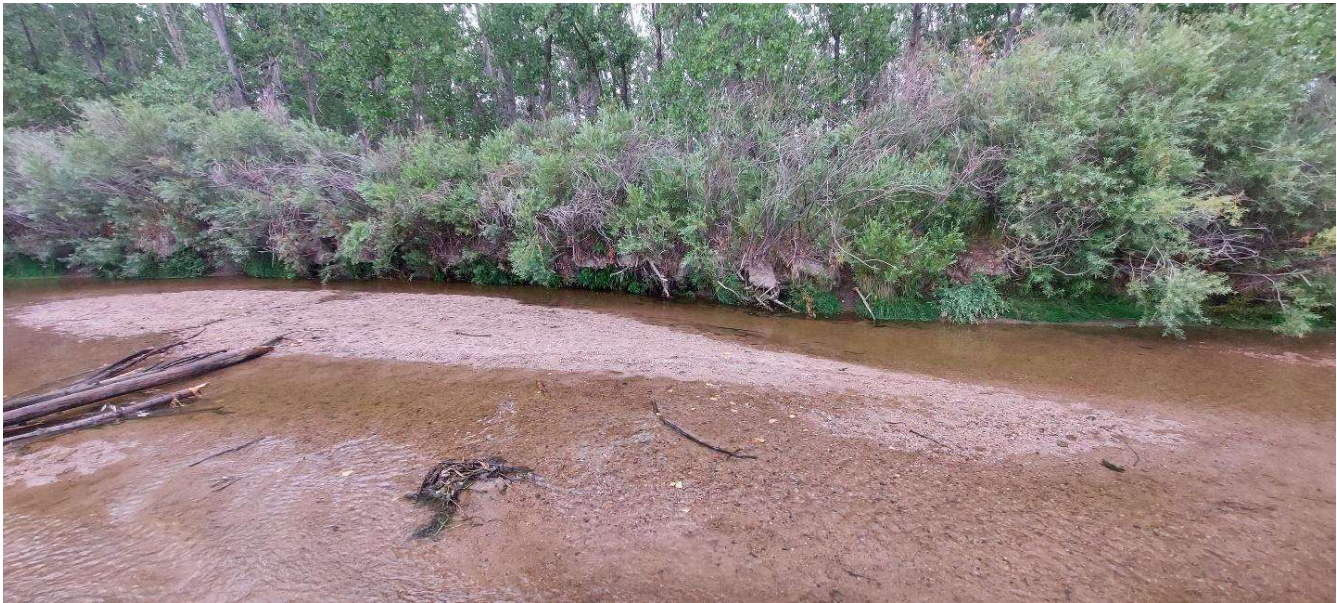
**Photo 27 – 7/28/22**

Cherry Creek 12-mile Park Phase II: Phase II was completed in 2014 and is experiencing high pedestrian and dog activity. Bed and bank erosion were observed near the boundary between Phase I and Phase II (**Photo 27**). Vegetation continues to be denuded by heavy park use (**Photo 28**). Additional bank erosion was observed (**Photo 29**) and the August storm event appears to have accelerated it (**Photo 30**). Bank erosion was observed on secondary channel, east of main stem (**Photo 31**). No maintenance was identified; however, a capital project for stream reclamation may be needed. Continued planning is suggested to identify work needed, overall priorities, and costs for Cherry Creek between Lake View Drive and the CCSP Boundary.

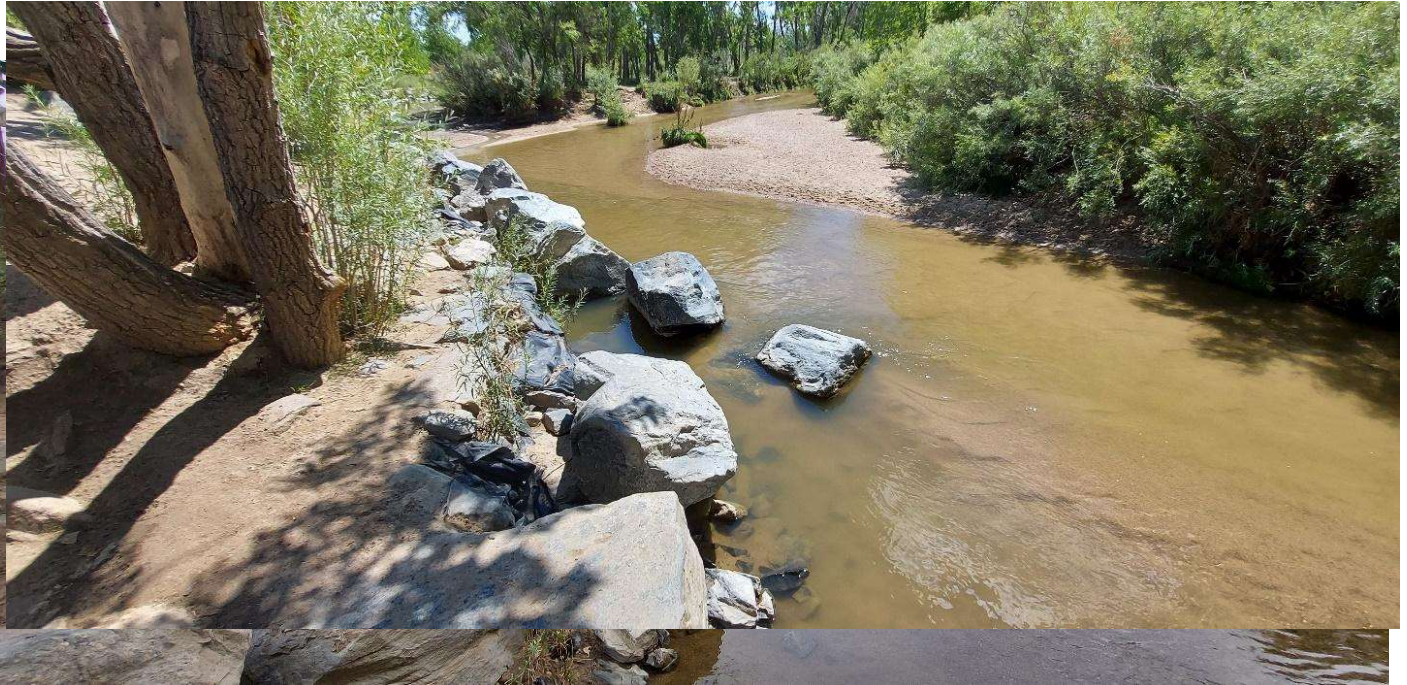
**Photo 29 (Bank and Bed Erosion on 7/28/22)**

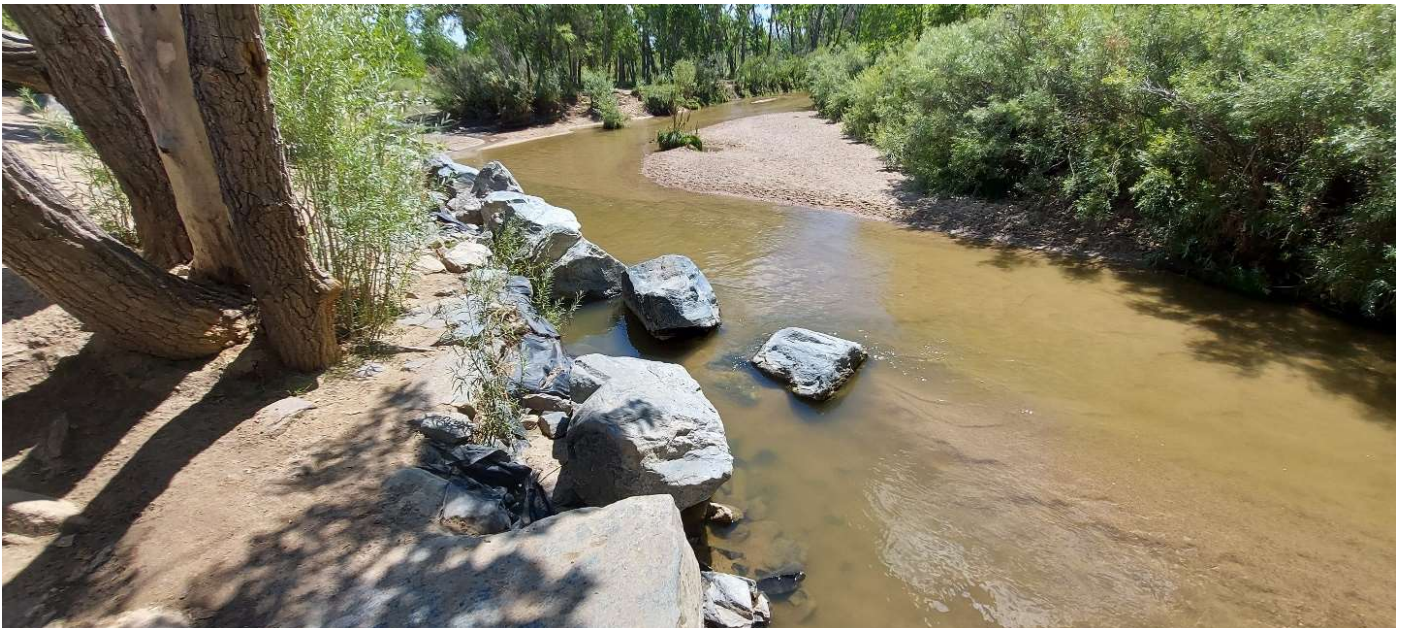
**Photo 30 (Bed and Bank Erosion at post-storm visit on 8/23/22)**

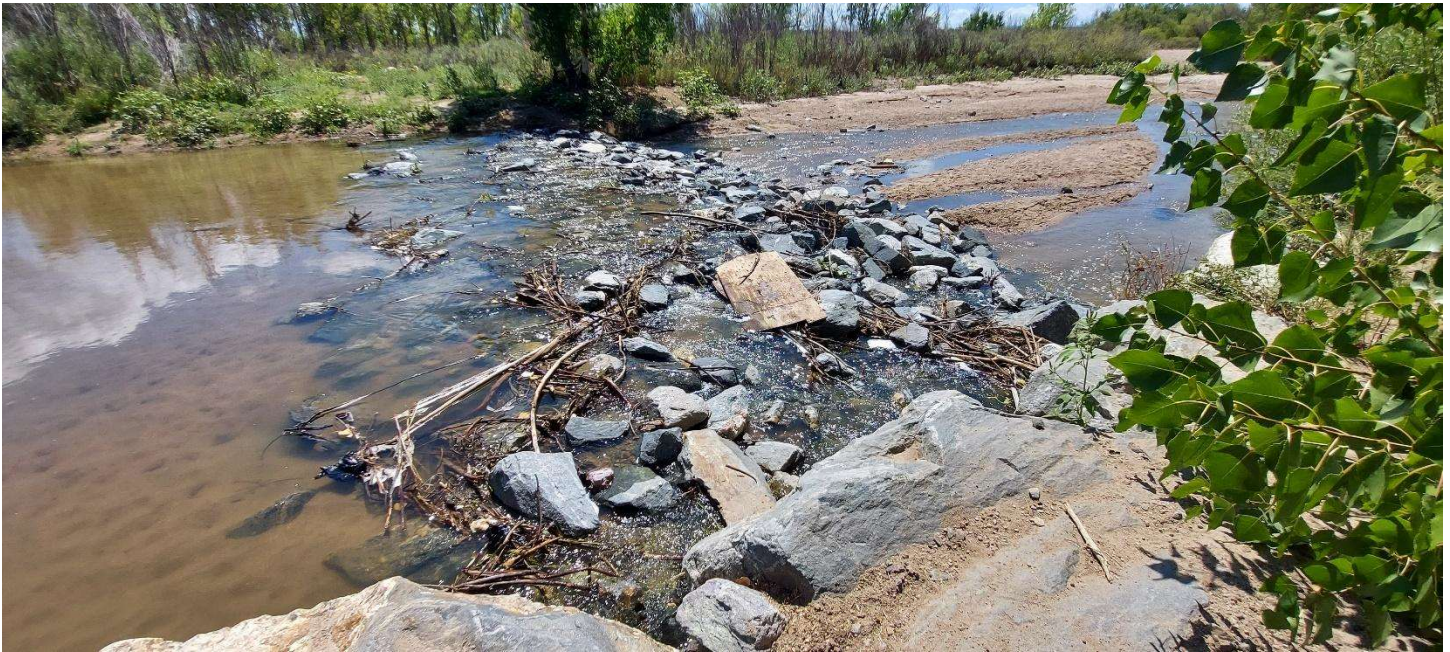
**Photo 34 – 8/23/22**

Cherry Creek 12-mile Park Phase III: Phase III was substantially complete (**Photos 32 and 33**) ahead of the August storm event. There was some damage that resulted from the August storm event (**Photos 34 to 35**) and the construction Best Management Practices/Stormwater Control Measures greatly minimized the storm impact. Repairs are anticipated to be made in 2022 as the project is not fully closed out at the time of this report. Weed control is needed to help with vegetation re-establishment in project area; it will likely start with mechanical control and then move to herbicide once grasses start to mature. A capital project for stream reclamation may be needed, continued planning is suggested to identify work needed, overall priorities, and costs for Cherry Creek between Lake View Drive and the CCSP Boundary.

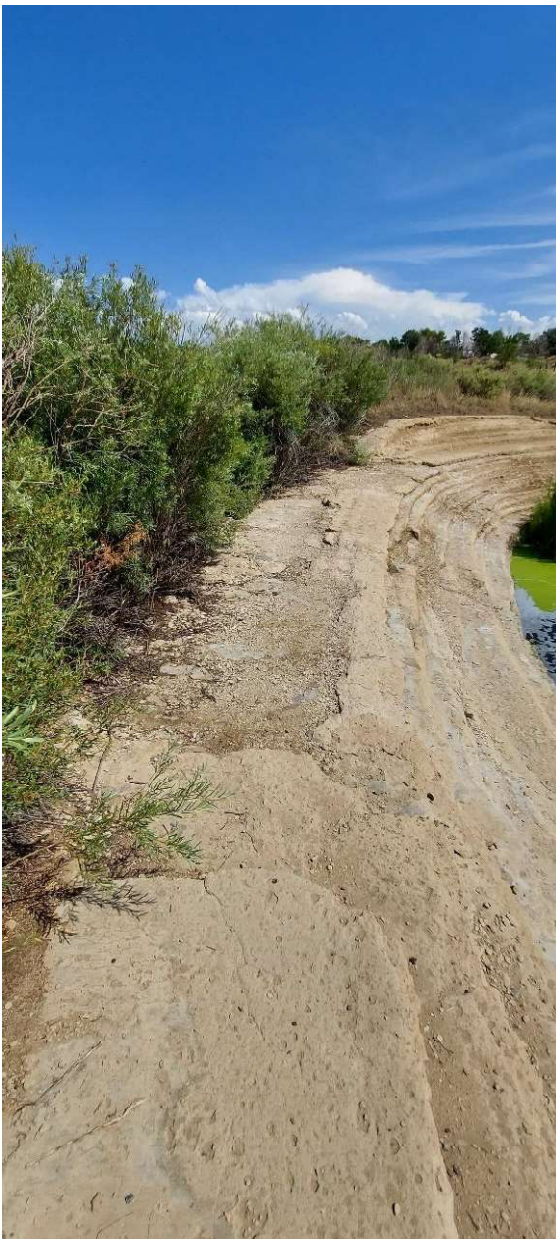
**Photo 36 – Drop 1 – 7/27/22**

Shop Creek: There are 5 drop structures within CCSP numbered 1 through 5 from upstream to downstream, and an additional drop structure outside of the CCSP Boundary. Drop 1 has spalling concrete along the crest (**Photos 36**). Drop 2 has spalling concrete along the crest, seepage between layers of roller-compacted concrete, and vegetation growing on downstream face (**Photo 37**). Drop 3 has spalling concrete along the crest, a tree growing next to drop with tree root intrusion in drop (**Photos 38 to 39**), and vegetation growing on downstream face of drop (**Photo 40**). Drop 4 has vegetation growing on downstream face and less severe spalling of concrete (**Photos 41 to 42**). Drop 5 has seepage between layers of roller-compacted concrete and less severe spalling of concrete (**Photo 43**). CCSP performs regular maintenance by cleaning the trash racks and mowing and removing vegetation around inlets (**Photo 44**). No deficiencies were observed with the

educational signage. The maintenance identified for CCBWQA consideration is concrete repairs at crests of drops 1, 2, 3; removal of tree at drop 3; and vegetation control on face of drops 2, 3, and 4. Since seepage was noted on drops 2 and 5, it is recommended that seepage be monitored on all drops.

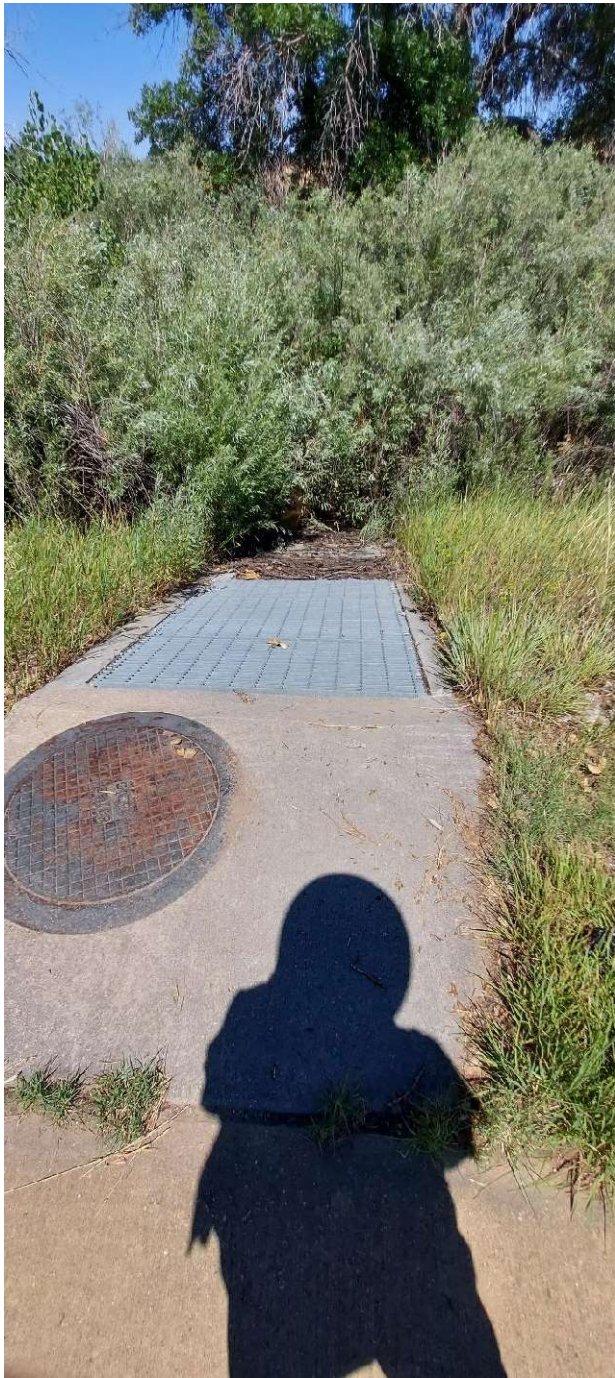
**Photo 45 – 7/27/22**

Quincy Drainage: CCSP Staff cleans outlet structure (**Photo 45**). Some dead standing and fallen trees were observed (**Photo 46**). Bed and bank erosion observed in channel from Lake View Drive to PRF (**Photos 47 to 48**). No maintenance was identified. A capital project for stream reclamation may be needed from Lake View Drive to PRF. Planning is suggested to identify work needed, overall priorities, and costs.

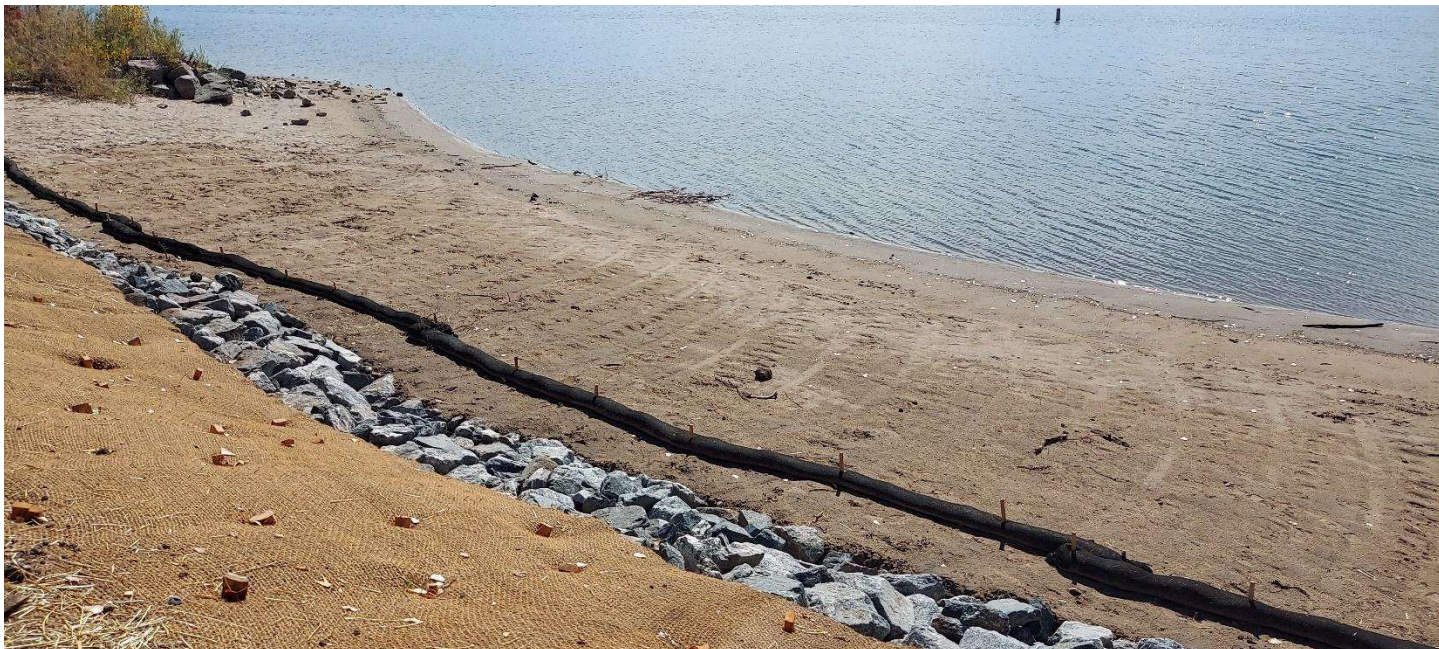
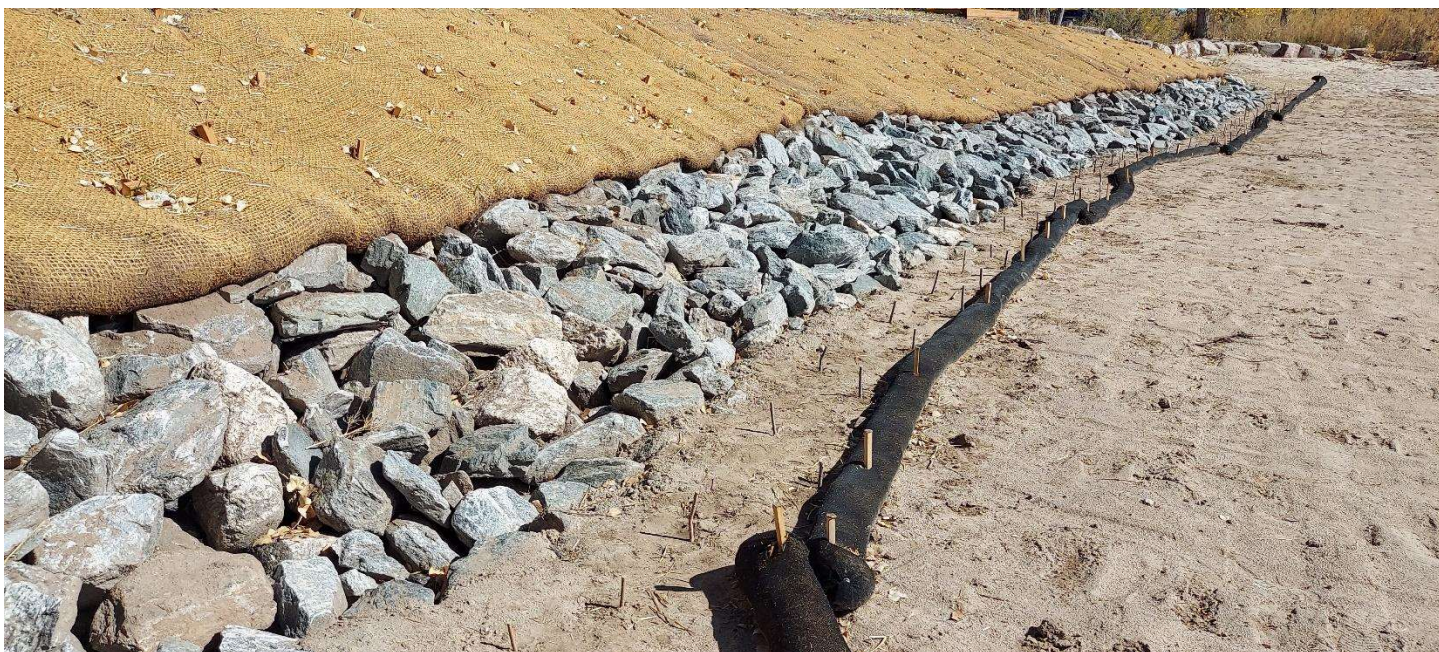
East Boat Ramp (Reservoir Water Surface Elevation = 5547.9 on 8/9/22, 5547.3 on 10/4/22): Boulders and riprap serve as protection of shoreline (**Photos 55 and 56**). Maintenance work was completed in October 2022 (**Photos 57 and 58**). Weed control is needed to help with vegetation re-establishment in the project area; it will likely start with mechanical control and then move to herbicide once grasses start to mature.

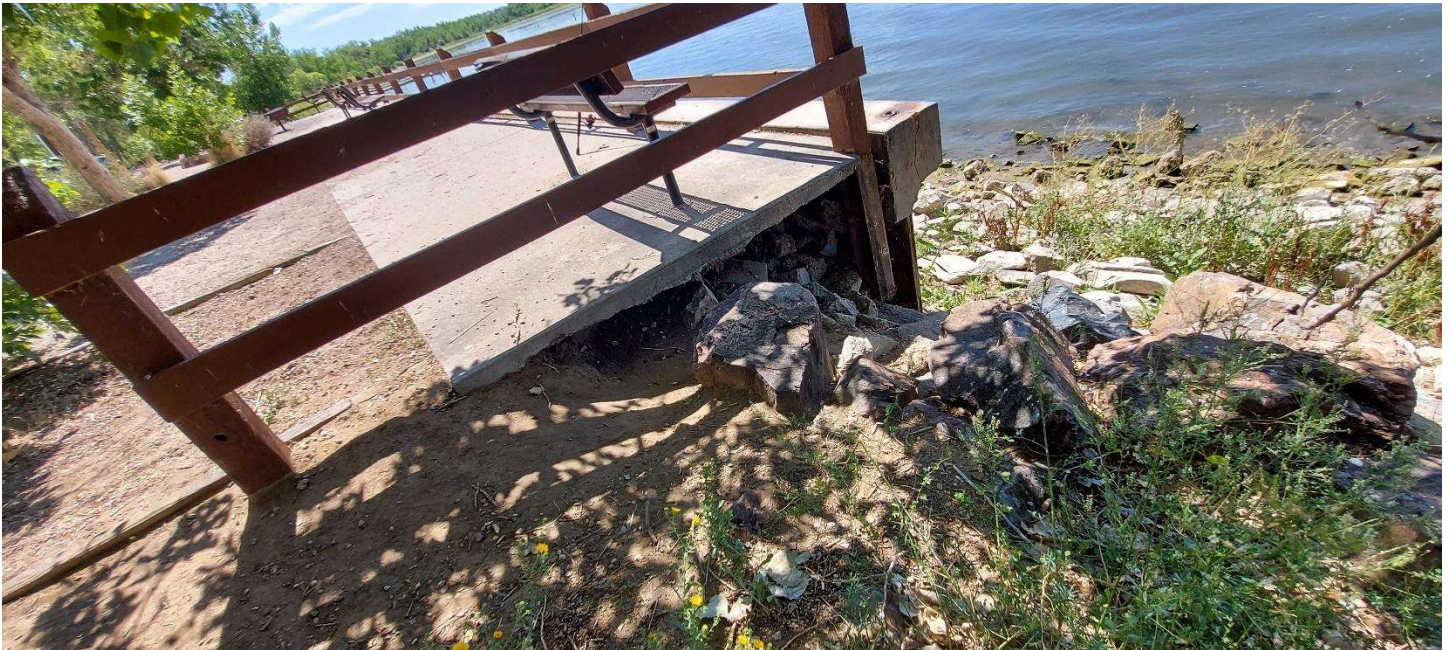
Photo 61 – 8/9/22

*South Section:* Boulders and riprap have shifted, and erosion was observed (**Photos 59 to 60, 62**). Concrete walk and bench have been eroded and undermined (**Photo 61**). Social trail with erosion (**Photos 63, 66, 68 to 70**). Shoreline bank erosion was observed (**Photos 64 to 65, 67**). No maintenance needs were identified. Shoreline stabilization may be needed for the erosion located in this section of this PRF, and a planning effort may be useful in identifying work needed, priority, and costs.

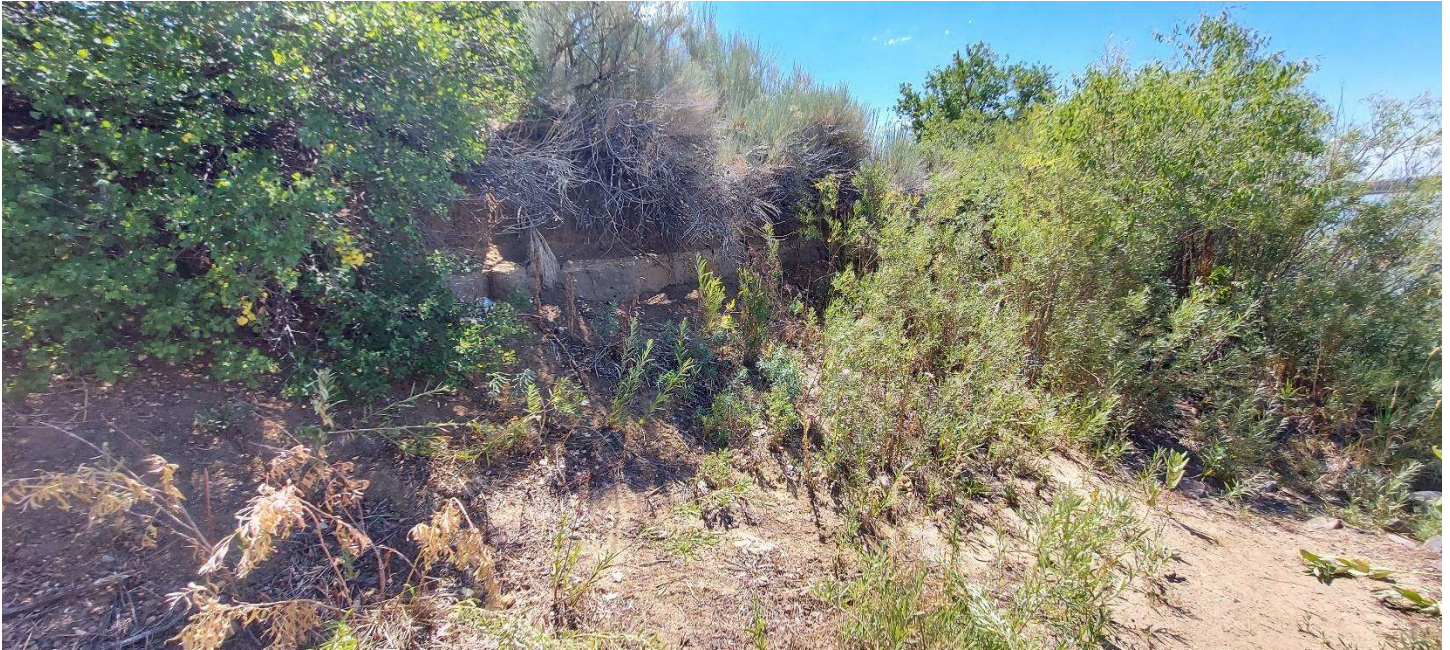
**Photo 71 – 8/9/22**

*North Section:* This area includes bank erosion (**Photo 71**) and social trails (**Photo 72**). A capital project is currently being designed to stabilize the shoreline. No maintenance needs were identified as the capital project is expected to address the bank erosion and minimize impact of trails.

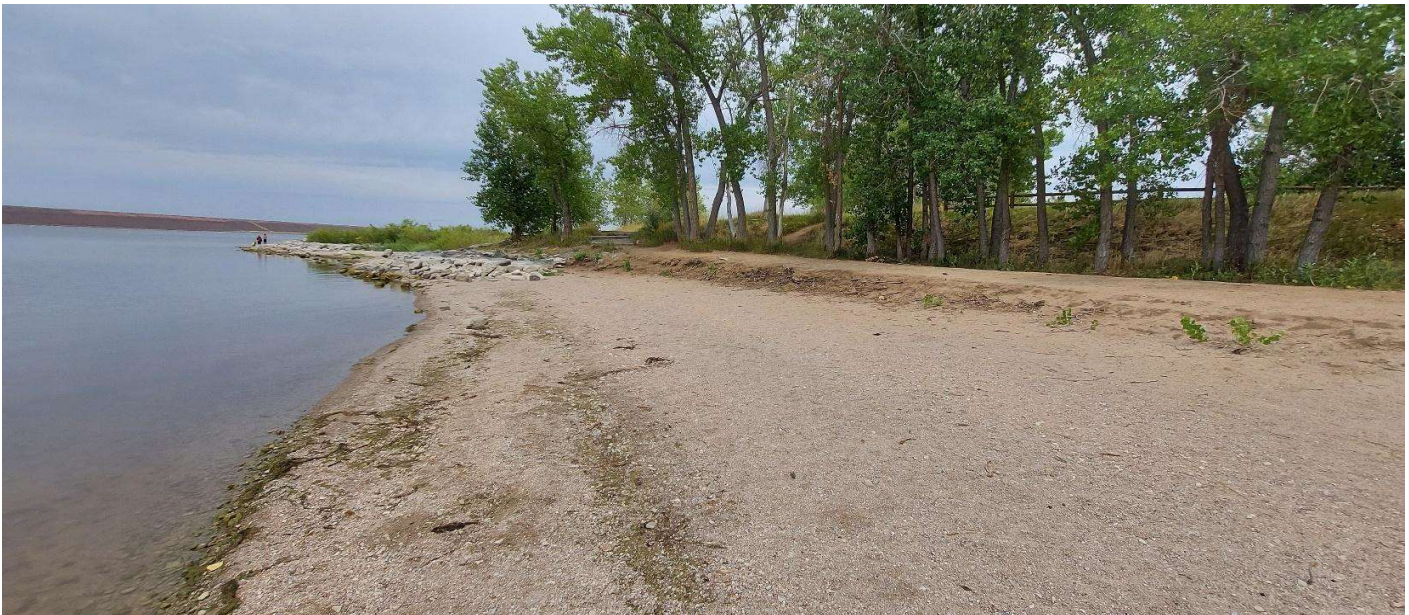
**Photo 73 – 7/28/22**

Mountain and Lake Loop (Reservoir Water Surface Elevation = 5548.1 on 7/28/22): Approximately 100 feet of shoreline is eroding (**Photo 73**) near the Lake Loop parking lot; there is a current maintenance design and permitting underway. Erosion was noted around a tree (**Photo 74**) near the rowing club storage buildings and the tree's roots seem to be providing some protection. No additional maintenance was identified beyond the current project. It suggested that erosion at tree near rowing club storage buildings be monitored.

No.	Item	Quantity	Unit	Unit Price	Extension
1	Mobilization	1	EA	\$ 1,200.00	\$ 1,200.00
2	Construction Fence	800	LF	\$ 4.50	\$ 3,600.00
3	Erosion Control Log	80	LF	\$ 3.00	\$ 240.00
4	Type M Soil Riprap	85	CY	\$ 185.00	\$ 15,725.00
5	Seed	0.5	AC	\$ 2,500.00	\$ 1,250.00
6	Mulch	0.5	AC	\$ 2,500.00	\$ 1,250.00
7	Remove and Reset Fence for Access	50	LF	\$ 32.00	\$ 1,600.00

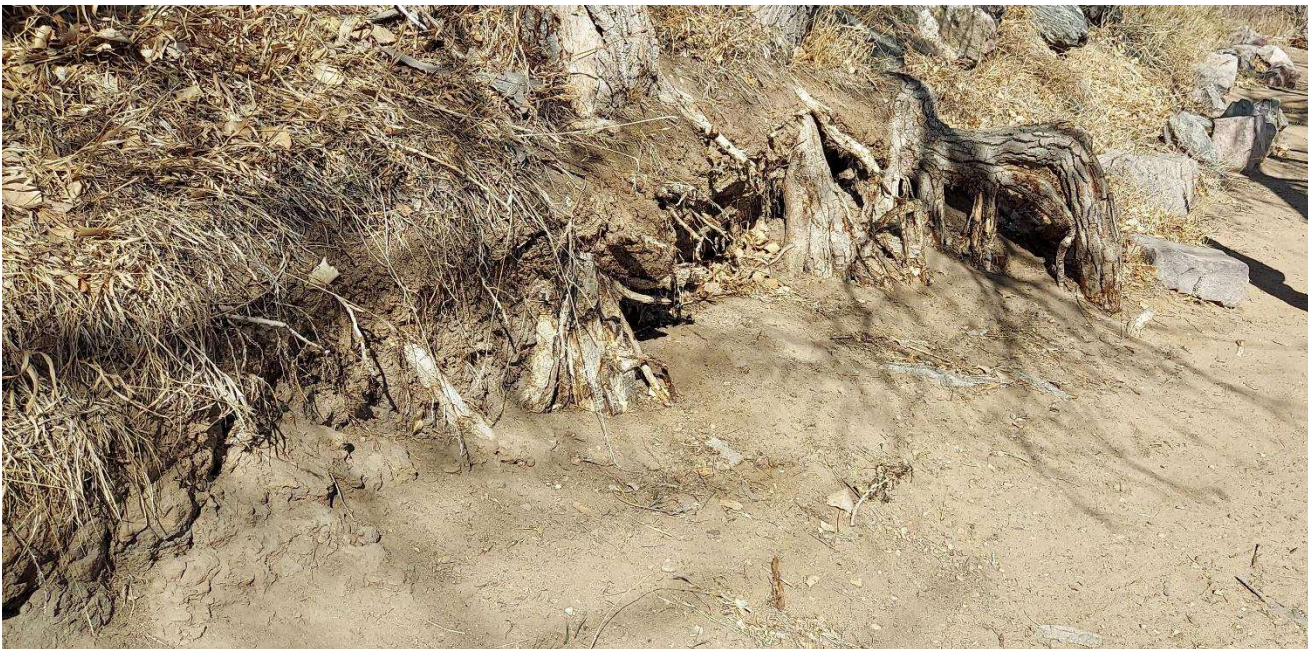
**Photo 76**

Tower Loop (Reservoir Water Surface Elevation = 5548.2 on 7/12/22): This area includes boulders and riprap for shoreline protection (**Photo 75**). Bank erosion and social trails (**Photo 76**) are located to the south and east of the PRF; a capital project is currently being designed to stabilize the shoreline. No maintenance needs were identified as the capital project is expected to address the bank erosion and minimize impact of trails.
