TASK MEMORANDUM

DATE: November 21, 2024

FROM: Ricardo Gonçalves, PE

SUBJECT: 2024 Annual Inspection of Pollution Reduction Facilities (PRFs) at CCSP

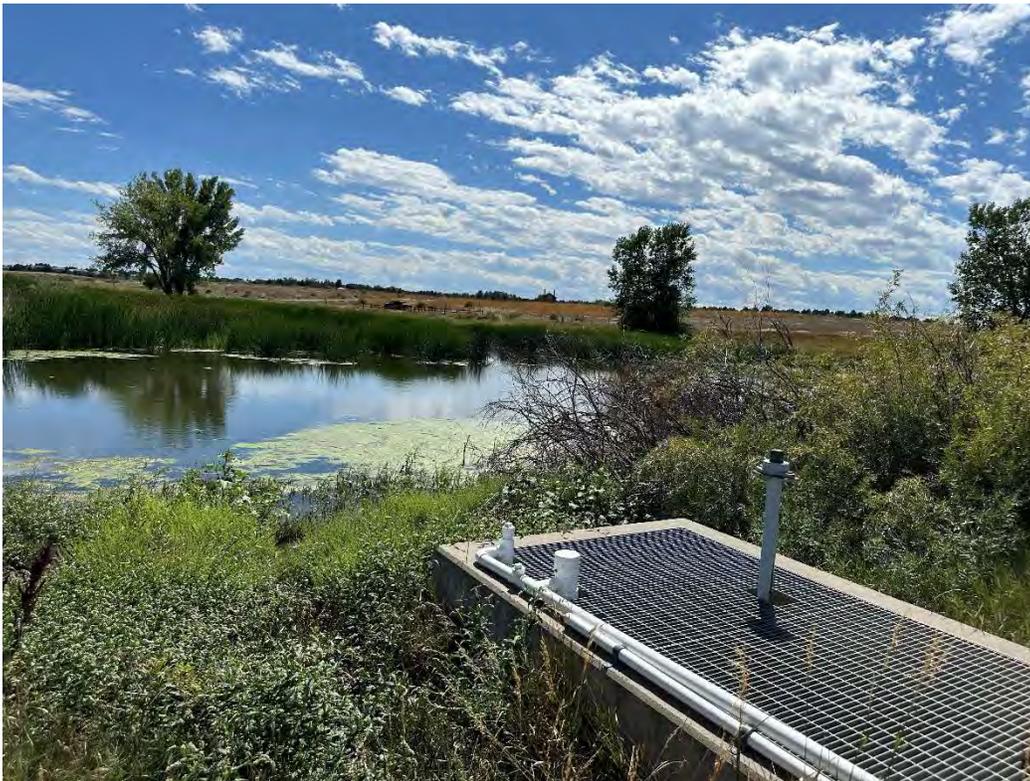
Cottonwood Wetlands: Aquatic vegetation and cattail debris was observed on the surface of the water. The water level was up significantly at the time of the inspections, principally due to the outlet structure being clogged, and high enough that water was overflowing the access trail. The educational signs were in good shape. Some plant stress was observed from last year's floods and dead areas observed where the higher than normal water surface remained too long. Maintenance recommendation is re-vegetation of the dead areas with some weed control and cleaning out of the outlet structure grate twice in 2025 to maintain normal pond operating levels.

Outlet structure with excessively high water level and clogging of the outlet grates

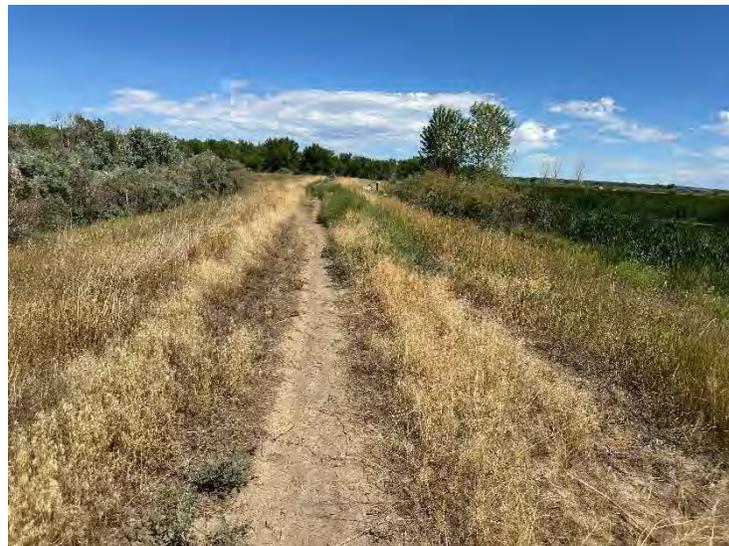
Wheel-tracking from last year's harvesting activities regrown well except for social trail

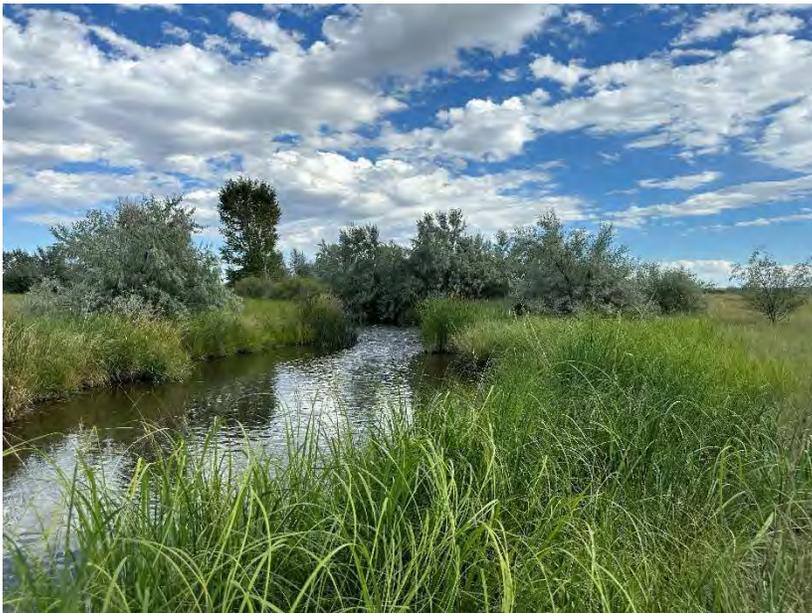
Thriving vegetation

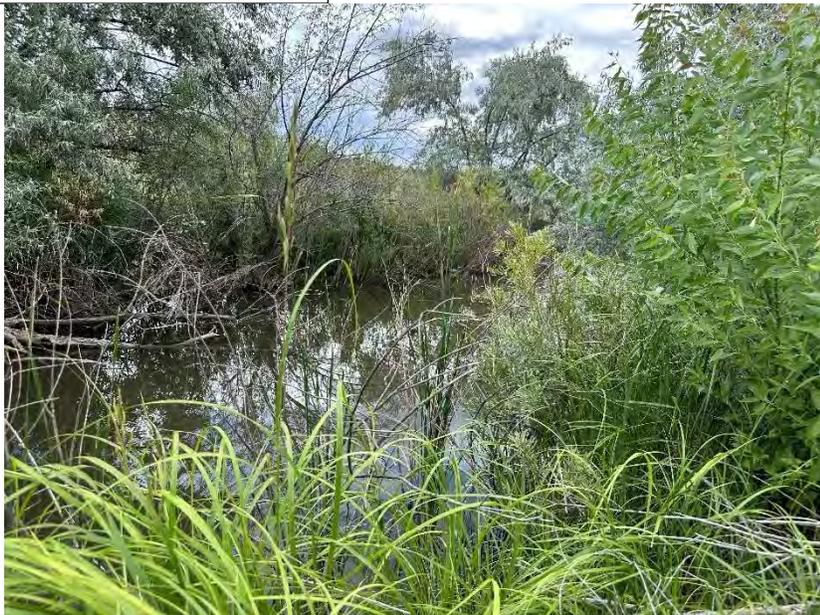
Thriving vegetation

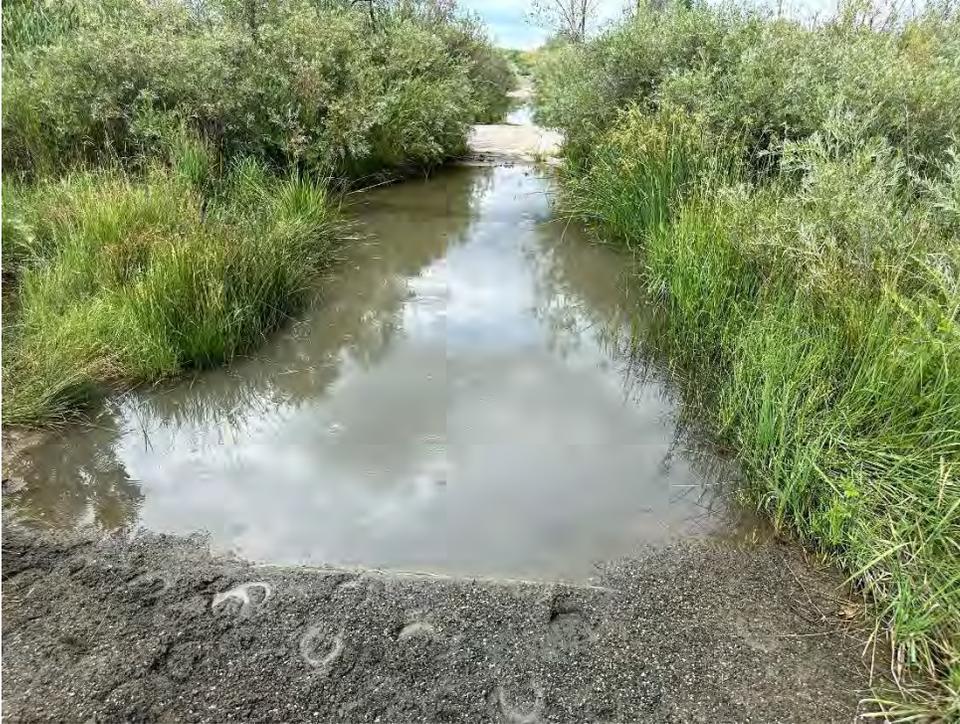
Stream back-up at southern-most stream crossing

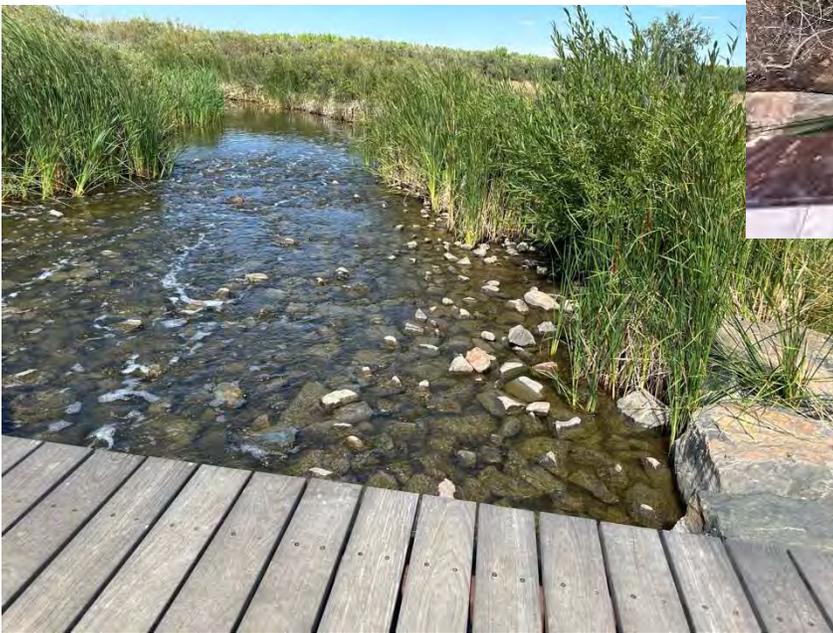
Riffle structure at lowest trail crossing in excellent condition

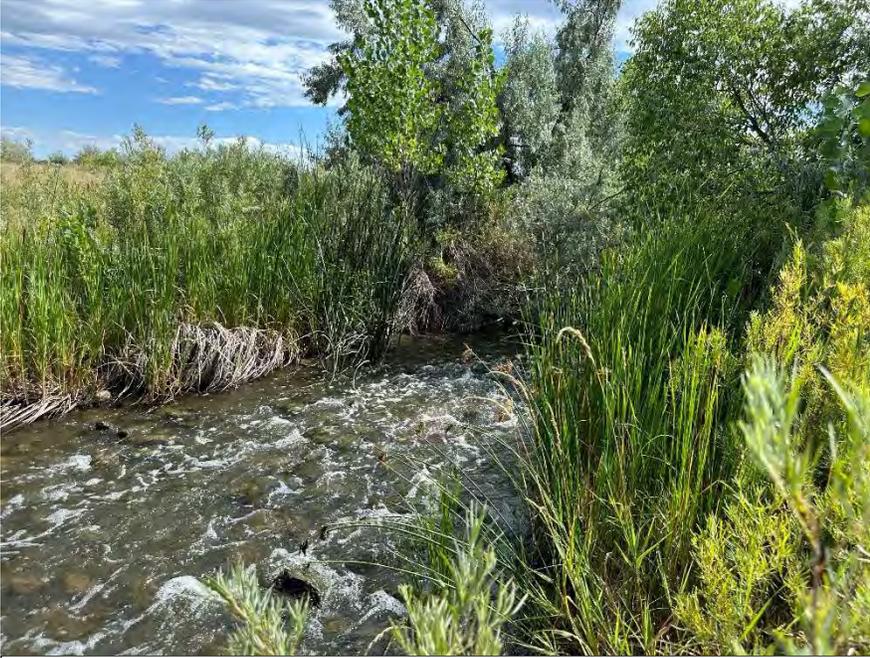
Riffle structure near old Cottonwood alignment and shooting center

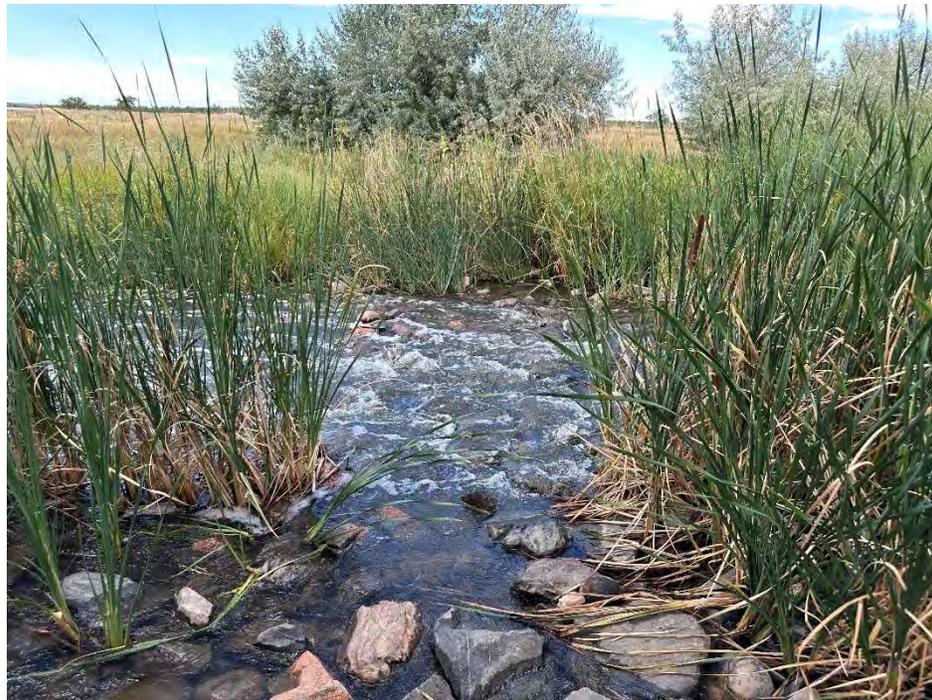
Riffle structure downstream of confluence with Lone Tree Creek

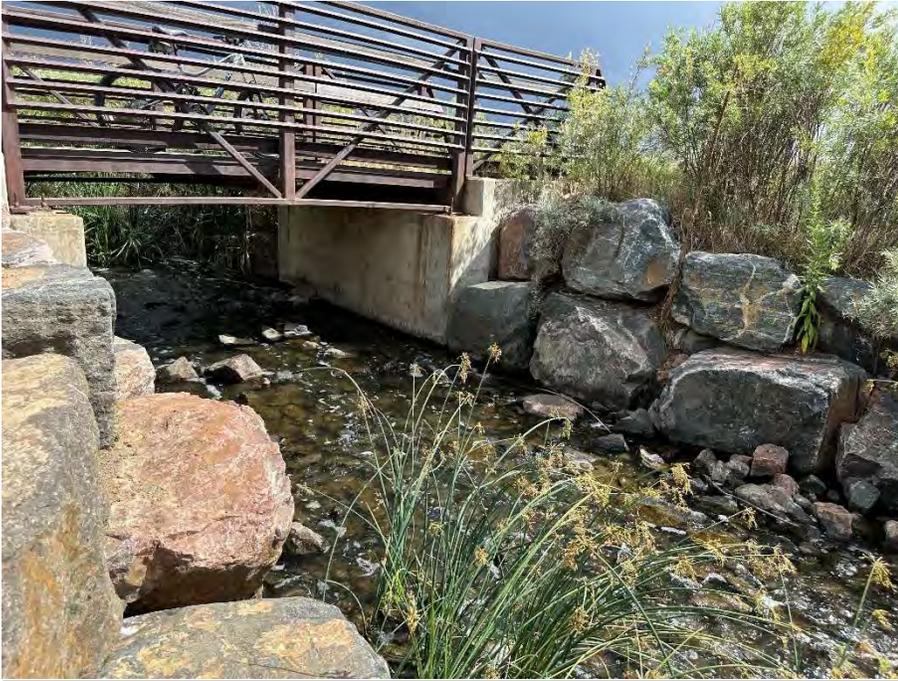
Crossing east of S Cherry Creek Drive and Peoria St. in excellent condition

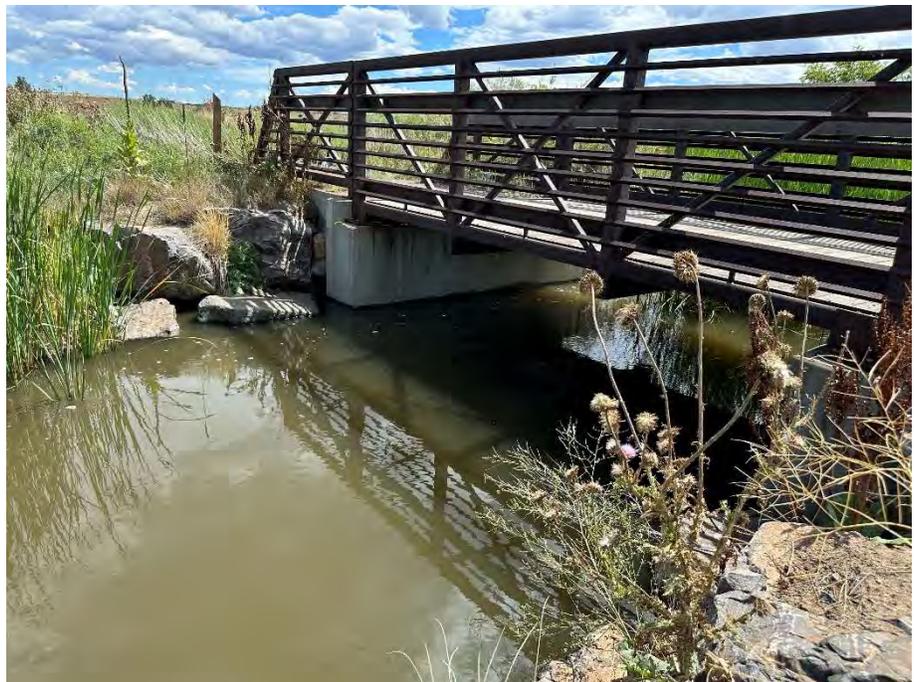
Stream back-up near middle crossing created by debris clogging

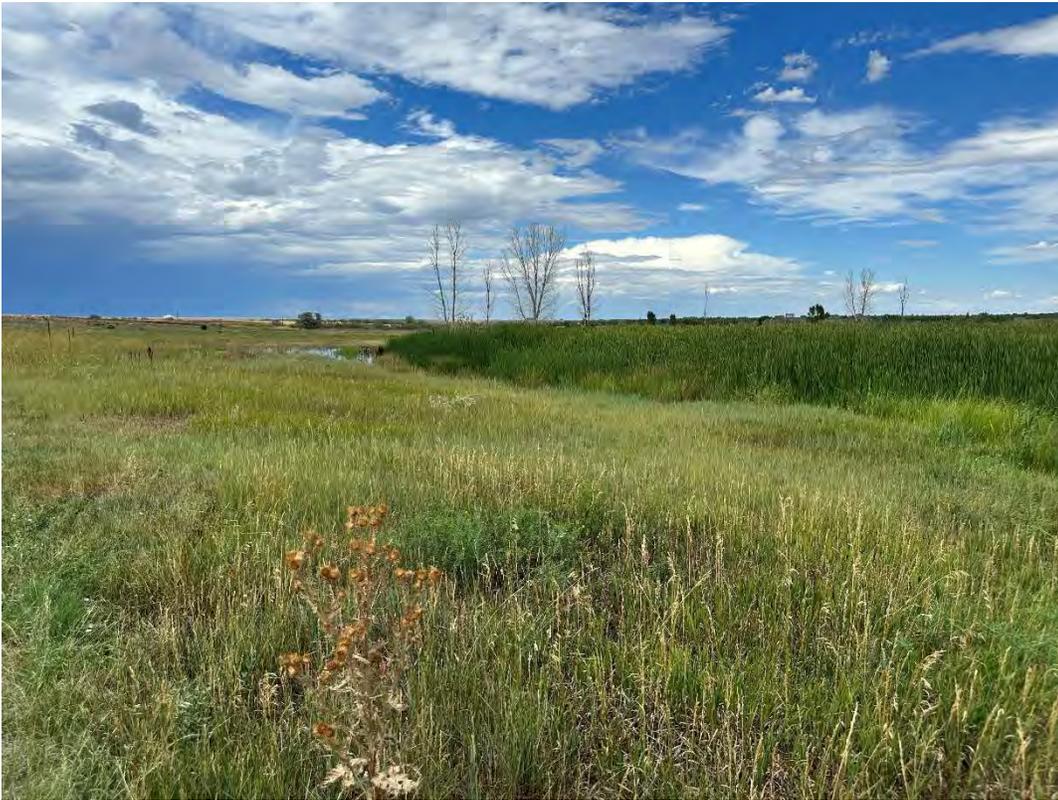
No plant stress and no evidence of erosion from last year's storms typical in the over-bank areas. Very healthy growth is abundant

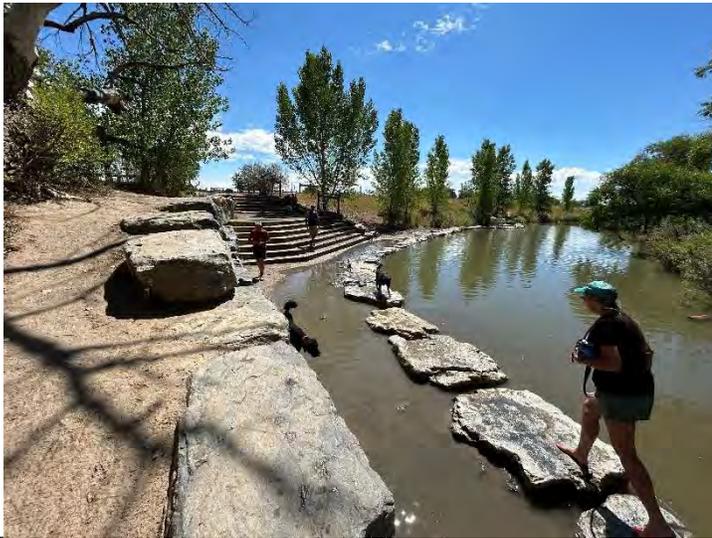
Behind-the-boulder edging erosion at the fourth access point

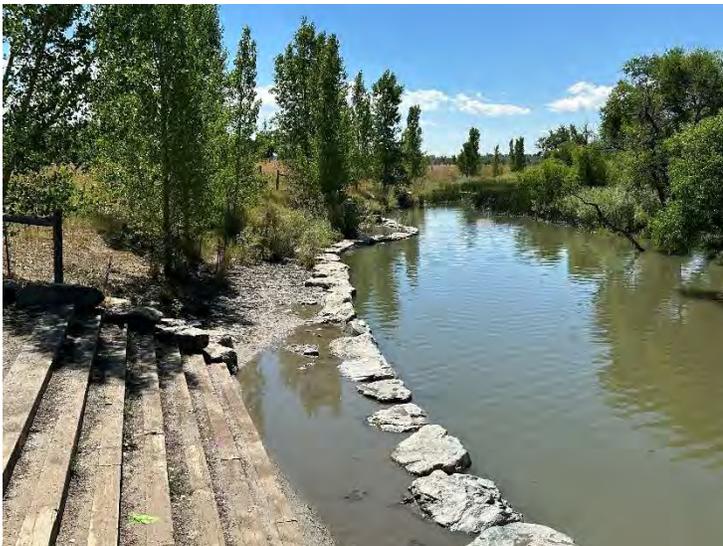
Behind the boulder edging erosion at the base of the stairs of the third access point-repair project for 2025

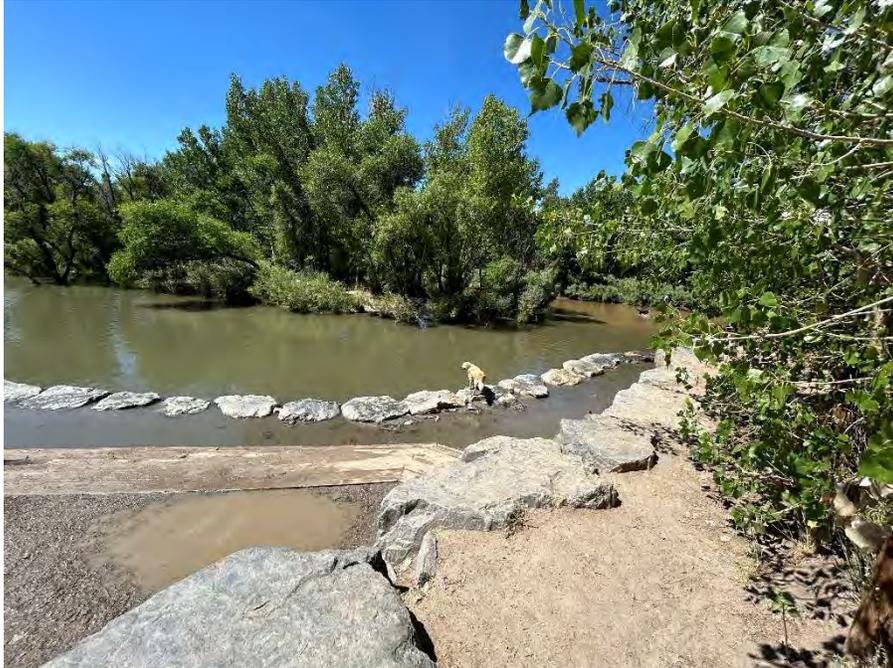
Behind-the-boulder edging erosion at the Fourth Access Point

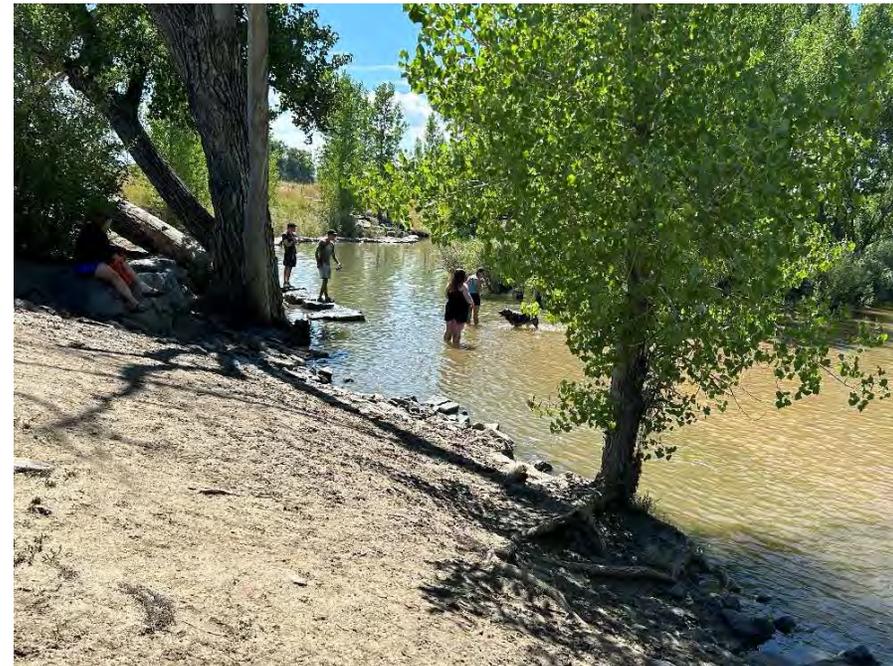
Boulder edging erosion just below Fourth Access Point

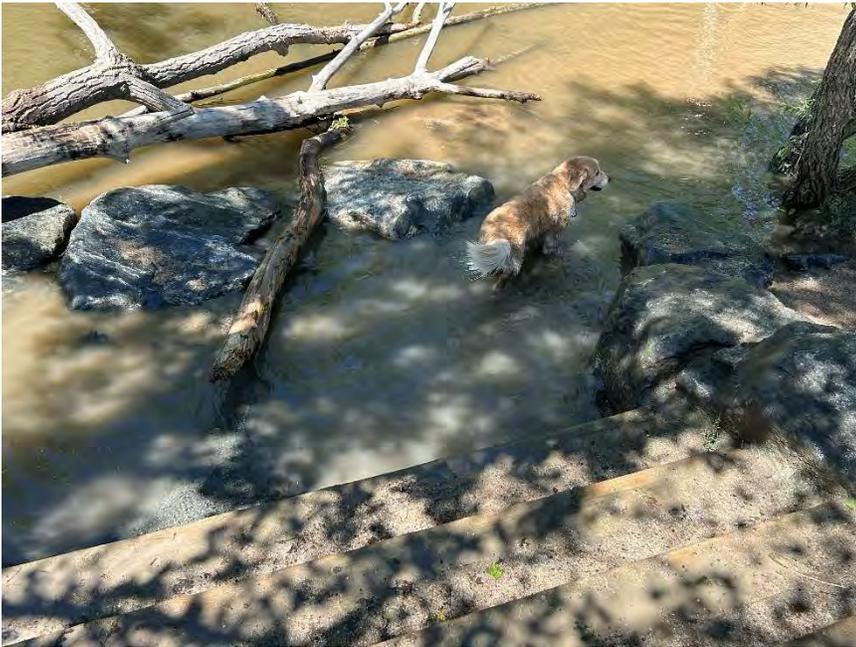
Boulder edging erosion below Access 4. Also sediment deposition almost to the level of the original boulders.

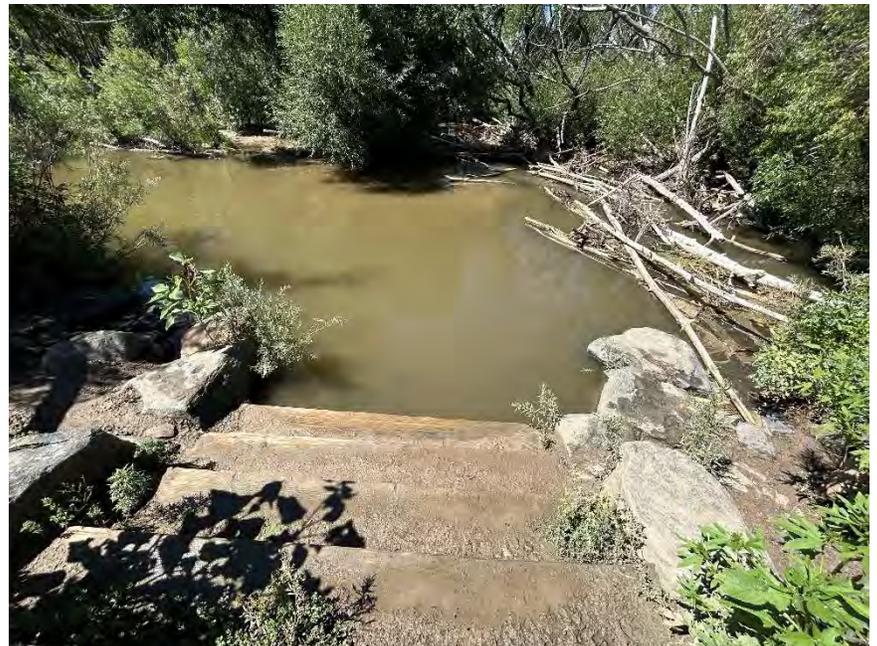
One more edge-boulder missing from last year at bottom of steps. Logjam is acting as a natural grade control structure

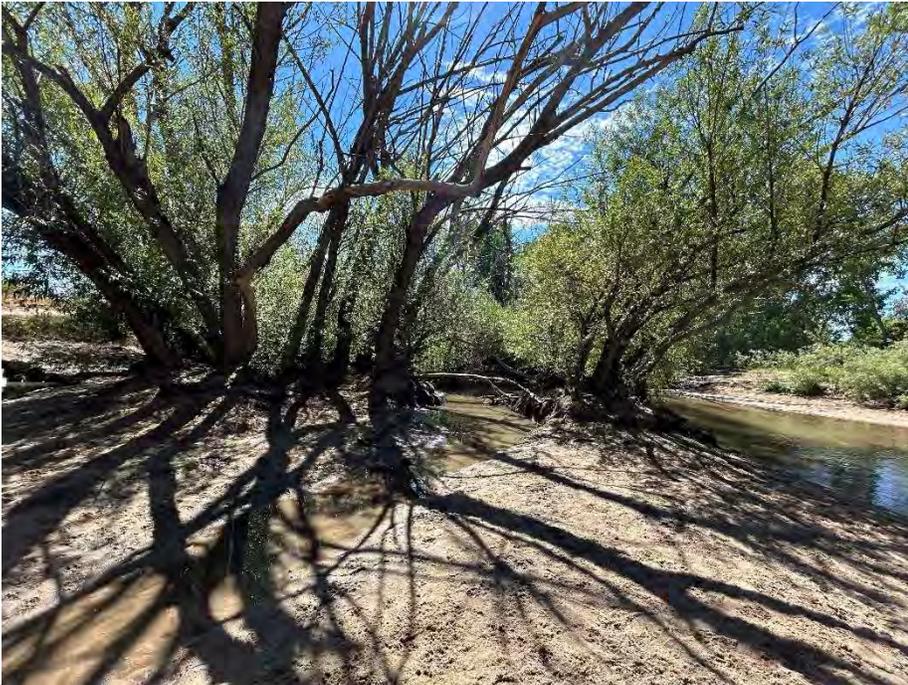
Tree islands caused by extreme bed scour

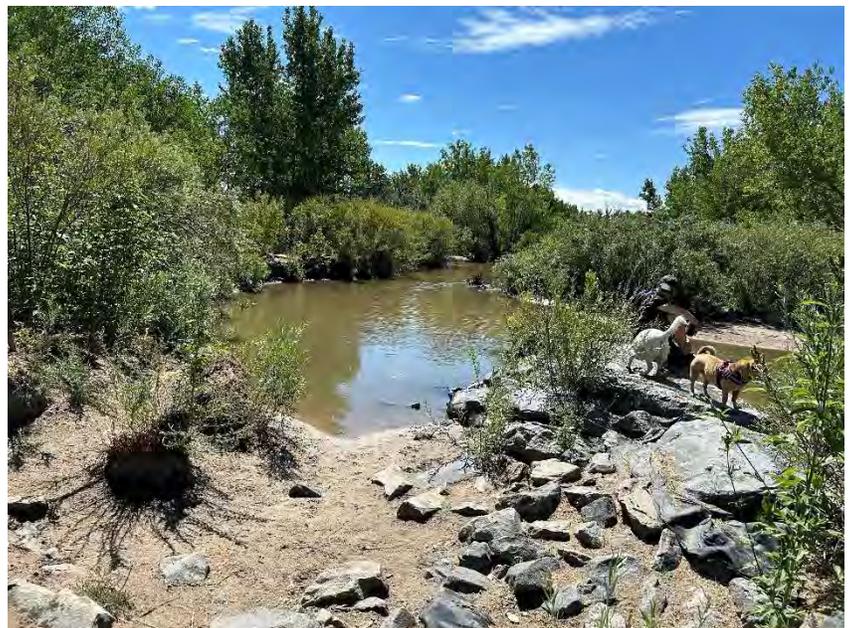
Beginning of beach area- severe erosion behind the boulder edging starting a second channel behind the boulder edging

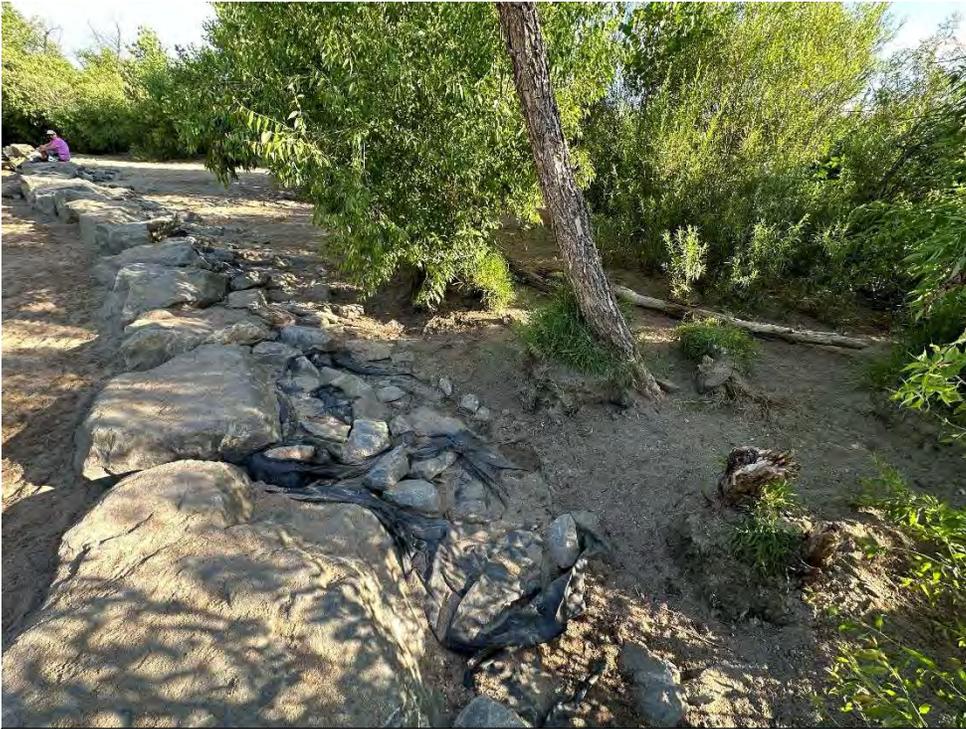
Severe erosion behind boulder edging just before the beach area.

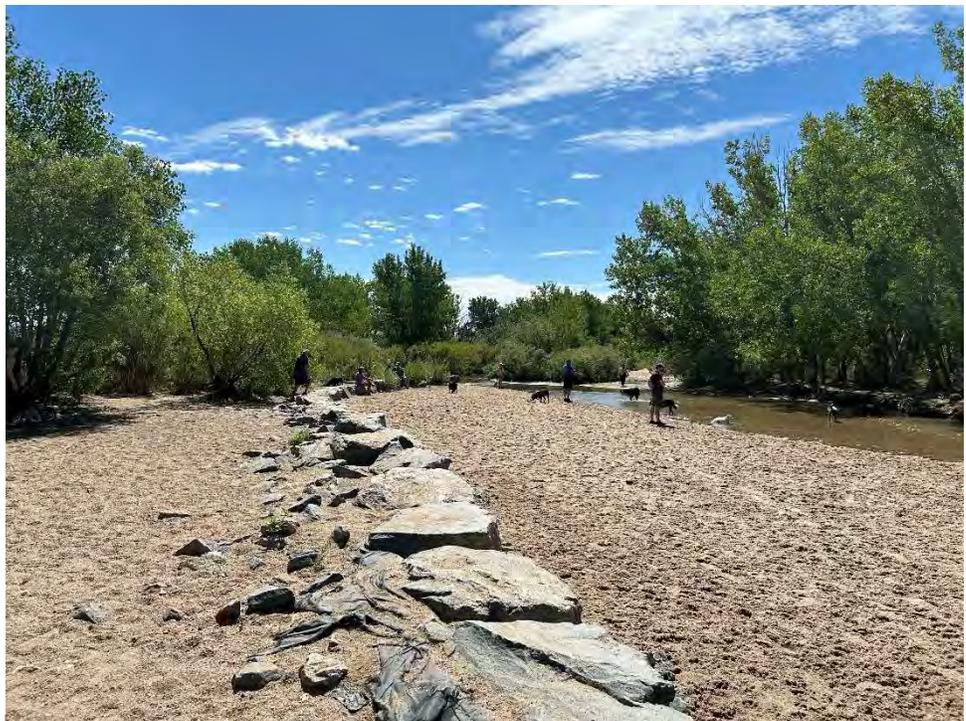
The boulder edging is now a spine, away from the water and the high point of the bank, with beach on both sides, not an “edge” of anything.

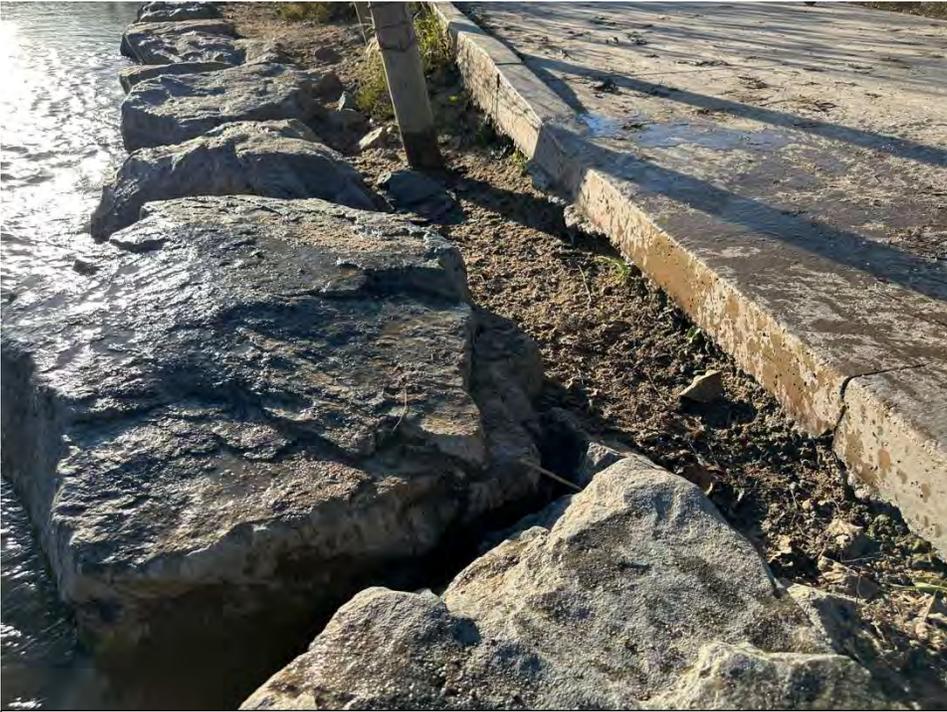
Erosion behind boulders undercutting trail.

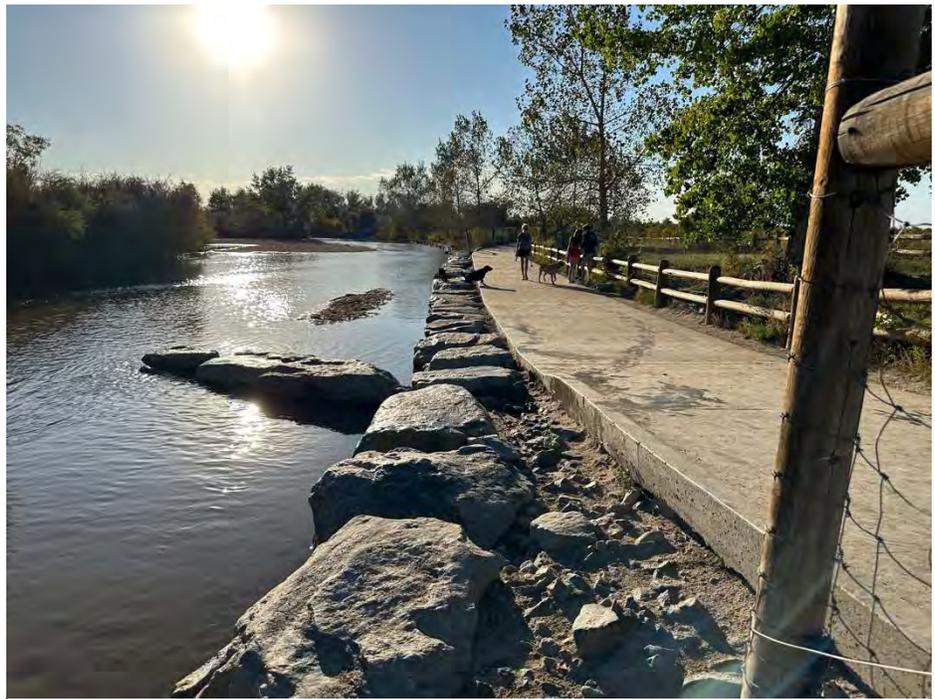
Erosion behind boulders undercutting trail.

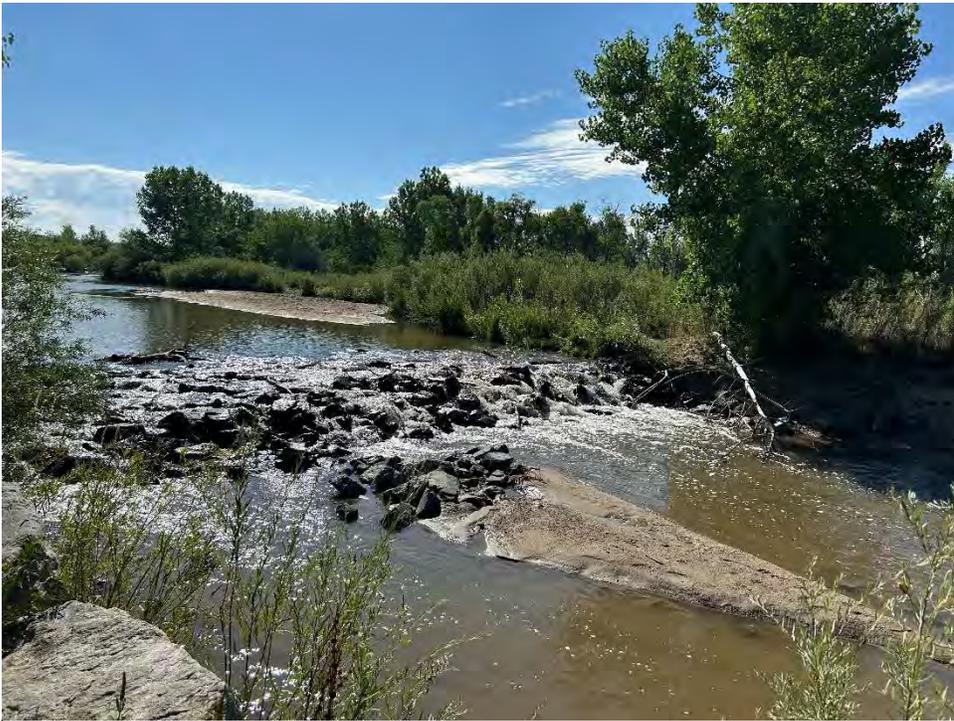
Grade control structure continued to work well-some of the riprap that has washed downstream will be relocated back to the structure as a repair project for next year

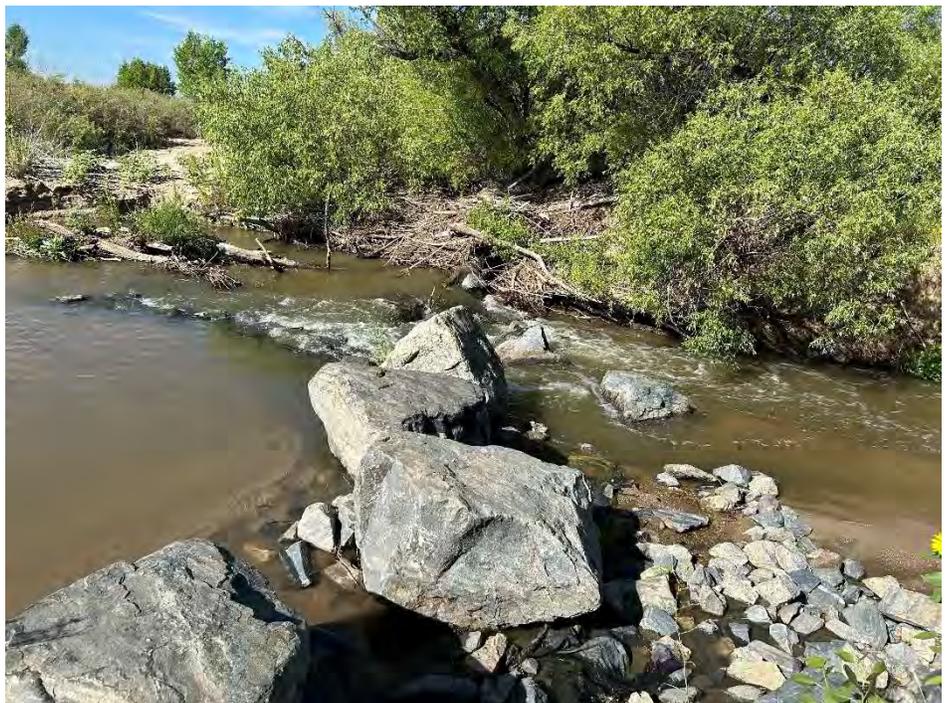
Severe erosion at breakout area

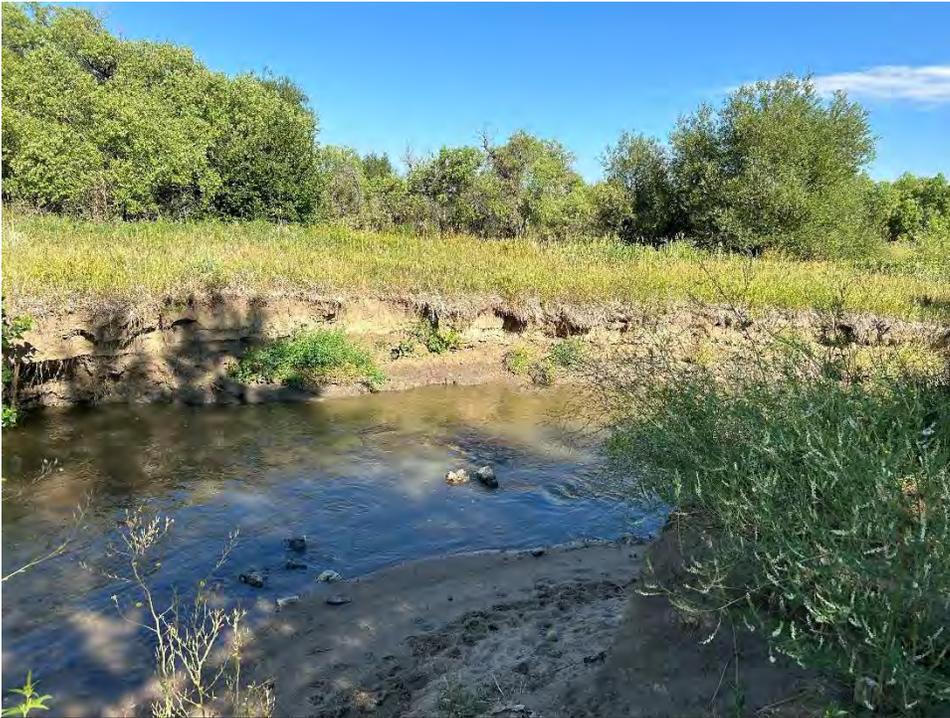
Severe erosion at breakout area-stream is degrading down below claystone level.

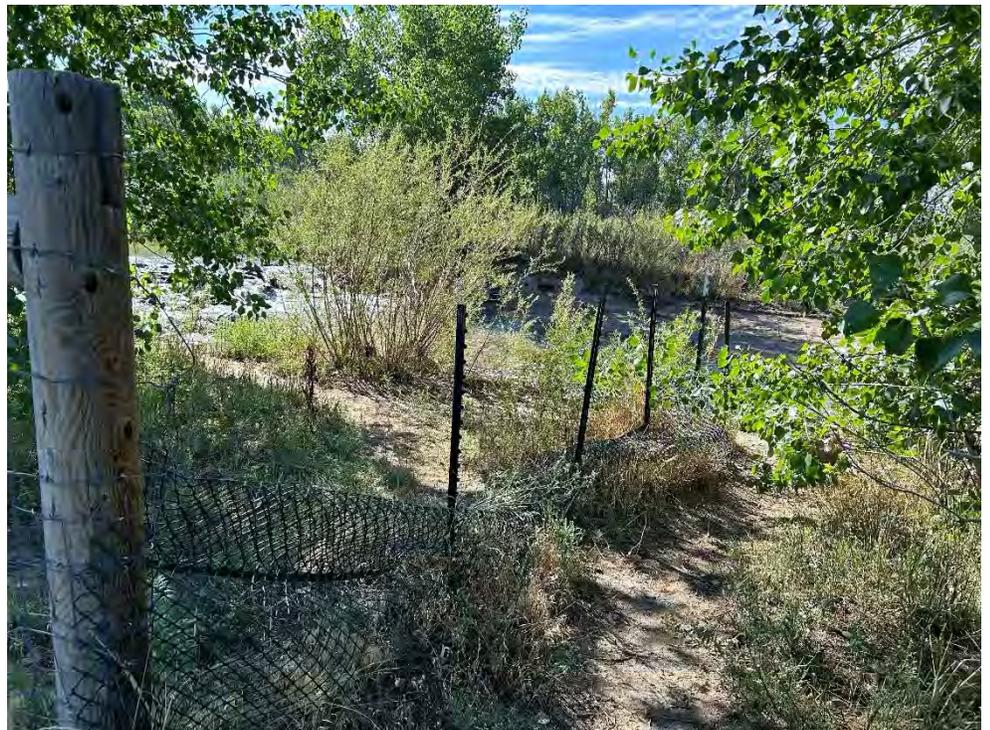
Failed revegetation from Phase III project- will be part of repair project for 2025

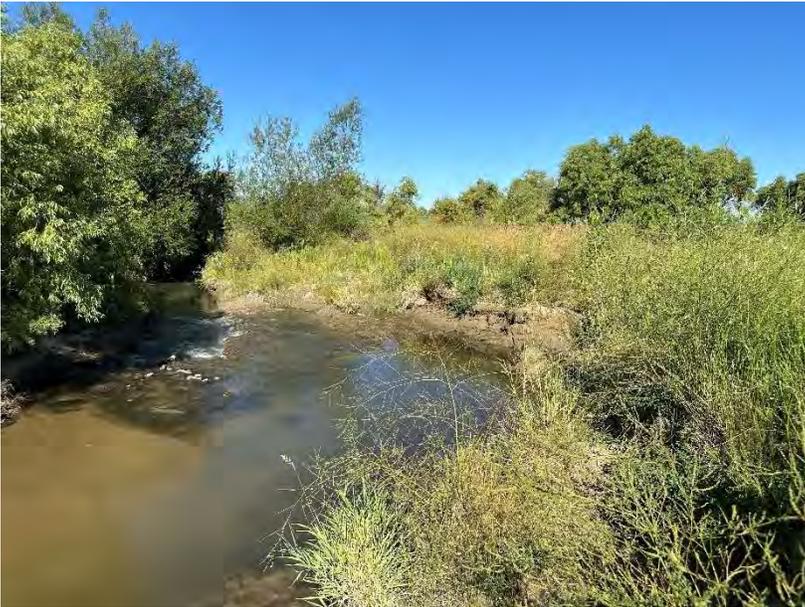
Downstream of the breakout area

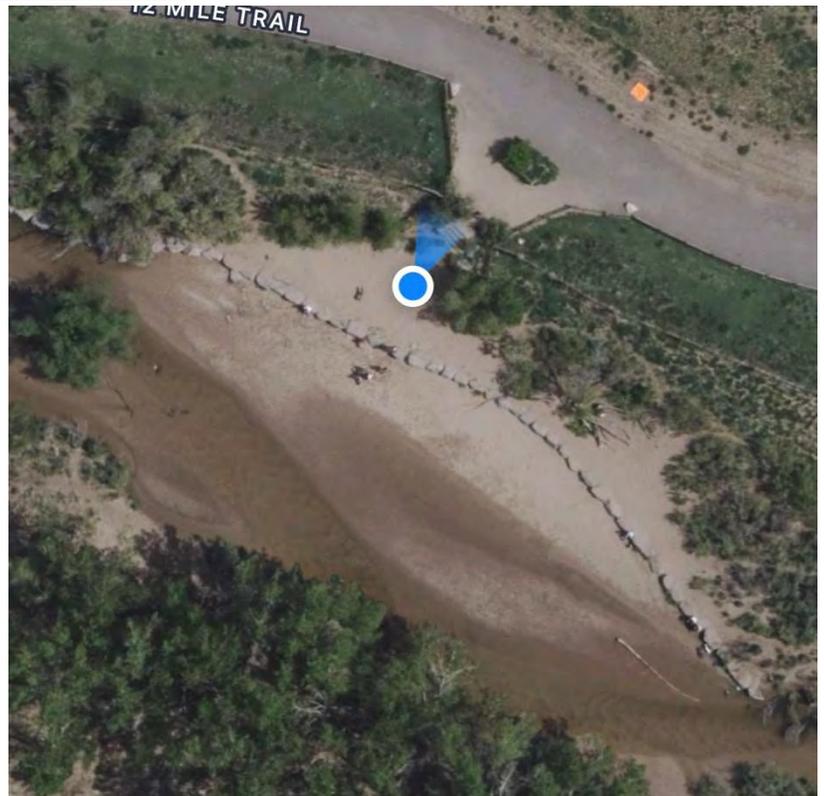
Satellite photo of DOLA beach showing how the creek doesn't follow the path that was used for the boulder edging design.

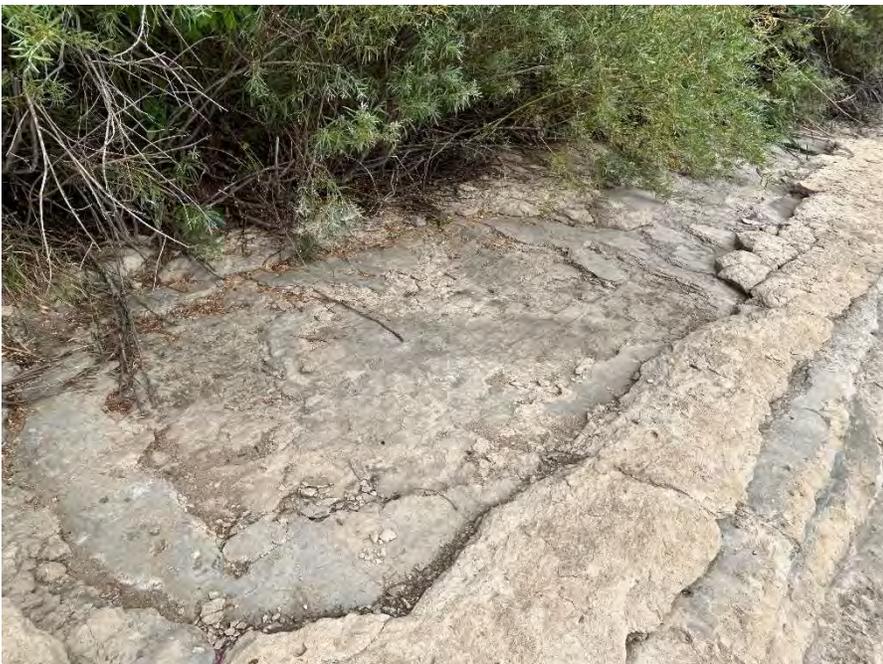
Drop No. 1 outlet structure overtopped and clogged with weeds

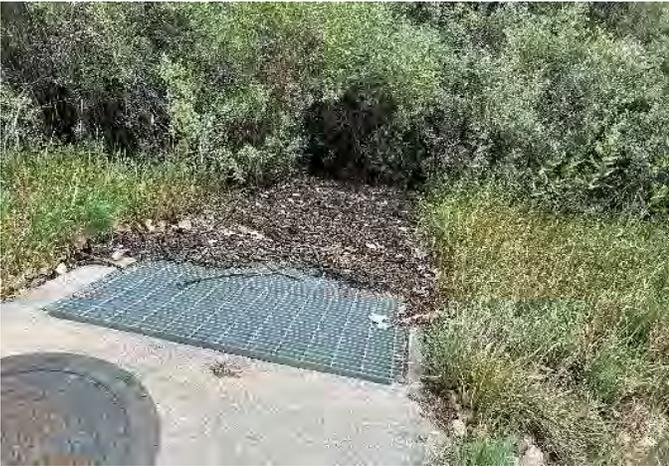
Debris clogging of the outlet structure

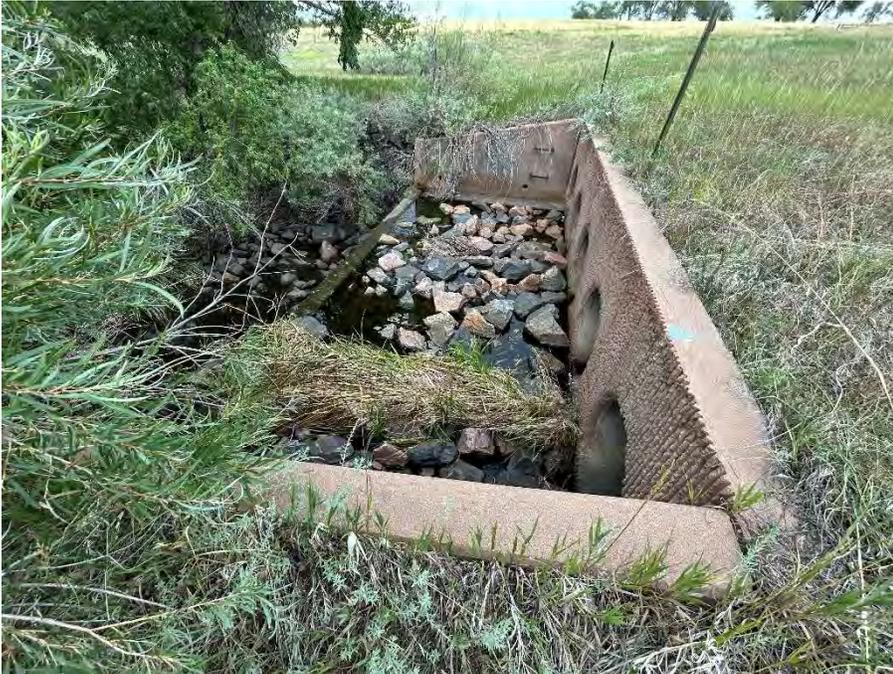
Outlet at Lakeview Dr. becoming clogged with plants

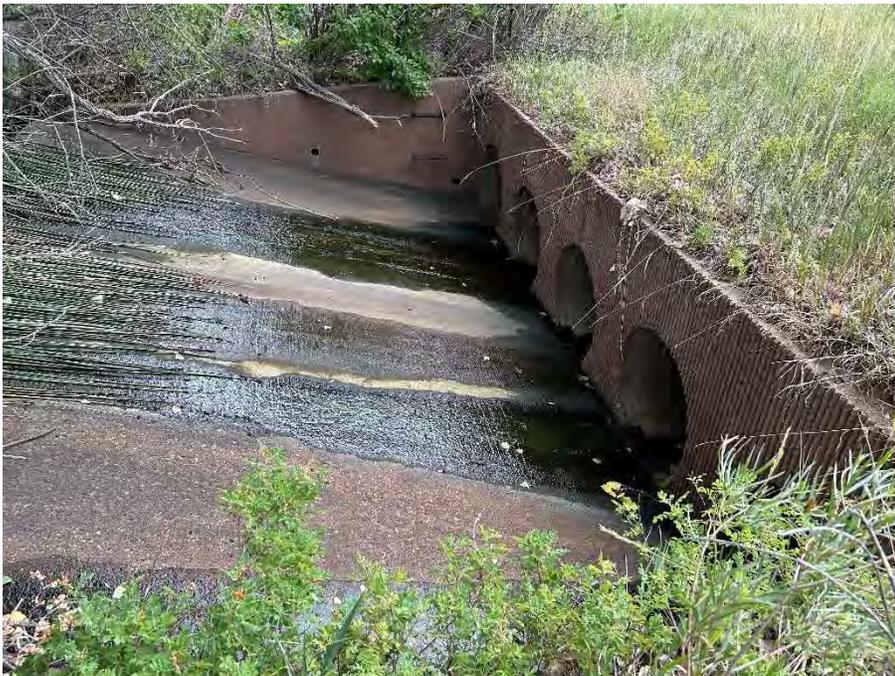
Inlet at Lakeview Dr. is clear

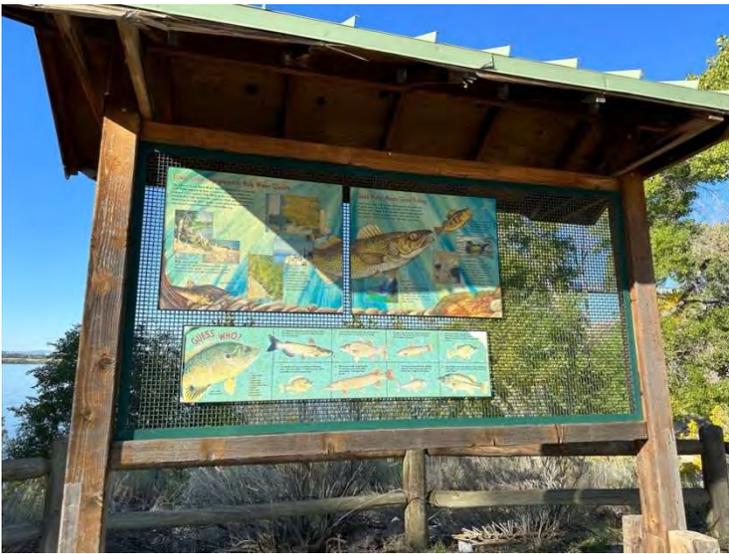
Informational sign in good condition

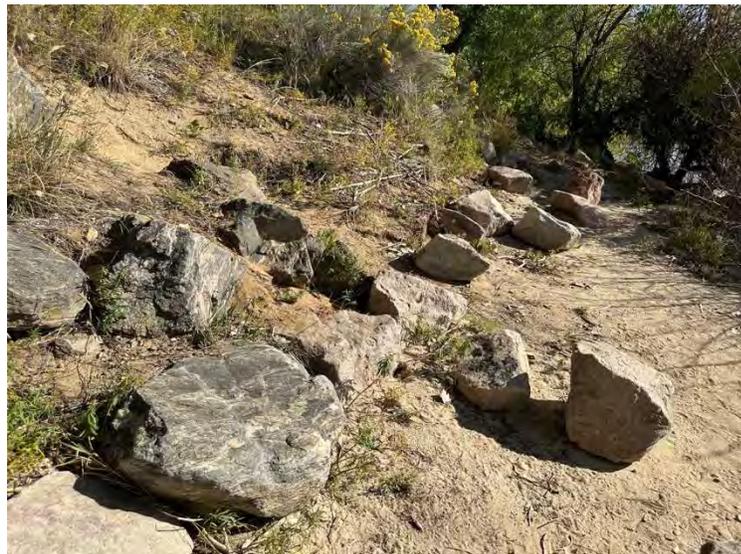
Human-displaced boulders

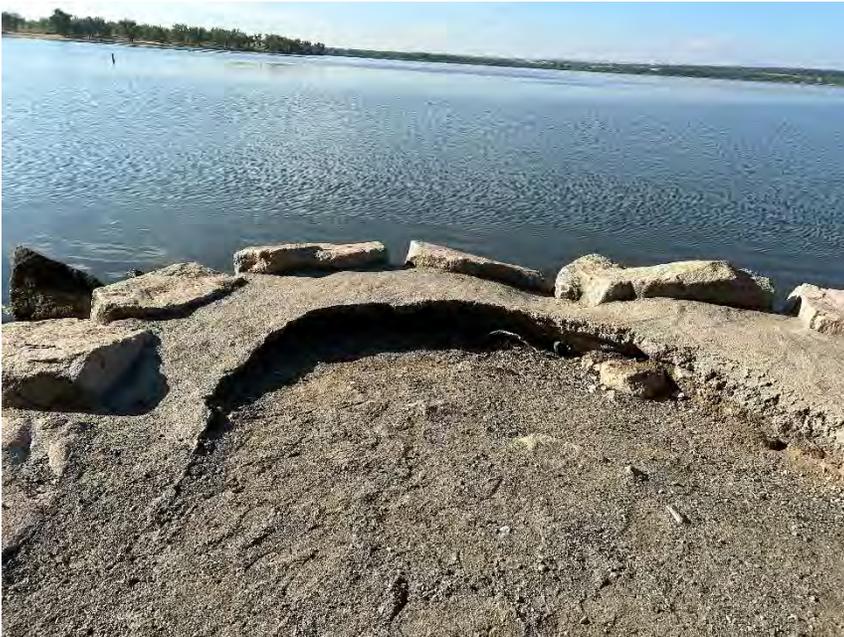
Eroded material from behind the grout at the fishing promontories-will be backfilled yet this year

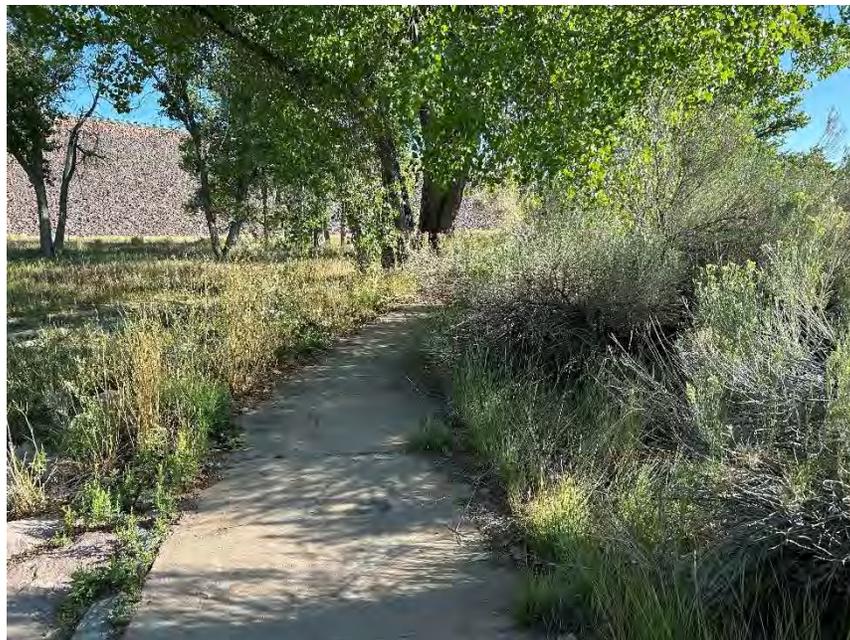
Spot weed control

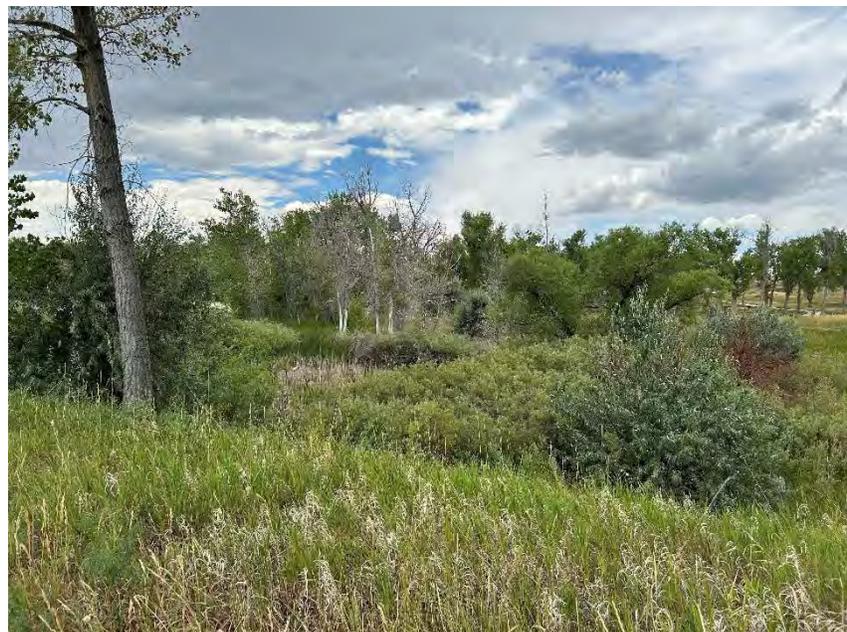
Vibrant water quality capture area
