TASK MEMORANDUM

DATE: November 21, 2024

FROM: Ricardo Gonçalves, PE

SUBJECT: 2024 Annual Inspection of Pollution Reduction Facilities (PRFs) at CCSP

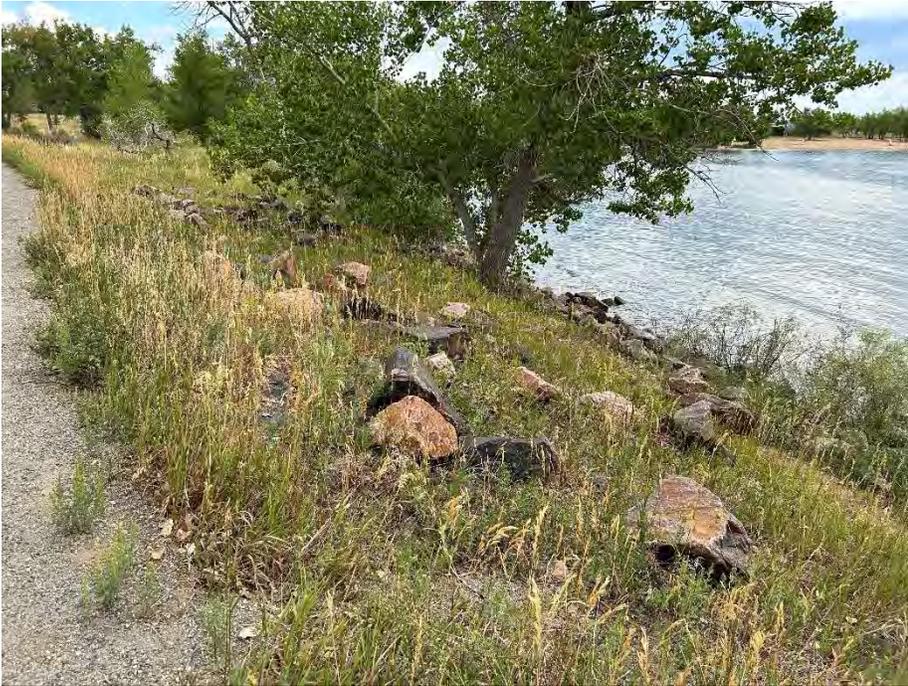
Area south as candidate for future Shore Stabilization CIP project

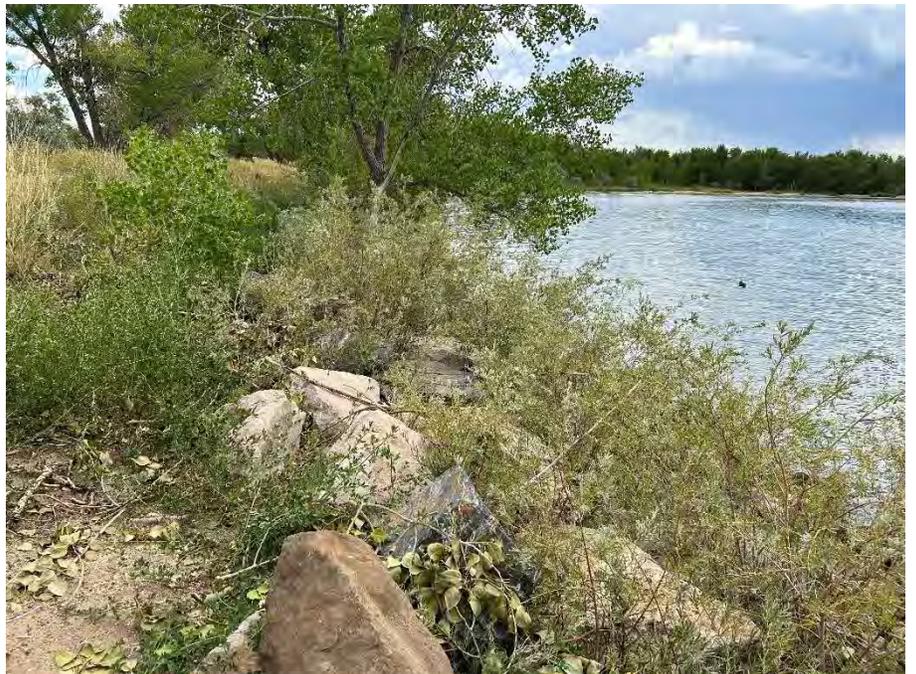
Area south as candidate for future Shore Stabilization CIP project

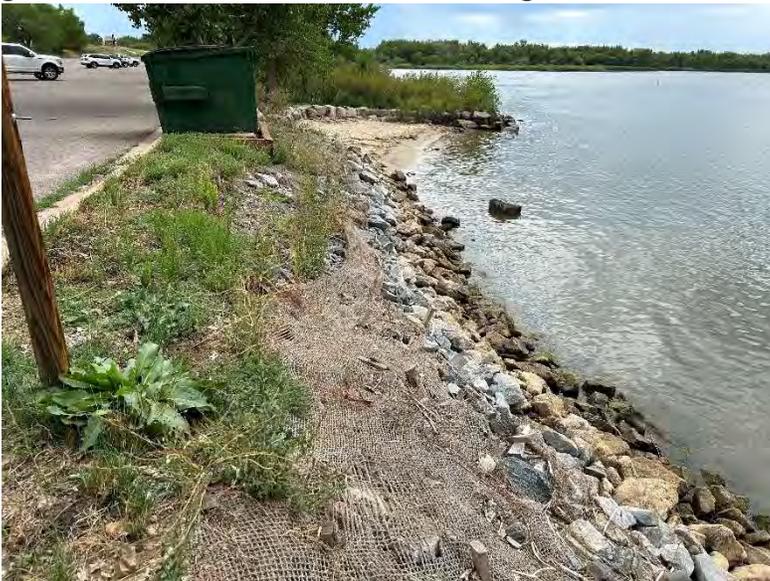
Reseed and mulching of this 2022 project, eroded by the floods of 2023 will be completed this year

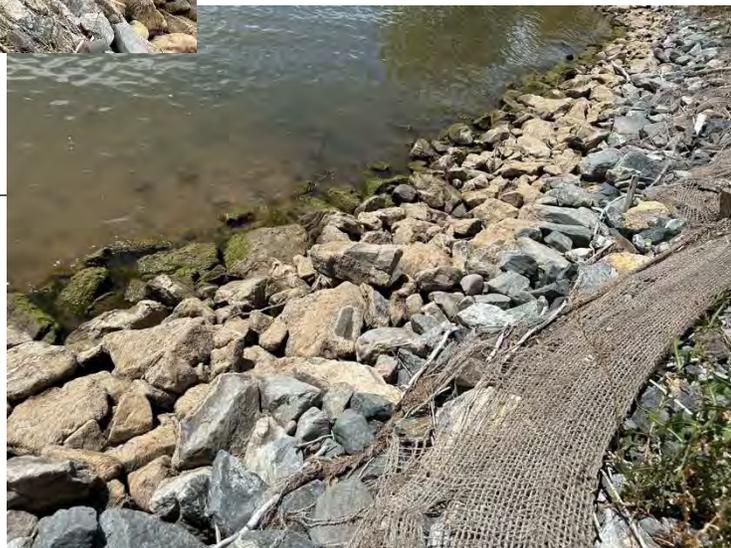
Riprap showing void-filling washed out

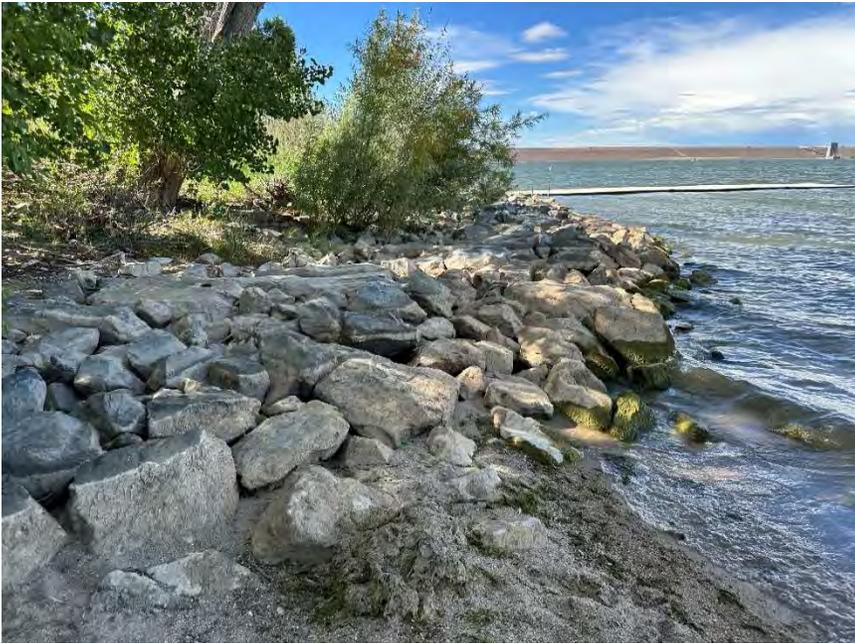
Shoreline riprap in good condition

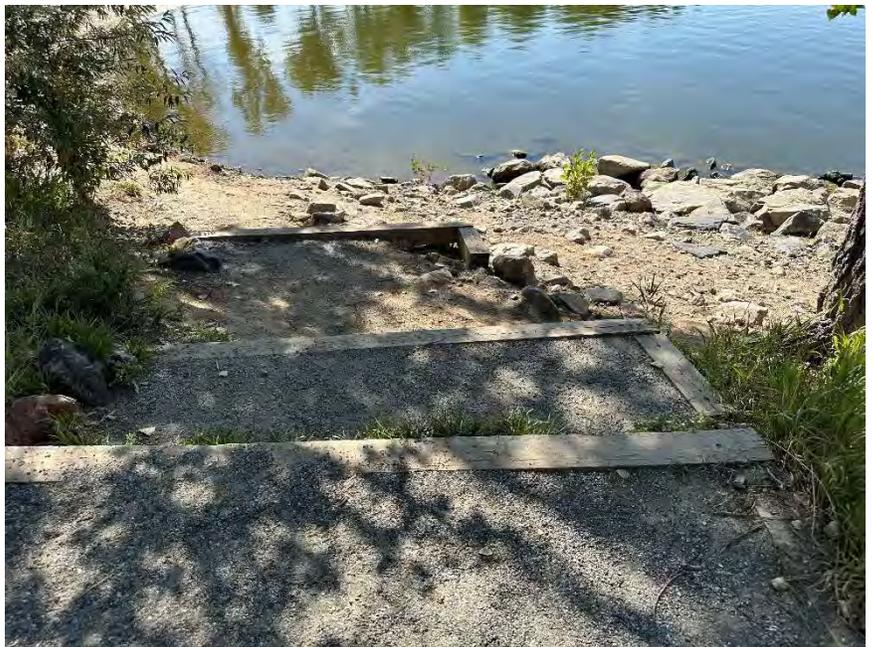
Access steps need CCSP maintenance

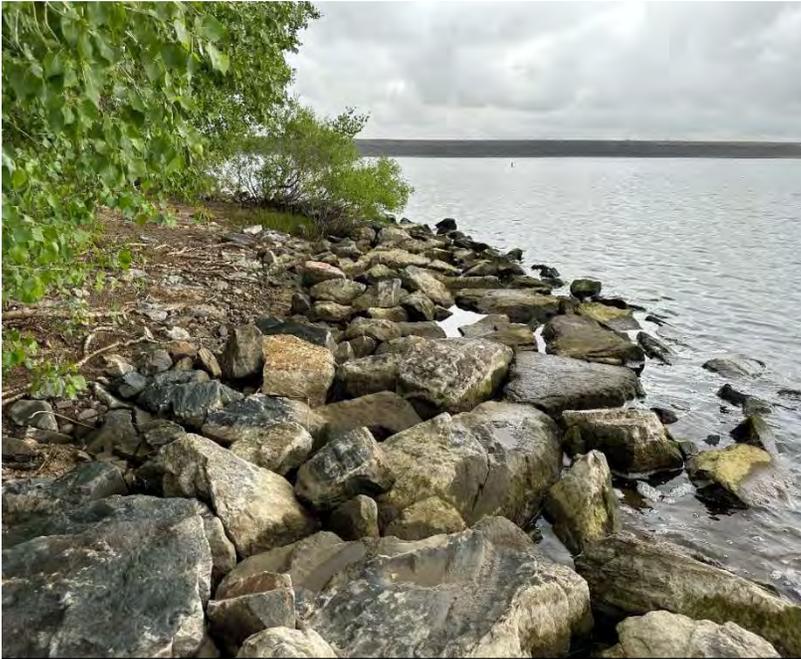
Current condition of shoreline stabilization

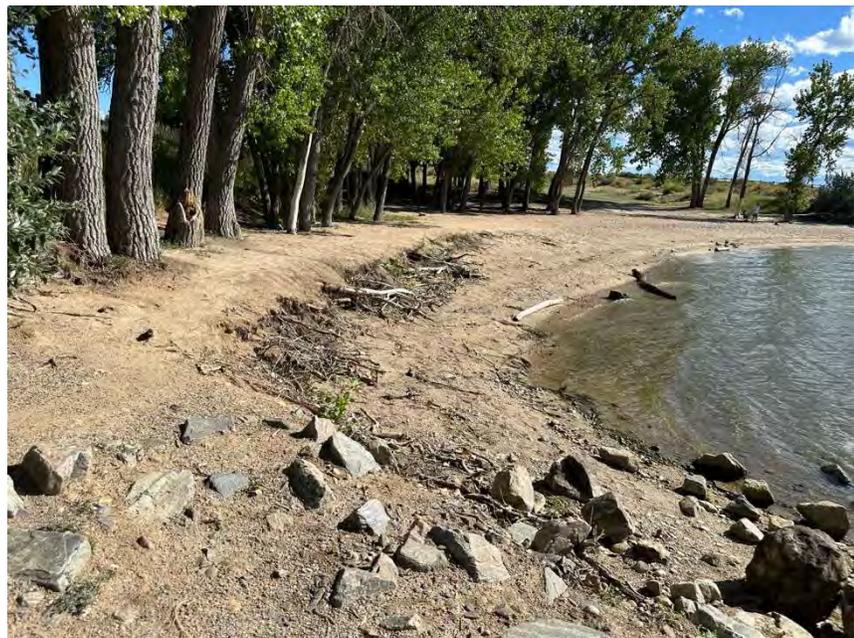
New area SW of the existing PRF originally contemplated for a shoreline stabilization project, but

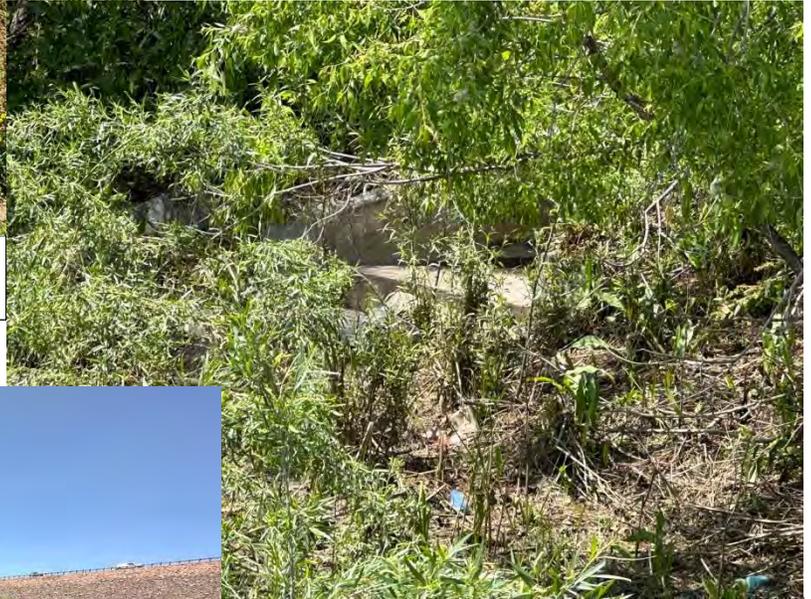
Plant-clogged inlet

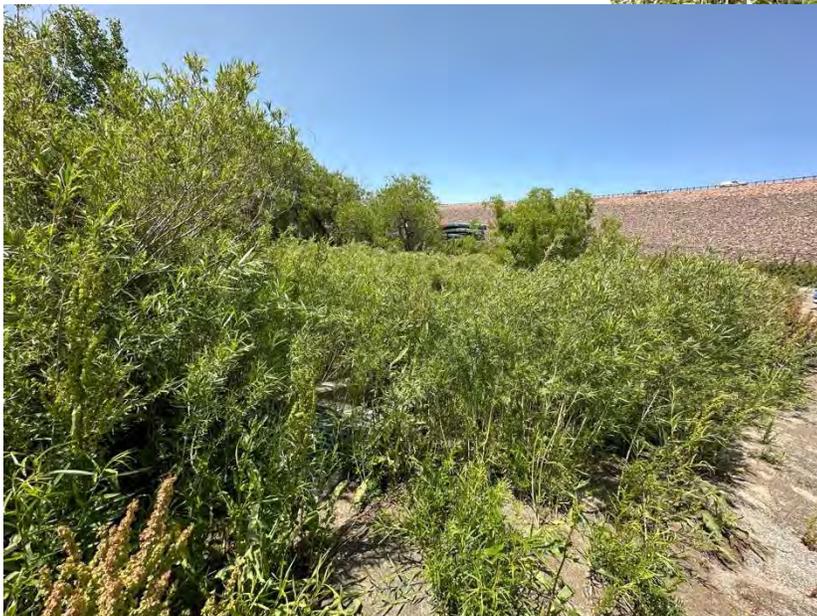
Total facility clogged with plants

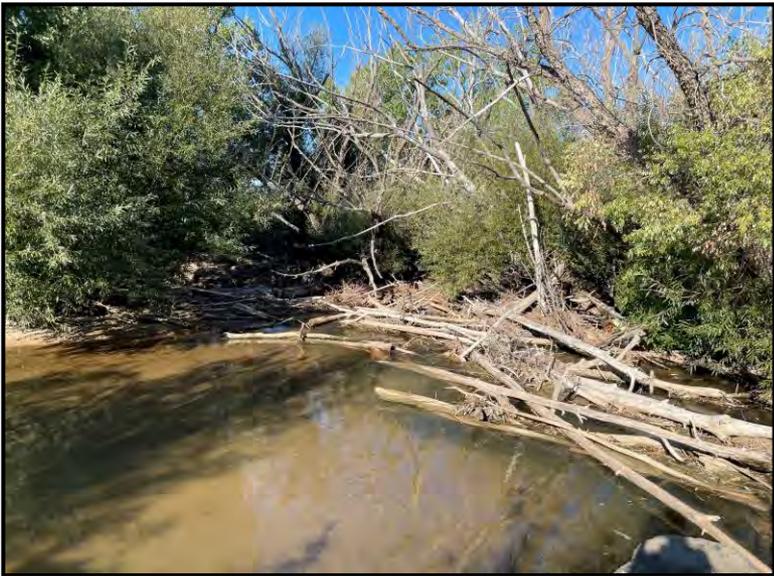
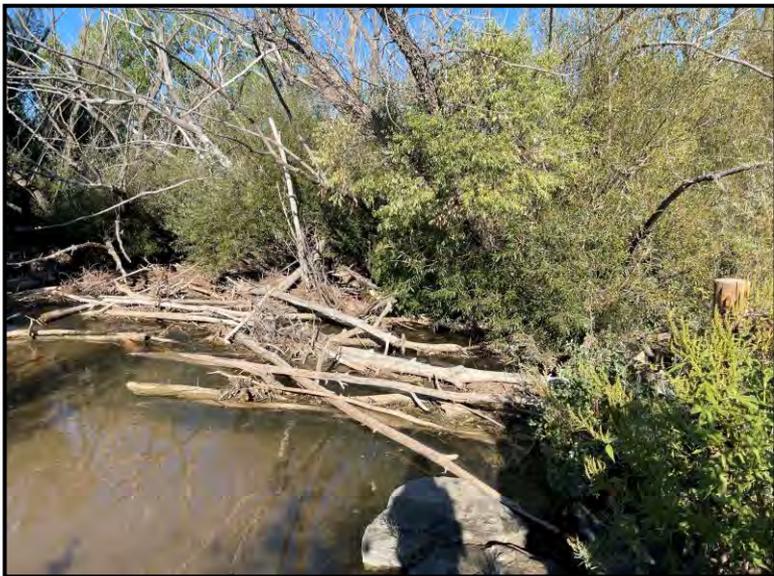
1. Near the upstream end of the reach, there is a significant log jam, presumably from flooding in 2023 (see photos 1 – 7). The log jam pushes flow in the creek to the west and appears to be acting as a grade control structure. Downstream of the log jam, the sand bed channel has incised by several feet, leaving “islands” of higher ground around trees where sediment is held in place by roots. Removal of the log jam would be a major effort going beyond O&M, and with the stabilizing function the log jam is currently providing, removing this may not be advisable. As a part of studying this reach in the future, it would be worth evaluating the stability of this area. If the log jam is well anchored, perhaps it could be reinforced to act as a grade control in the long term. Removal of the log jam would likely mobilize significant amounts of sediment and would leave behind an area in need of stabilization.

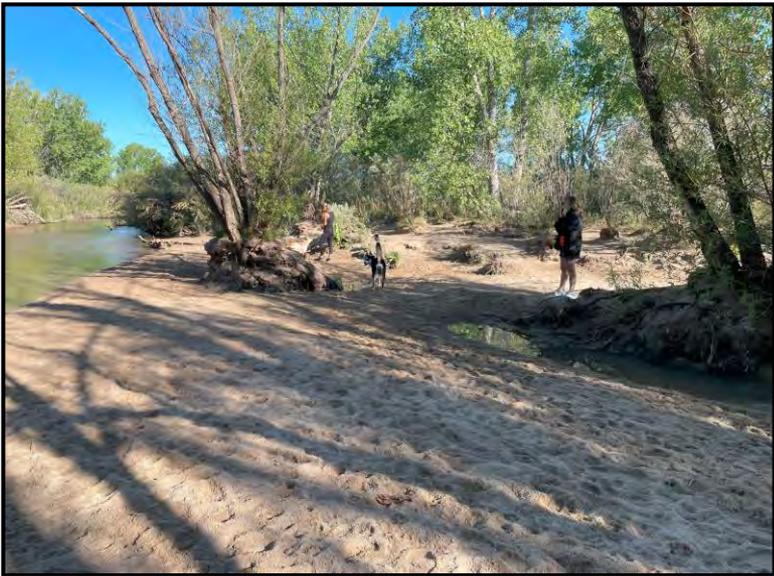
Photo 13.

2. Downstream of the log jam, the channel appears to have degraded by two to three feet judging from the depth of sediment remaining around some of the trees (see photos 8 - 13). Some trees may be undermined and lost in future flood events and some of the vegetation on the banks may be stressed by the lowering of the water table. Revegetation of banks that are now exposed due to the channel incision could be considered for a short or long term project. Using willow staking could be an effective practice based on stands of willows along some sections of the creek.

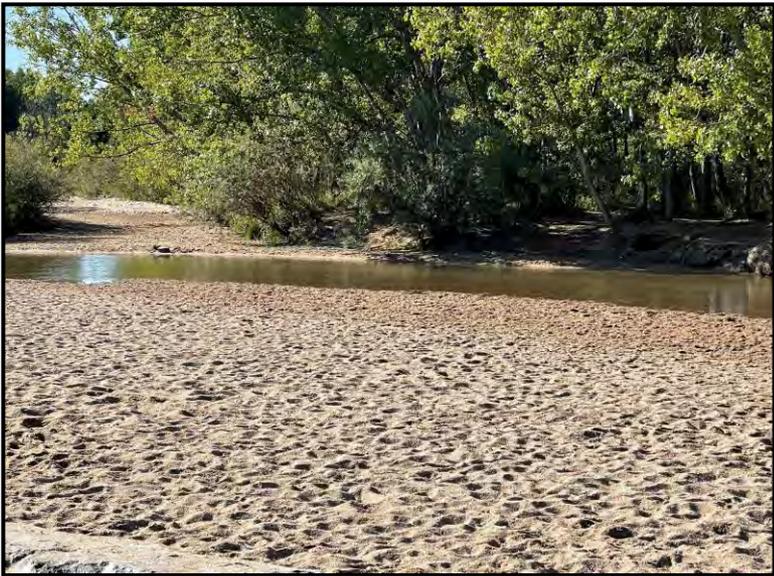
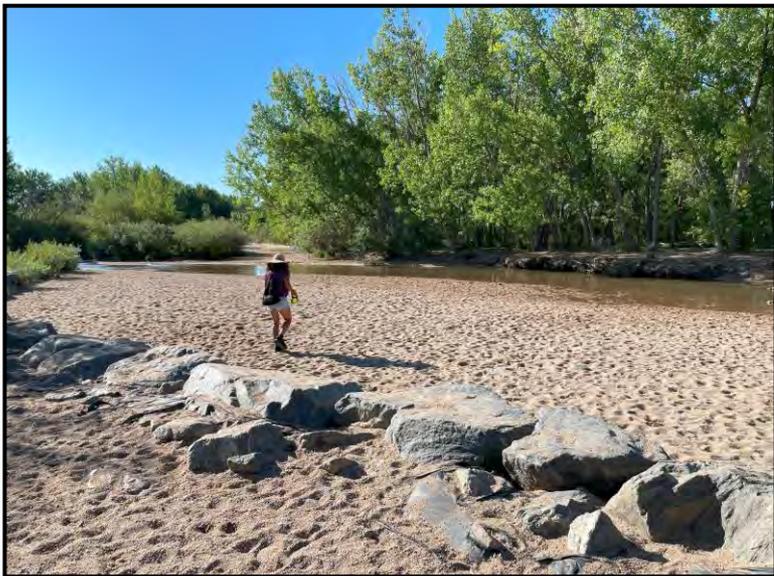
3. The next area visited was a large beach area that is very popular with human and canine users of the area (see photos 14 - 24). This section of creek was lined with large boulders along the outer edge of a bend in the stream alignment, although the low flow channel alignment has since shifted from its initial design alignment in this area now having the outer channel bend on the far bank (south) with sand deposition zones just inside the boulder lining. In recent floods, water got above these boulders and appears to have eroded some of the material in the floodplain bench behind the boulders, leaving some geotextile exposed. Some erosion along the far bank (south) where the outer bend has shifted was also observed. We discussed the potential for stabilizing some of the floodplain bench area with vegetation, which would require soil amendment or importing topsoil. Establish vegetation in this beach area would need to balance the stabilization objectives of revegetation with the active use of this area. Overall, the group felt that this area was a lower priority than others because it clearly serves its recreational objectives as a beach area and there are other areas along the creek with much more substantial erosion. Some erosion protection along the far bank could be considered as a maintenance activity or as part of a capital project.

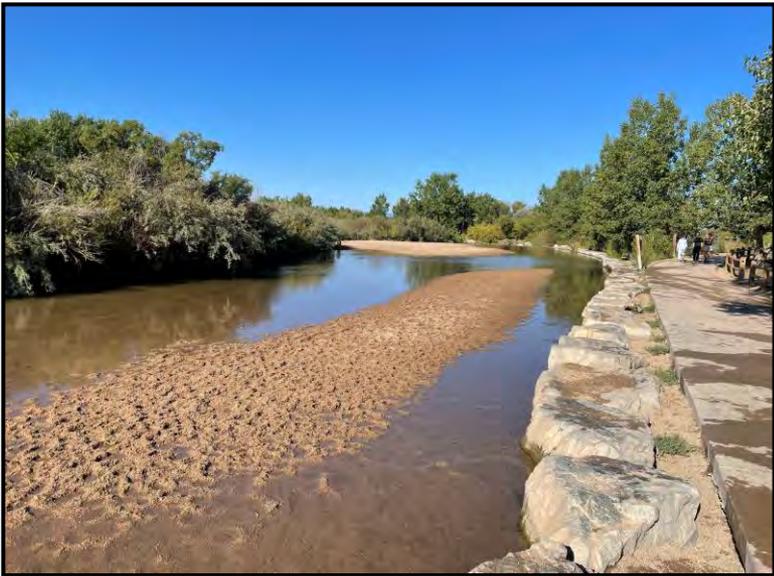
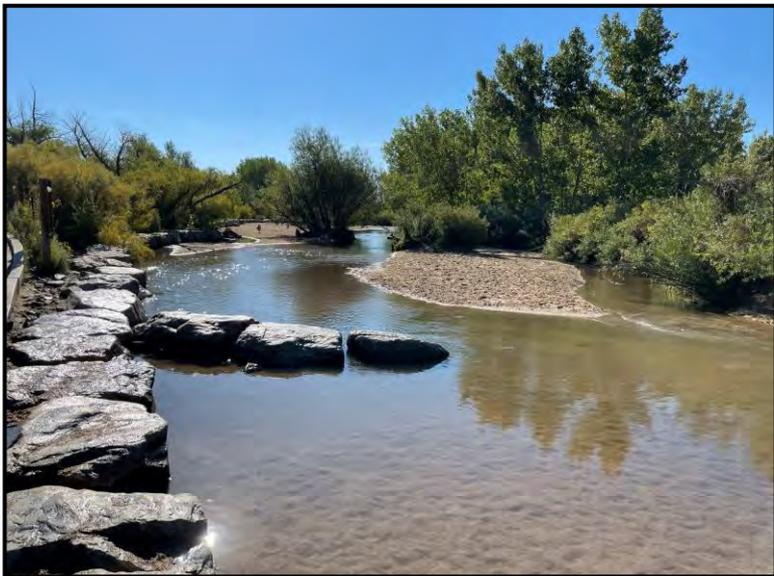
4. Moving further downstream, the group visited the area where the multi-use path runs along a floodplain bench on the north side of the creek (see photos 25 - 29). Some material has washed out from behind the boulders lining the bank and is leading to some undermining of the path. Rick stated that there is a maintenance project out for bids to fill in this area with rock with a d_{50} of 2 inches, which will help shore up the multi-

use path. The bendway weir in this location appears to be doing an effective job of redirecting the current toward the main channel and away from the outer bend.

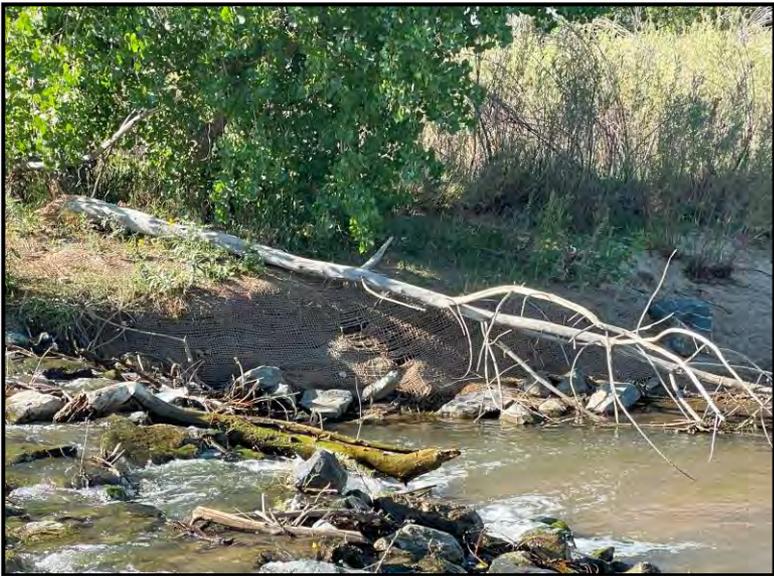
Photo 33.

5. The next area visited was the drop structure that was constructed as a part of Phase 3 of the channel improvements in this area (see photos 30 - 33). The drop structure appears to be in good condition, although it appears that some of the Riprap used to construct the drop have been deposited downstream of the structure (see photos 30 and 31). Upstream of the drop structure, the creek appears to flow towards the south bank; Elysa confirmed with record drawings for the Cherry Creek at 12-mile Phase 3 project that the sheet pile for the drop structure does extend approximately 93-ft beyond the south channel bank to protect from the channel eroding around the drop. In addition, it appears that some bank material may have been washed out from the bank on the opposite side of the creek, just downstream of the drop. Replacing the rock that has been dislodged from the drop structure and repairing bank erosion on the far bank could be considered as maintenance projects. The drop structure appears to be performing as intended, so repairing the drop and bank erosion would be good expenditures of O&M funds.

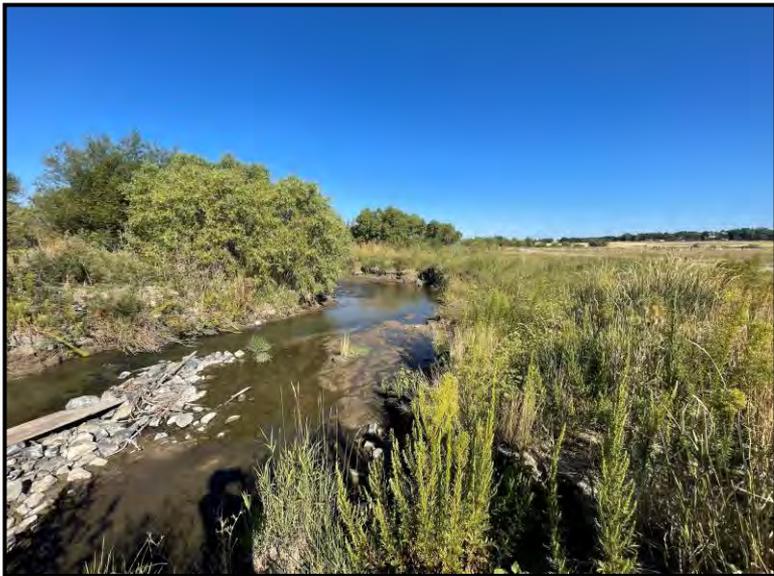
Photo 40.

6. Downstream of the drop structure, the channel has avulsed from its historic flow path to the north (see photos 34 - 45). The flow undermined the rock-lined northern bank of the creek, and a new channel has formed. The previous main channel has been filled in with sediment, and the channel that was created by this avulsion is now actively shaping itself. Downstream of avulsion, we observed steep cut banks, as well as a drop naturally forming in the channel bottom due to less erodible claystone bedrock in the channel. The channel flows generally to the north from the avulsion with several sharp eroding bends observed during the site visit. While the old main channel now appears abandoned, it likely would serve as an active flow path in a large flood event in addition to the new channel. Work to repair the breached boulder channel bank and convert this into a formalized grade control structure would require heavy equipment. This may be advisable in the long-term but goes beyond an O&M project. We also noted a rock bar across part of the channel downstream of the avulsion area (see photos 40 – 43 and 45). It appears that this is a deposit of material washed out from upstream. The avulsed channel appears to lose a lot of grade over a short distance, so turning this into a formal grade control structure also could be a good maintenance project. At the point of avulsion and in the channel downstream, there are several locations where the channel significantly narrows as it goes around sharp bends. One alternative to consider in these areas is grading back the banks to lessen the constriction. This would help to reduce velocities through the areas, and high flow path cutting off bends could be evaluated and armored to avoid excessive erosion in flood events. We also discussed collecting samples of exposed claystone bedrock material along the banks of the channel downstream of the avulsion to better assess the phosphorus content and risk of phosphorus loading downstream.
