MEMORANDUM

DATE: August 28, 2019

FROM: Richard G. Borchardt PE, CFM

SUBJECT: 2019 Annual Inspection of Pollution Reduction Facilities (PRFs) at CCSP

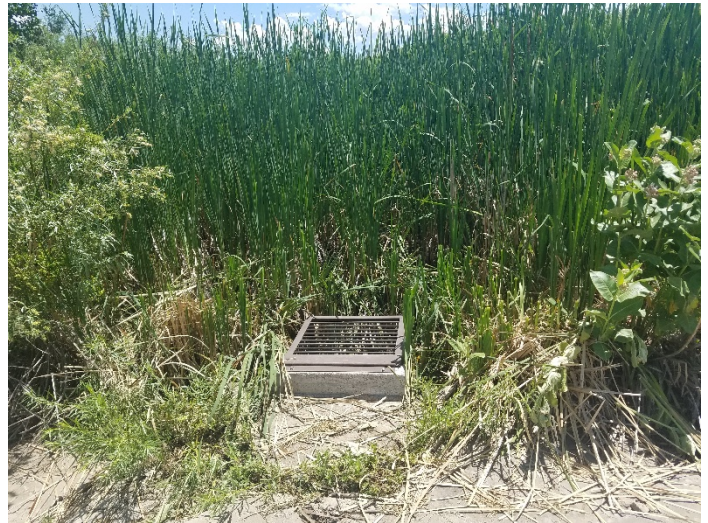
Photo 18

Shop Creek: Minor deterioration of the top of the roller compacted concrete drop structures #2 and #3 was noted (**Photo 17**) similar to 2018 inspection; continued monitoring of this area is suggested. CCSP performs regular maintenance by cleaning the trash racks, mowing/removing vegetation around the trash racks, and removing woody vegetation in areas that could impact the soil cement structures (**Photo 18**). Trash racks require frequent cleaning for proper operation. The Mile High Flood District is coordinating and scheduling a sediment removal for upstream pond outside of state park (**Photo 19**)¹. Weed control for noxious weeds is needed and a maintenance project is being developed for consideration by Authority’s TAC and Board.

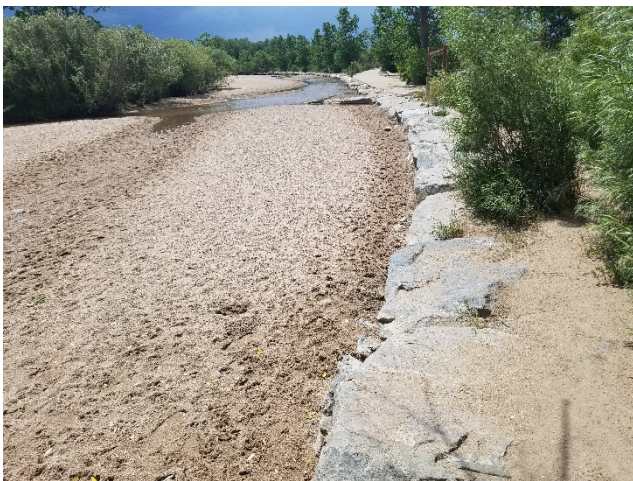
Photo 21

Cherry Creek 12-mile Park Phase I: Phase I was completed in 2012. It has experienced significant sediment aggradation from the 2014 and 2015 storm events. Maintenance identified in 2018 inspection (**Photo 24**); resulted in budgeting for fencing and revegetation which is scheduled for end of 2019. New for 2019, stream sediment levels appear to have a visible improvement over 2018 inspection; continued monitoring is suggested (**Photos 21-22**). Noxious weed control has been performed annually since 2014, and a maintenance effort is being prepared to continue treatment (**Photo 23**); for consideration by Authority's TAC and Board in 2020. Social trails are being formed along bank closed to Dog Off Leash Area; continued monitoring is suggested.

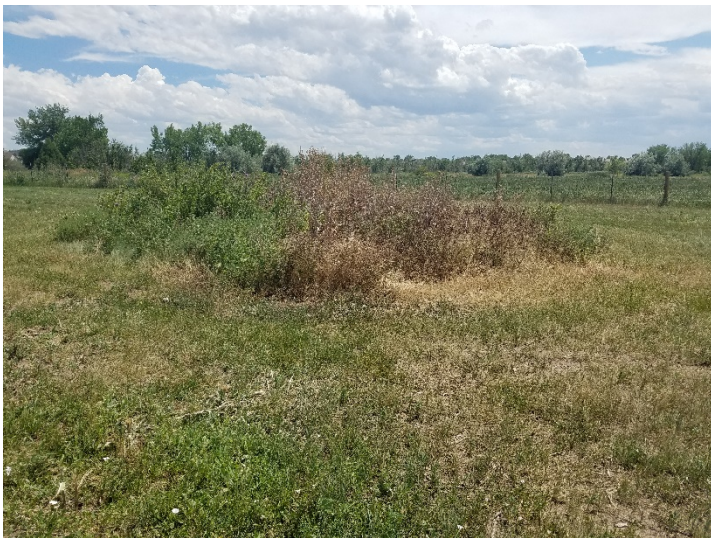
Photo 25

Cherry Creek 12-mile Park Phase II: Phase II was completed in 2014 and is experiencing high pedestrian / dog activity. It has experienced significant sediment aggradation from the 2014 and 2015 storm events. Stream sediment levels appear to have a visible improvement over 2018 inspection; continued monitoring of this area is suggested. Noxious weed control has been performed annually since 2014, and it was performed by CCSP and the Authority in 2019 (**Photo 25**). Traffic into the Creek has deteriorated the soil lifts (**Photo 26**) and created 10-12 foot wide social path at the edge of the stream damaging grasses and shrubs (**Photo 27**). A maintenance effort for continuing weed control and maintenance project for repairing damage is being developed for consideration by Authority's TAC and Board in 2020.

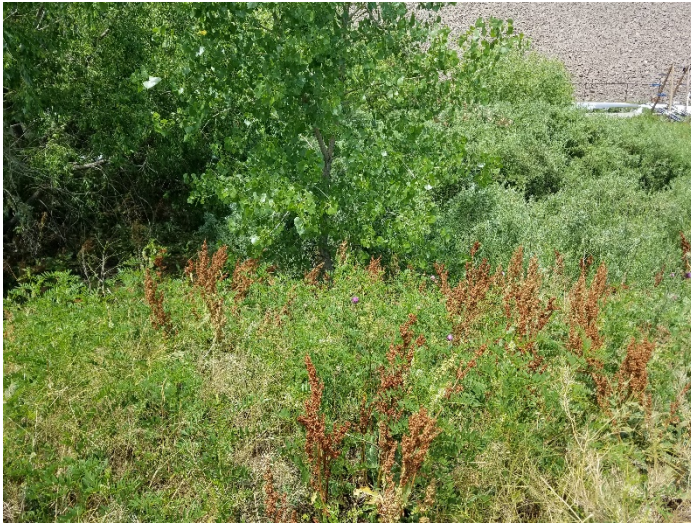
Photo 33

West Boat Ramp: Construction of this PRF was completed in 2014. All maintenance for this PRF is the responsibility of CCSP. Routine maintenance including noxious weed control (mowing and spray application), outlet structure cleaning (box and screen) and clearing willows and woody vegetation from the detention pond and over pipe outfall is needed (**Photos 33-35**). The Marina is storing equipment and materials in spillway area (**Photo 36**); CCSP will follow-up with Marina to relocate these items.
