R I F F L E S T O R I P P L E S

DATE: September 14, 2020 (Updated with TAC Comments on 10/8/20)

SUBJECT: 2020 Annual Field Observation of Pollution Reduction Facilities (PRFs) at CCSP

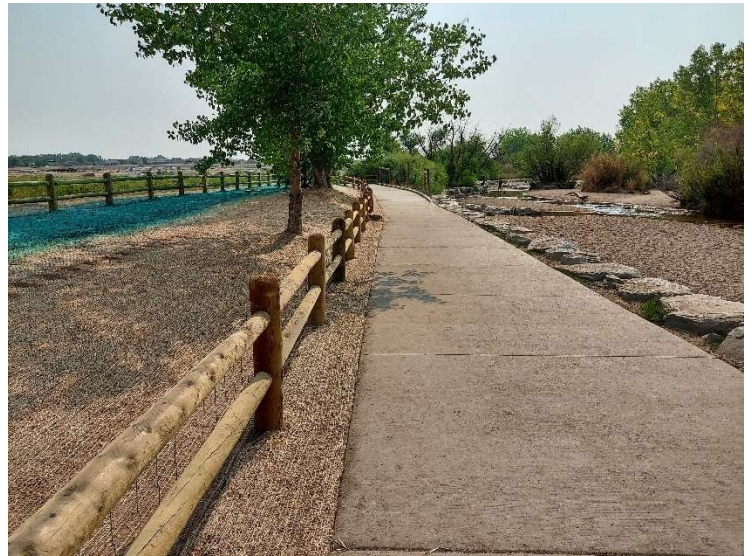
Photo 21

Cherry Creek 12-mile Park Phase I: Phase I was completed in 2012. It did experience significant sediment aggradation from the 2014 and 2015 storm events which appears to have resolved with the breach. Maintenance identified in 2018 FO (**Photo 21**); resulted in budgeting for fencing and revegetation which was completed on August 24, 2020 (**Photo 22**). Bank erosion and social trails were noted in 2019 FO (**Photo 23-24**); planning and permitting have started for this repair. Noxious weed control and mowing was done by CCSP in 2020 and should be continued by CCSP.

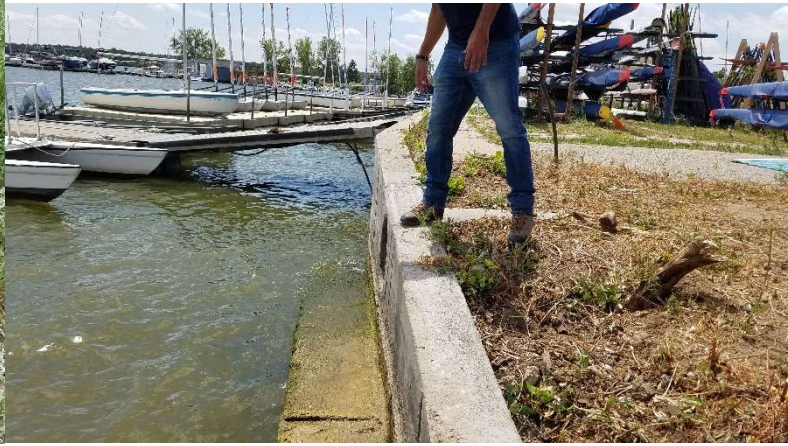
Photo 32

West Boat Ramp (Reservoir Water Surface Elevation = 5549.4): Construction of this PRF was completed in 2014. All maintenance for this PRF is the responsibility of CCSP. Routine maintenance that was noted in 2019 FO and has been completed: cleaning of the outlet structure box and screen and clearing of woody vegetation (**Photo 31**) and removal of tree over pipe outfall is needed (**Photos 32**). Weed control is still needed (**Photo 33**) and should be continued by CCSP. Marina continues to store equipment and materials in spillway area (**Photo 34**); CCSP staff will continue to work with the Marina to relocate these items.

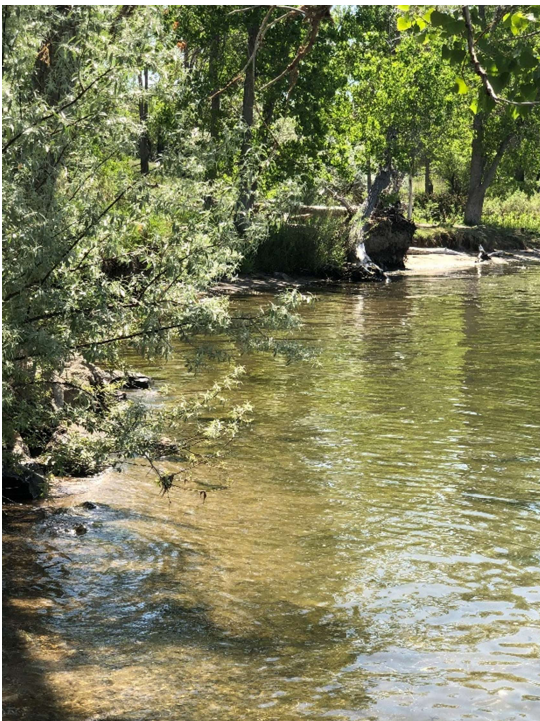
Photo 37

Dixon Grove (Reservoir Water Surface Elevation = 5550.2): A hole developed near the edge on the Shoreline (**Photo 35**); CCSP staff were notified and repair was made (**Photo 36**). A gap between a boulder and the grout has formed (**Photo 37**), continued monitoring of this issue is suggested. Starting with the 2019 FO, an area to the south of the existing shoreline protection shows some erosion (**Photo 38**), a second phase of shoreline protection will be included in the upcoming Capital Improvement Program for consideration by TAC and Board. The riprap installed along the shoreline appears to be working (**Photo 39**).
