RIFFLES TO RIPPLES

**DATE:** November 1, 2022 (Revised to include TAC input on November 4, 2022)

**SUBJECT:** 2022 Annual Field Observation of Pollution Reduction Facilities (PRFs) at CCSP

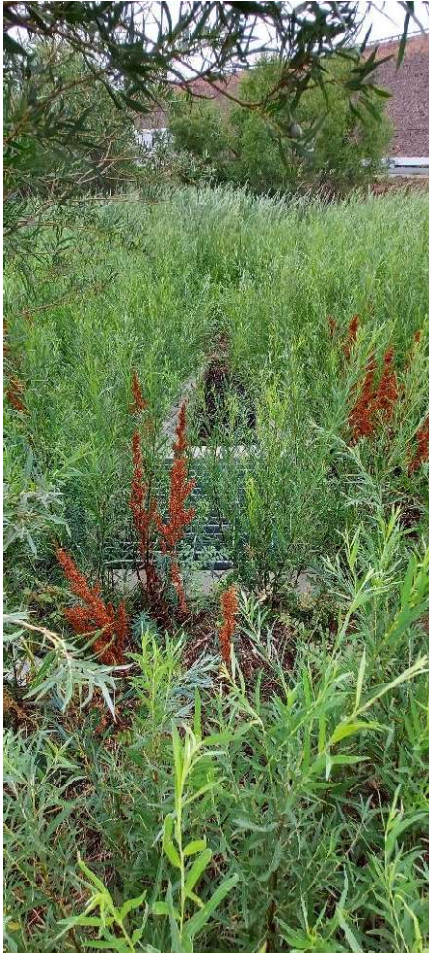
**Photo 1 - 7/28/22**

West Boat Ramp (Reservoir Water Surface Elevation = 5547.7 on 7/28/22): Construction of this PRF was completed in 2014. All maintenance for this PRF is the responsibility of CCSP. Routine maintenance is needed to clear woody vegetation (**Photo 1**). At the 8/2/22 meeting with CCSP, CCSP staff marked limits of the spillway with paint and will coordinate with Marina and associated groups to relocate items currently stored there to another location (**Photo 2**). Maintenance that was identified for CCSP is cutting and clearing of vegetation around outlet and relocating stored items outside of spillway.

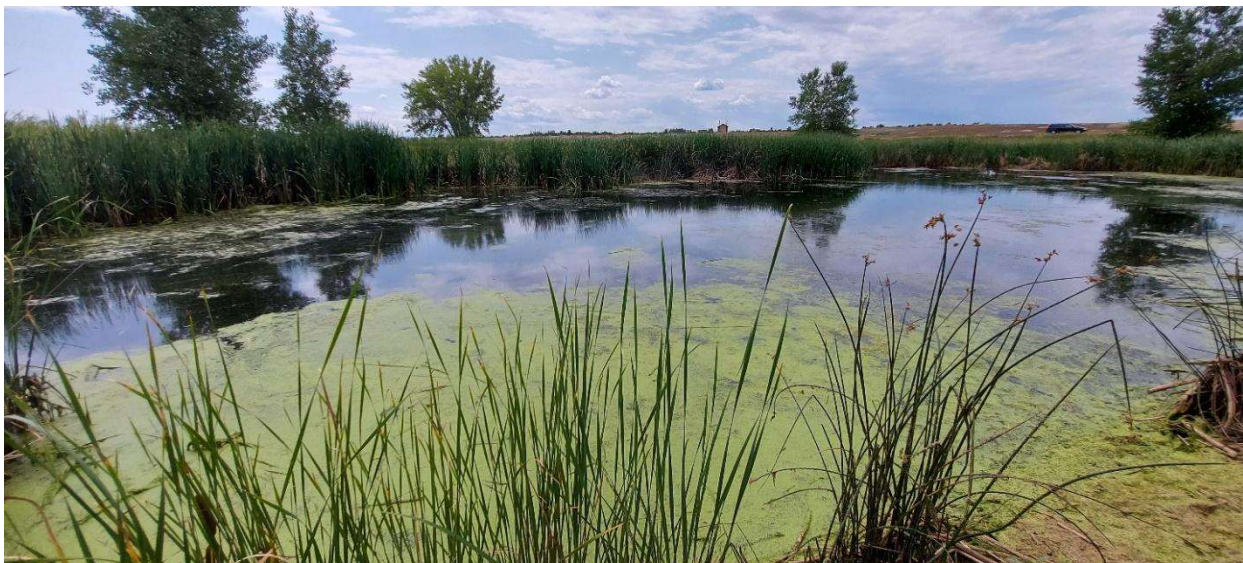
**Photo 4 – 8/1/22**

**Cottonwood Wetlands:** Some woody vegetation was observed around outlet (**Photo 3**). This vegetation was subsequently cut and removed with the wetland harvesting effort. Some aquatic vegetation and algae were observed in water (**Photo 4**) and maintenance bench above outlet grate had cattail debris covering it (**Photo 5**); the outlet grate and bench were subsequently cleaned with the wetland harvesting. Several standing dead trees were noted around the PRF (**Photo 6**). The educational signs appear to be in functional shape (**Photos 7 and 8**). The post-storm visit was done on August 26, 2022; no damage was observed from the post-storm visit and a higher water surface was observed (**Photos 9 and 10**). Stressed vegetation and compaction of soils was observed on the access along the embankment (**Photos 11-14**); decompaction and reseeded will likely benefit the recovery of the native grasses and protection of embankment during overtopping events. The maintenance identified for CCBWQA's consideration is cleaning of the outlet grate and decompaction and revegetation of the access along the embankment.

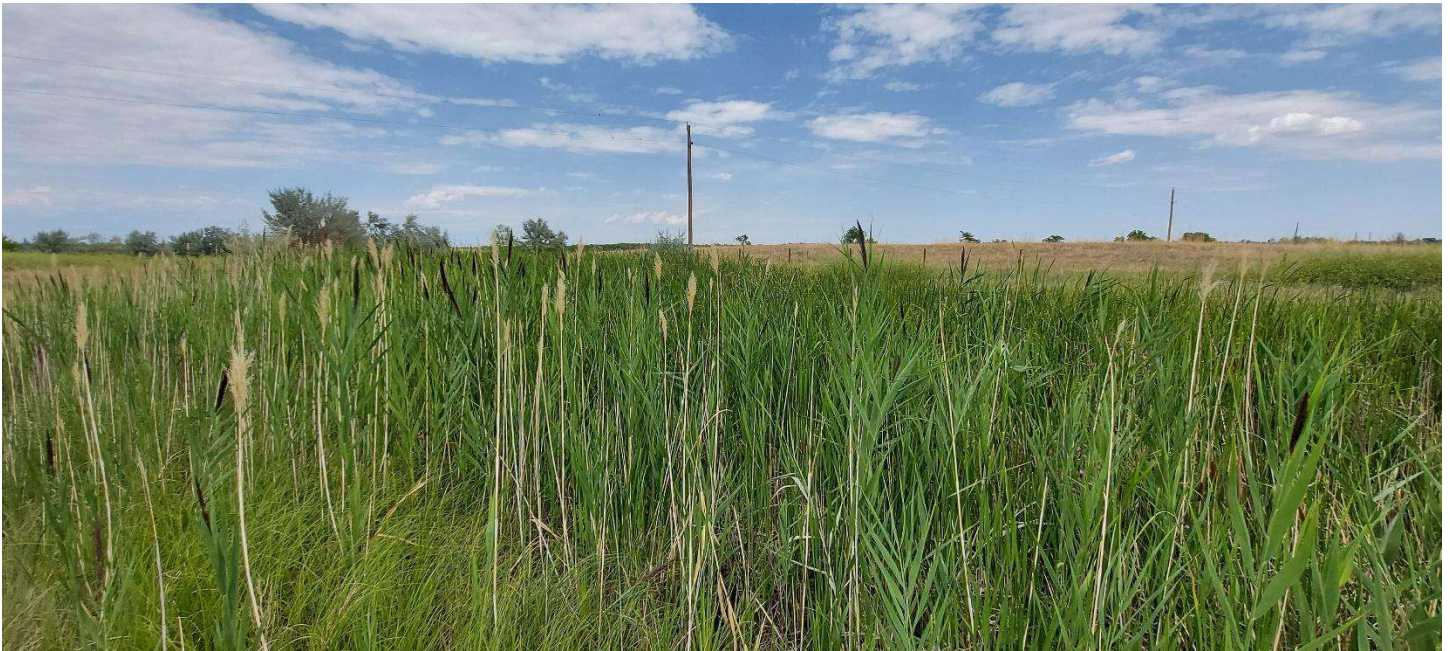
**Photo 17 – 8/1/22**

Cottonwood Creek Stream Reclamation: Riparian and wetland vegetation along stream banks is thriving (**Photo 15**). Riffle drops are functioning with some Russian olives, a Colorado noxious weed list B species, present (**Photo 16**). Common reed, a Colorado noxious weed watch-list species, was observed (**Photo 17**). Several downed trees were noted from beaver activity (**Photo 18**). The post-storm visit was done on August 26, 2022; no damage was observed from the post-storm visit and evidence of high-water debris was observed (**Photos 19 and 20**). No maintenance was specifically identified; however, continued monitoring and coordination with CCSP staff on noxious weeds is suggested.

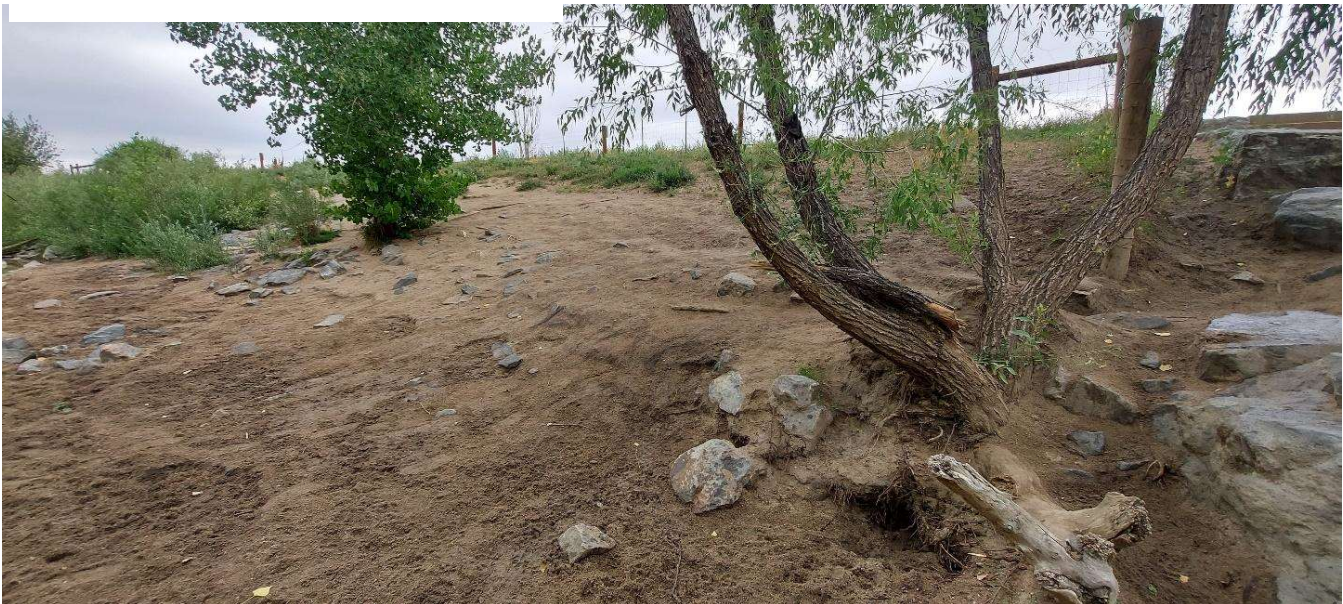
**Photo 28 – 7/28/22**

Cherry Creek 12-mile Park Phase II: Phase II was completed in 2014 and is experiencing high pedestrian and dog activity. Bed and bank erosion were observed near the boundary between Phase I and Phase II (**Photo 27**). Vegetation continues to be denuded by heavy park use (**Photo 28**). Additional bank erosion was observed (**Photo 29**) and the August storm event appears to have accelerated it (**Photo 30**). Bank erosion was observed on secondary channel, east of main stem (**Photo 31**). No maintenance was identified; however, a capital project for stream reclamation may be needed. Continued planning is suggested to identify work needed, overall priorities, and costs for Cherry Creek between Lake View Drive and the CCSP Boundary.

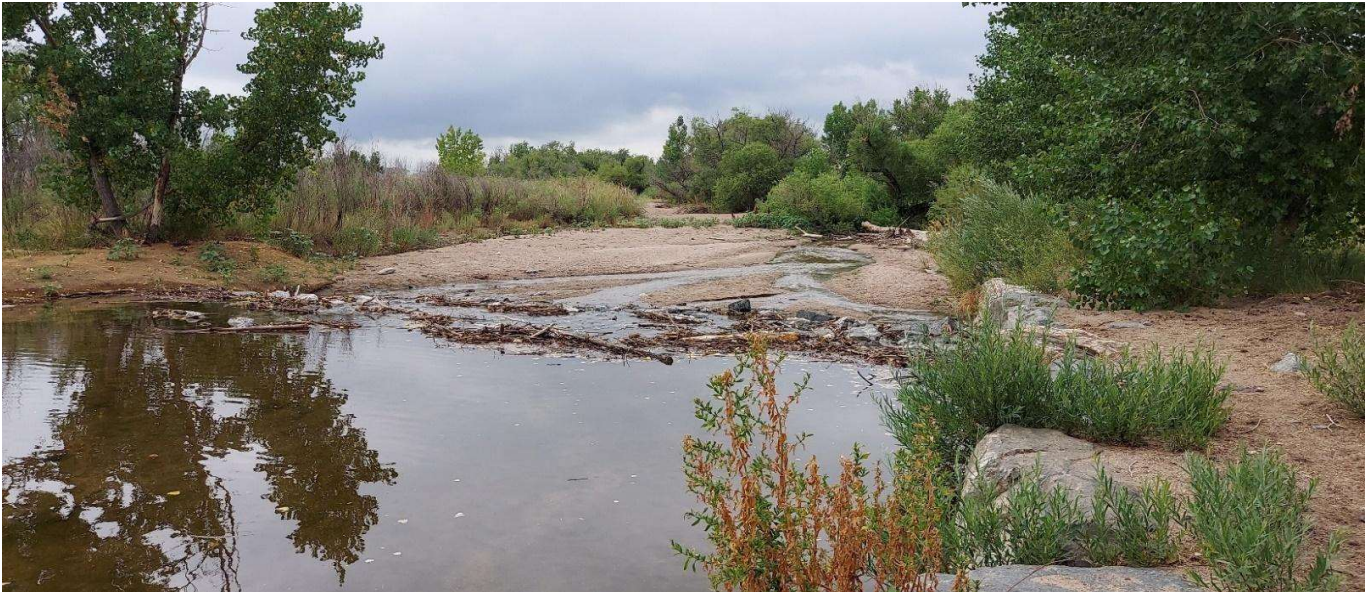
**Photo 32 – 7/28/22**

Cherry Creek 12-mile Park Phase III: Phase III was substantially complete (**Photos 32 and 33**) ahead of the August storm event. There was some damage that resulted from the August storm event (**Photos 34 to 35**) and the construction Best Management Practices/Stormwater Control Measures greatly minimized the storm impact. Repairs are anticipated to be made in 2022 as the project is not fully closed out at the time of this report. Weed control is needed to help with vegetation re-establishment in project area; it will likely start with mechanical control and then move to herbicide once grasses start to mature. A capital project for stream reclamation may be needed, continued planning is suggested to identify work needed, overall priorities, and costs for Cherry Creek between Lake View Drive and the CCSP Boundary.

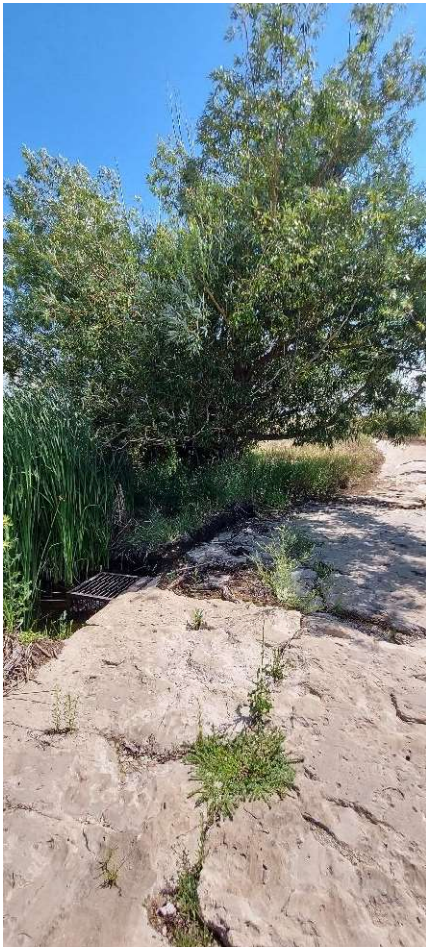
**Photo 38 – Drop 3 – 7/27/22**

Shop Creek: There are 5 drop structures within CCSP numbered 1 through 5 from upstream to downstream, and an additional drop structure outside of the CCSP Boundary. Drop 1 has spalling concrete along the crest (**Photos 36**). Drop 2 has spalling concrete along the crest, seepage between layers of roller-compacted concrete, and vegetation growing on downstream face (**Photo 37**). Drop 3 has spalling concrete along the crest, a tree growing next to drop with tree root intrusion in drop (**Photos 38 to 39**), and vegetation growing on downstream face of drop (**Photo 40**). Drop 4 has vegetation growing on downstream face and less severe spalling of concrete (**Photos 41 to 42**). Drop 5 has seepage between layers of roller-compacted concrete and less severe spalling of concrete (**Photo 43**). CCSP performs regular maintenance by cleaning the trash racks and mowing and removing vegetation around inlets (**Photo 44**). No deficiencies were observed with the

educational signage. The maintenance identified for CCBWQA consideration is concrete repairs at crests of drops 1, 2, 3; removal of tree at drop 3; and vegetation control on face of drops 2, 3, and 4. Since seepage was noted on drops 2 and 5, it is recommended that seepage be monitored on all drops.

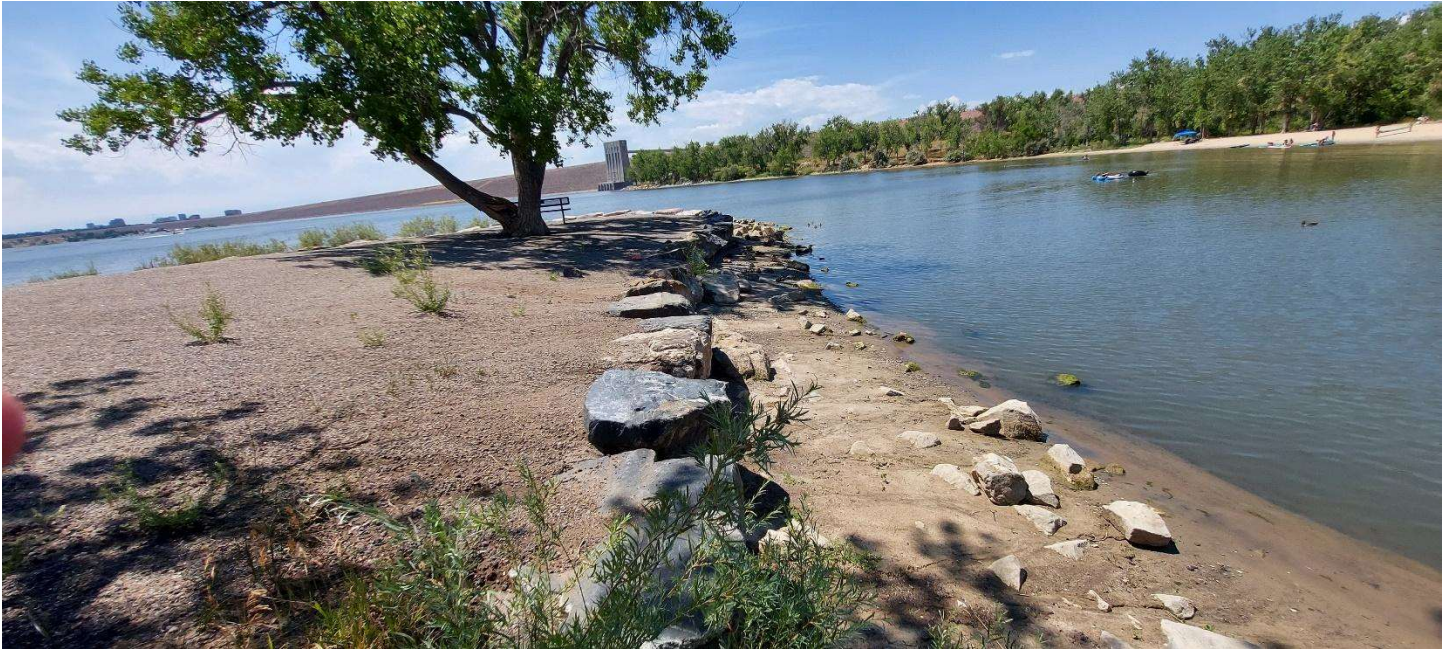
**Photo 49 - 7/27/22**

Dixon Grove (Reservoir Water Surface Elevation = 5548.1 on 7/27/22): Boulders and riprap serve as protection of shoreline (**Photos 49 and 50**). Area includes a water quality capture area (**Photo 51**) that receives runoff from adjacent parking lot (**Photos 52 and 53**). Shoreline erosion was observed just south of Dixon Grove (**Photo 54**). No maintenance needs were identified. Shoreline stabilization may be needed for the erosion located to the south of the PRF, and a planning effort may be useful in identifying work needed, priority, and costs.

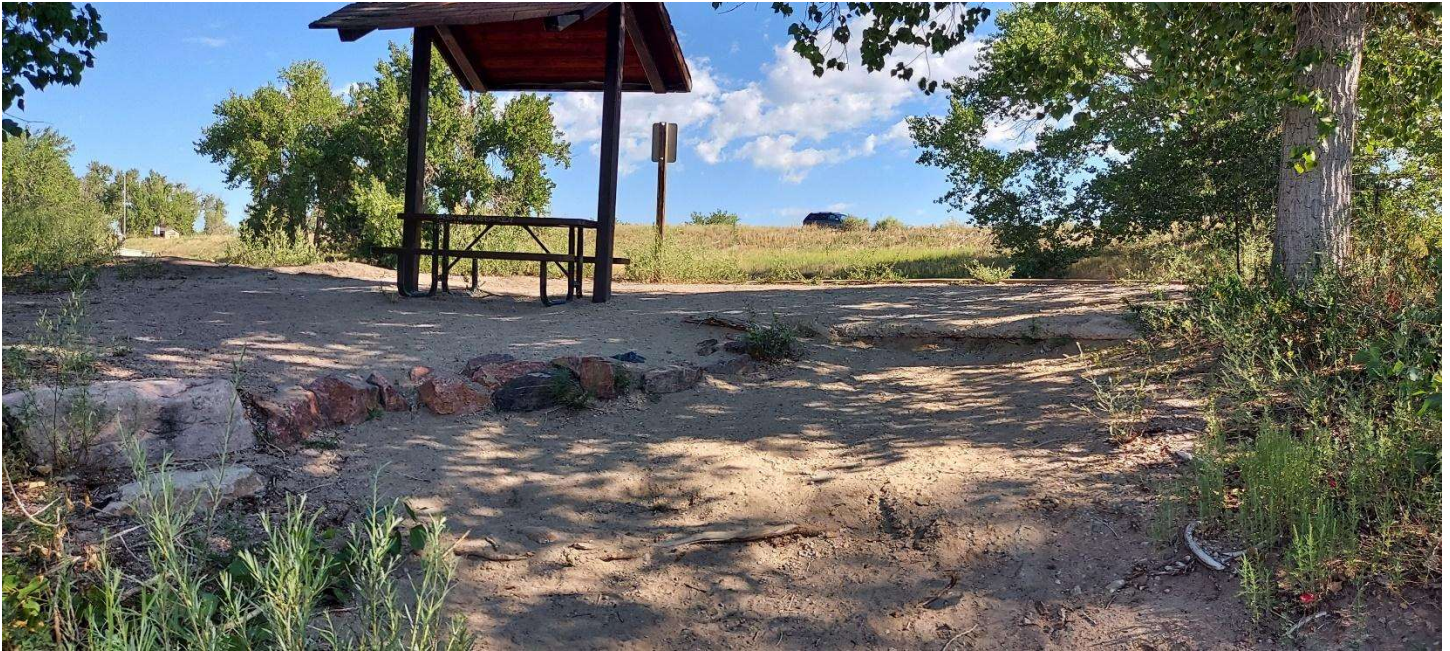
**Photo 55 - 8/9/22**

East Boat Ramp (Reservoir Water Surface Elevation = 5547.9 on 8/9/22, 5547.3 on 10/4/22): Boulders and riprap serve as protection of shoreline (**Photos 55 and 56**). Maintenance work was completed in October 2022 (**Photos 57 and 58**). Weed control is needed to help with vegetation re-establishment in the project area; it will likely start with mechanical control and then move to herbicide once grasses start to mature.

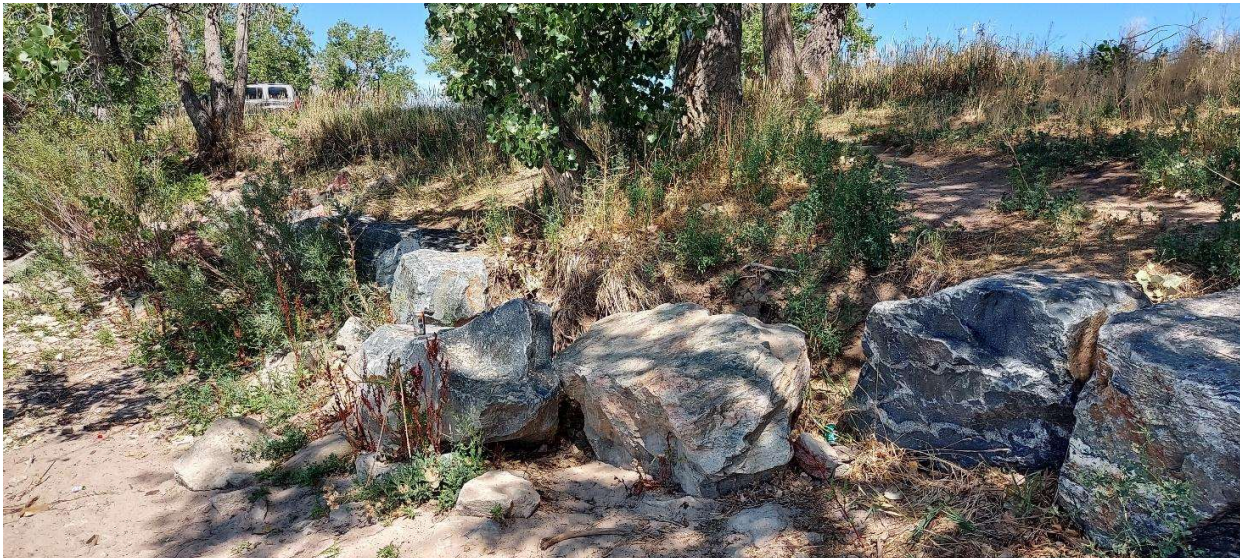
**Photo 59 – 8/9/22**

*South Section:* Boulders and riprap have shifted, and erosion was observed (**Photos 59 to 60, 62**). Concrete walk and bench have been eroded and undermined (**Photo 61**). Social trail with erosion (**Photos 63, 66, 68 to 70**). Shoreline bank erosion was observed (**Photos 64 to 65, 67**). No maintenance needs were identified. Shoreline stabilization may be needed for the erosion located in this section of this PRF, and a planning effort may be useful in identifying work needed, priority, and costs.

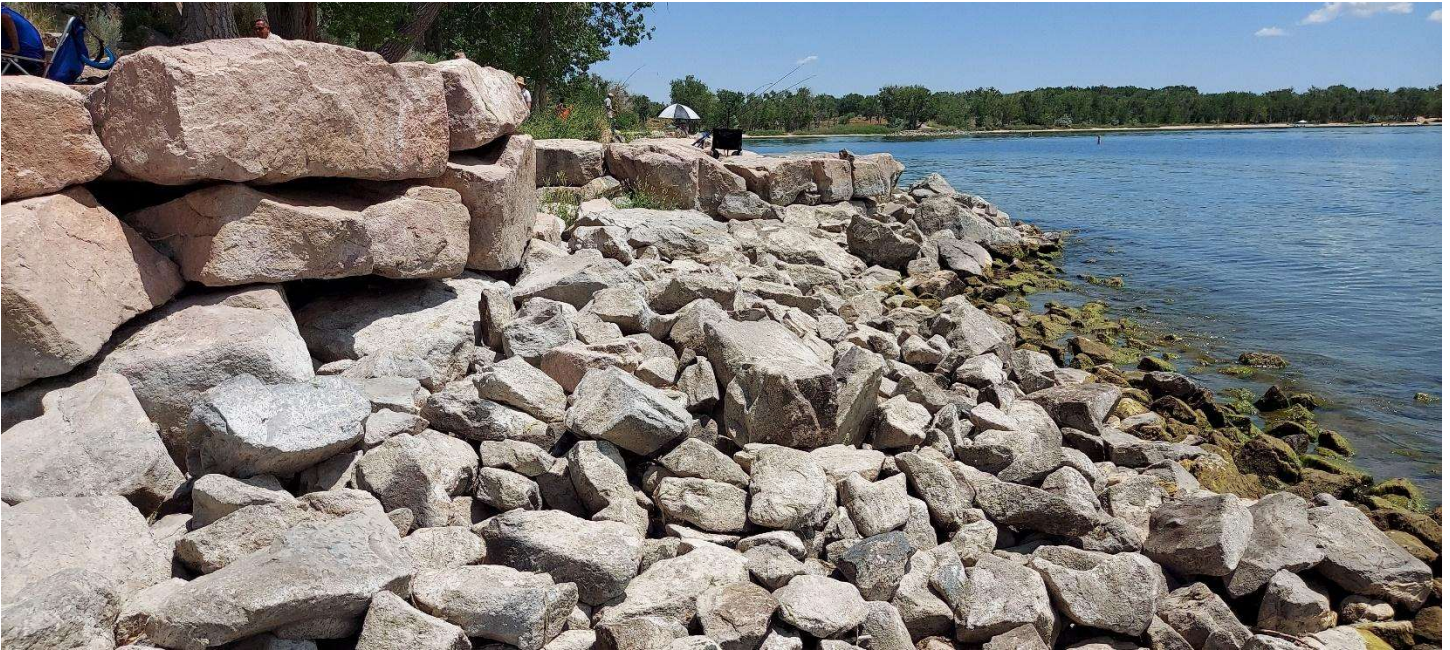
**Photo 75 – 7/12/22**

Tower Loop (Reservoir Water Surface Elevation = 5548.2 on 7/12/22): This area includes boulders and riprap for shoreline protection (**Photo 75**). Bank erosion and social trails (**Photo 76**) are located to the south and east of the PRF; a capital project is currently being designed to stabilize the shoreline. No maintenance needs were identified as the capital project is expected to address the bank erosion and minimize impact of trails.
