TASK MEMORANDUM

DATE: November 21, 2024

FROM: Ricardo Gonçalves, PE

SUBJECT: 2024 Annual Inspection of Pollution Reduction Facilities (PRFs) at CCSP

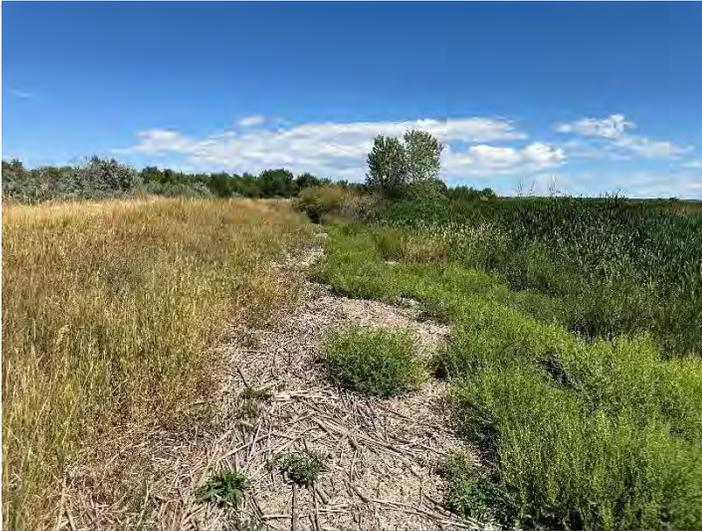
Weeds growing in dead areas created by excessively high water levels

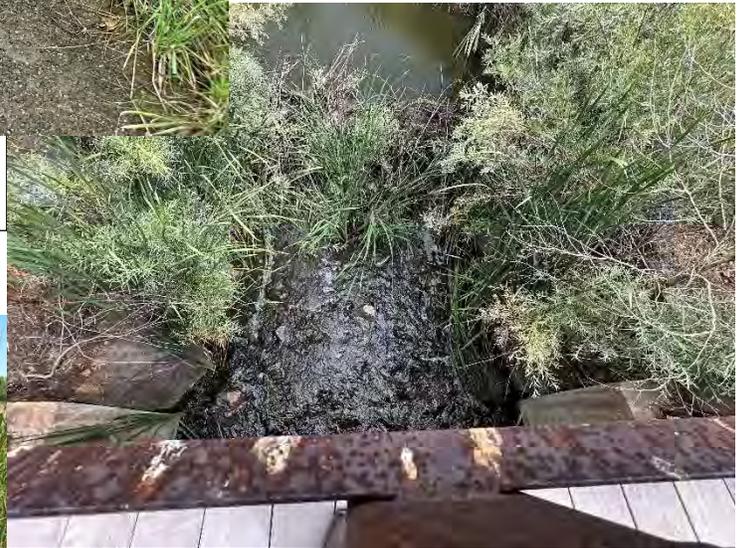
Vegetative debris blocking stream channel

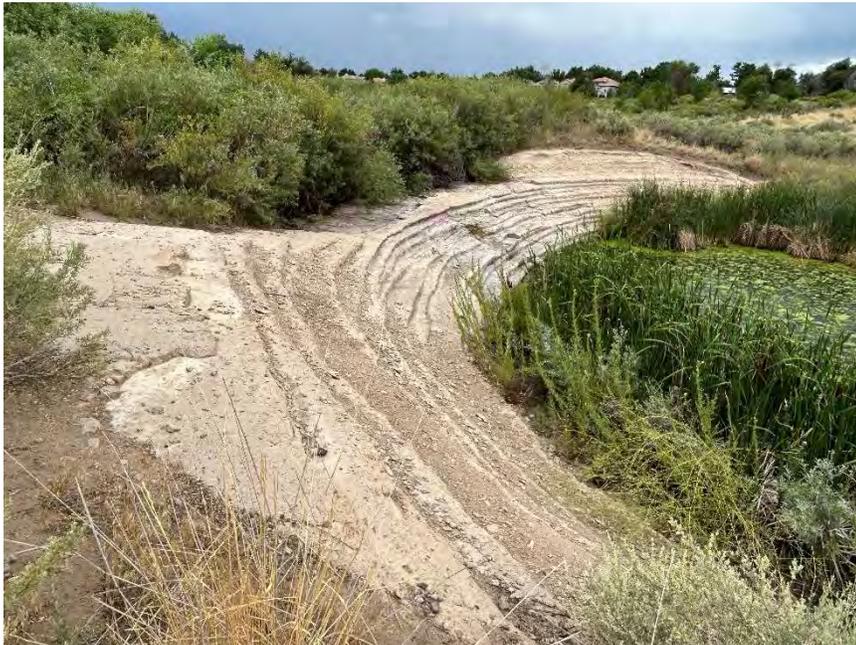
Drop No.1

Shop Creek: There are 5 drop structures within CCSP numbered 1 through 5 from upstream to downstream, and an additional drop structure outside of the CCSP Boundary. All of the drops have the same basic problems with spalling concrete along their crests, seepage between layers of roller-compacted concrete on some, vegetation growing on downstream faces, and severe erosion and spalling around their outlet structures. The recent floods did not appear to have created any of the damage, most of it being created through general wear and tear. Repair of the concrete around the outlet structures, herbicide application, and one tree

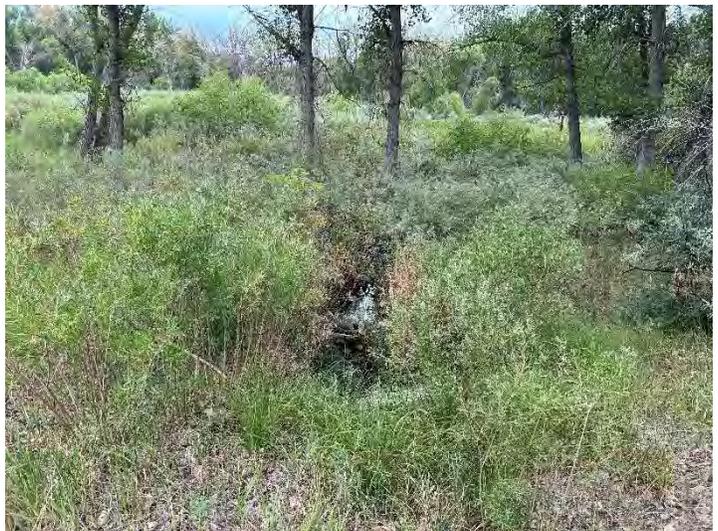
Quincy Drainage: Debris clogging was observed at the outlet structure, as were numerous plants growing in the energy dissipators of the outlet structure at the Lakeview Dr. crossing. These plants may need to be eradicated in the next couple of years. CCSP staff will take care of debris removal. At this time, no maintenance or repair needs were identified, except for weed control, although a capital project for stream reclamation may be needed in the future.

Outlet of the outlet structure

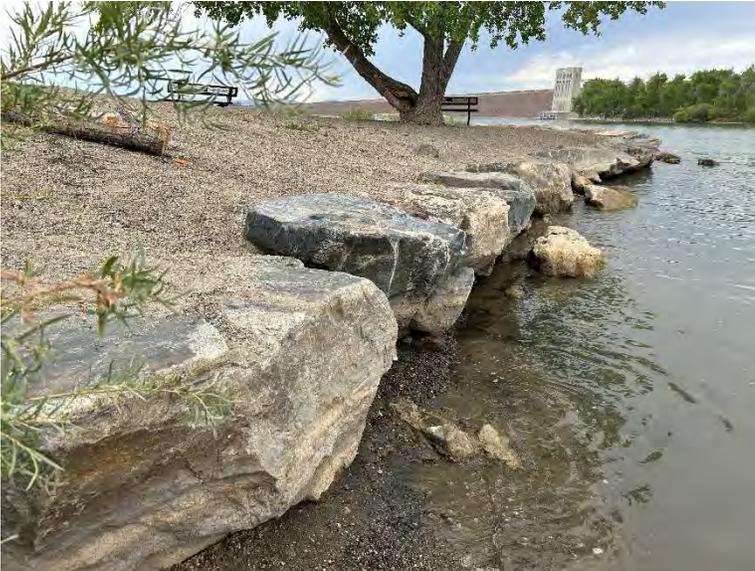
Dixon Grove: Boulders and riprap serve as protection of shoreline for this PRF. There is a water quality capture area that treats runoff from the parking lot that is appearing to function very well. The only maintenance needs that were identified was some spot weed control. The east shore of the large promontory appears to be beginning to be undercut, and should be considered for a future project. An area of shoreline south of the west shoreline stabilization area could also be a good candidate for a future shoreline stabilization capital project. Various dead trees and debris from the floods were identified for CCSP maintenance.

East Shore of Stabilized area showing the beginnings of boulder undercutting

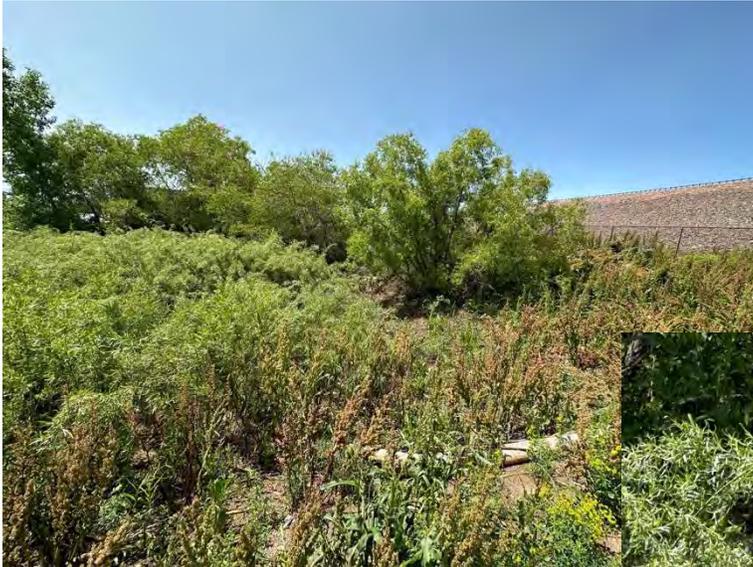
Outlet clogged with plant material

West Boat Ramp: All maintenance for this PRF is the responsibility of the CCSP. Maintenance identified for CCSP was cutting and clearing of all the vegetation inside the bounds of the pond, especially at the outlet.

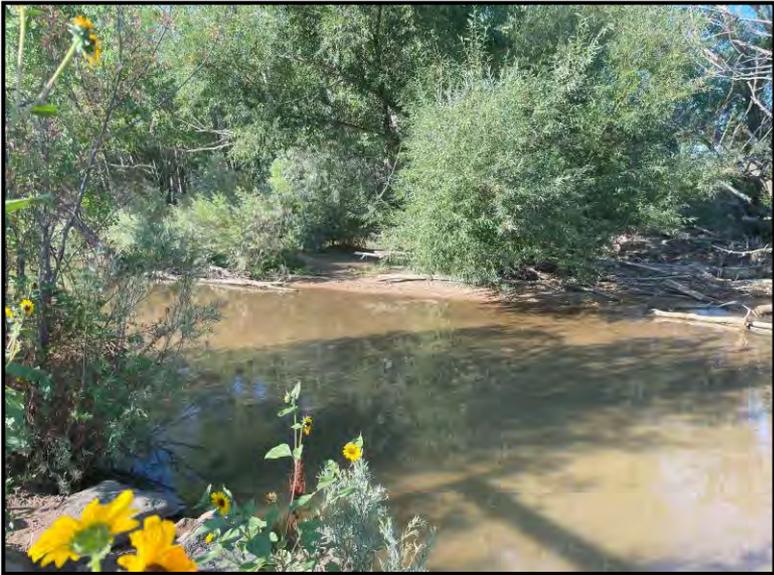
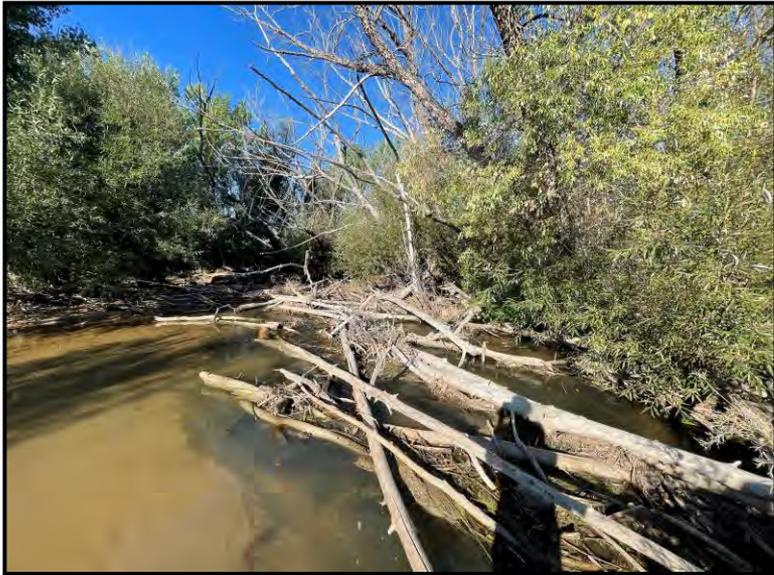
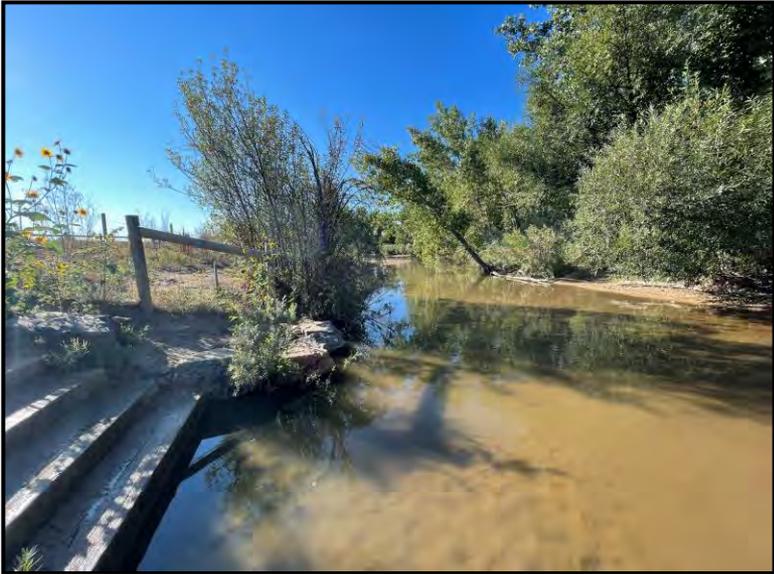
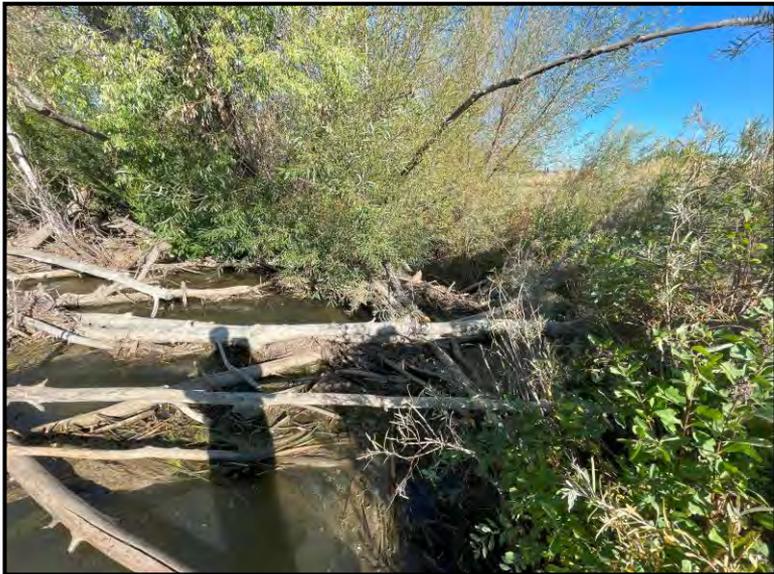
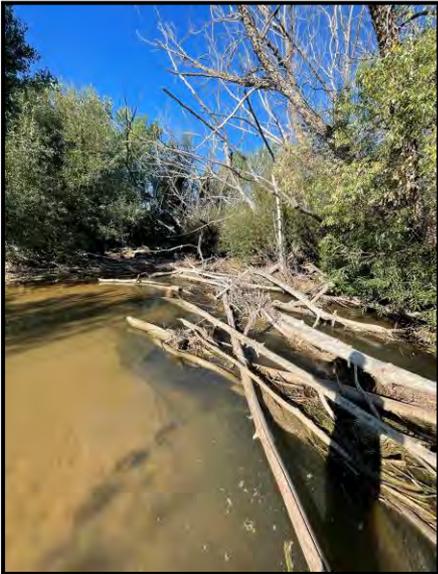
1. Near the upstream end of the reach, there is a significant log jam, presumably from flooding in 2023 (see photos 1 – 7). The log jam pushes flow in the creek to the west and appears to be acting as a grade control structure. Downstream of the log jam, the sand bed channel has incised by several feet, leaving “islands” of higher ground around trees where sediment is held in place by roots. Removal of the log jam would be a major effort going beyond O&M, and with the stabilizing function the log jam is currently providing, removing this may not be advisable. As a part of studying this reach in the future, it would be worth evaluating the stability of this area. If the log jam is well anchored, perhaps it could be reinforced to act as a grade control in the long term. Removal of the log jam would likely mobilize significant amounts of sediment and would leave behind an area in need of stabilization.

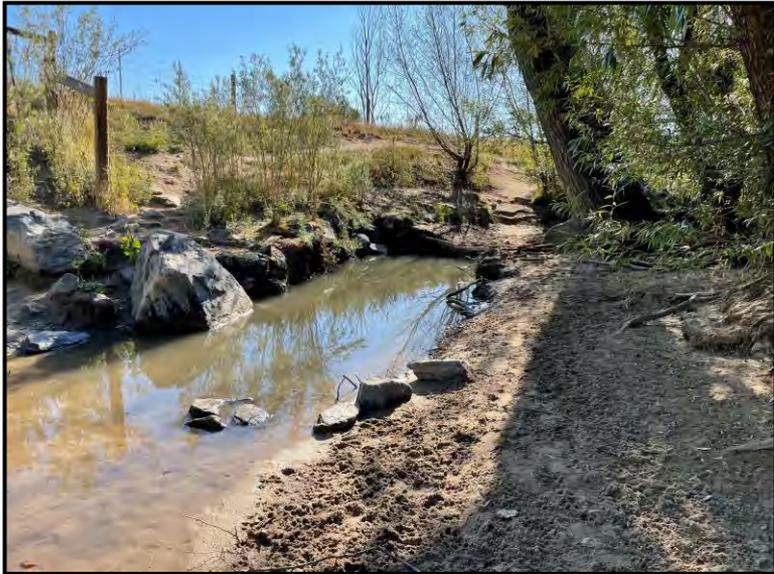
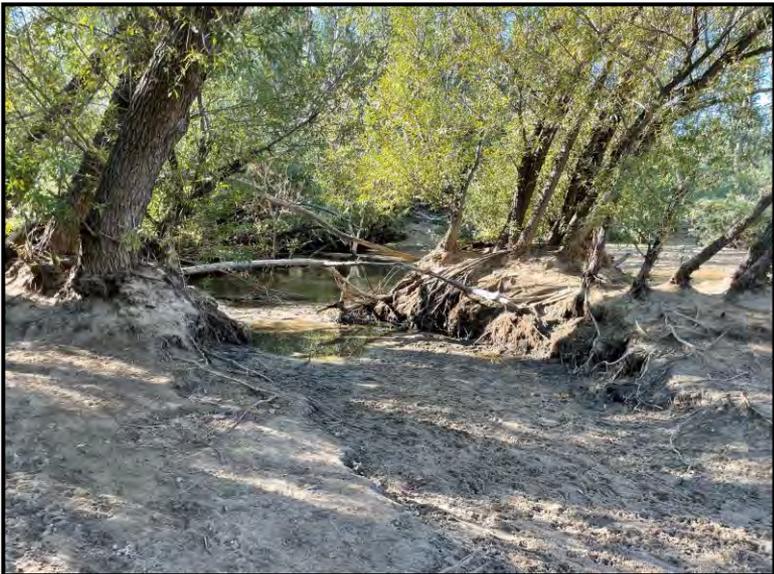
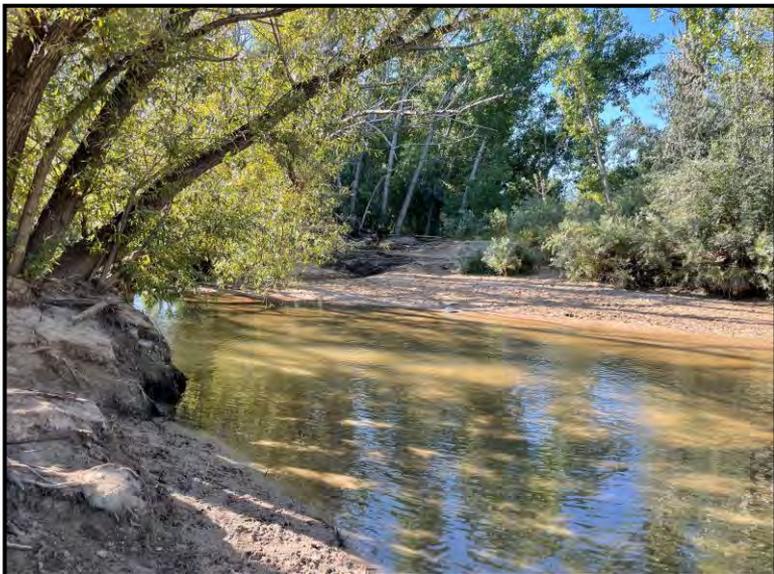
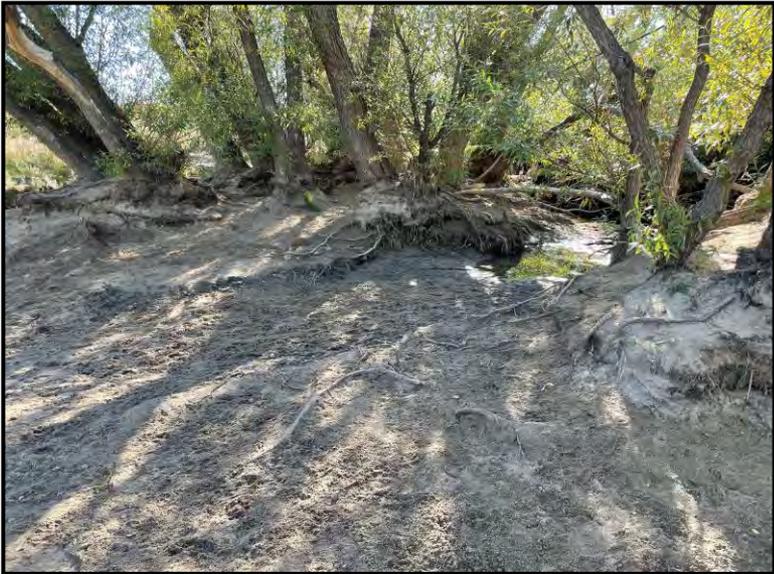
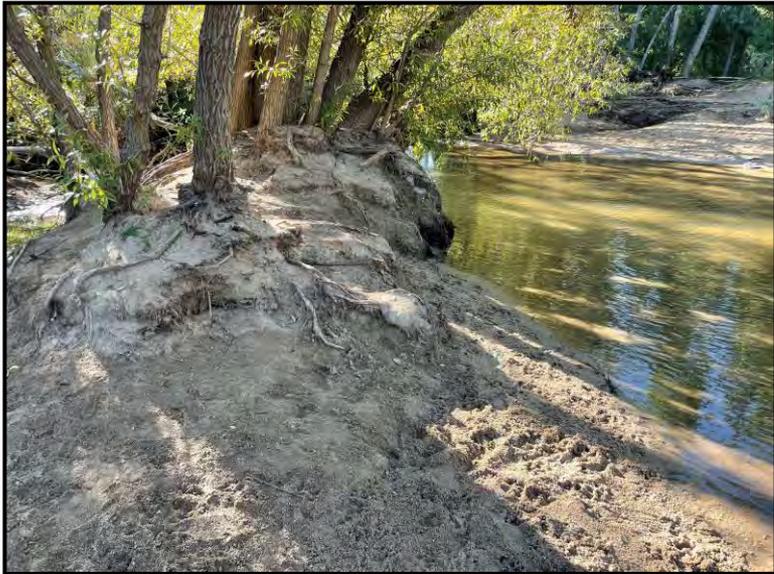
2. Downstream of the log jam, the channel appears to have degraded by two to three feet judging from the depth of sediment remaining around some of the trees (see photos 8 - 13). Some trees may be undermined and lost in future flood events and some of the vegetation on the banks may be stressed by the lowering of the water table. Revegetation of banks that are now exposed due to the channel incision could be considered for a short or long term project. Using willow staking could be an effective practice based on stands of willows along some sections of the creek.

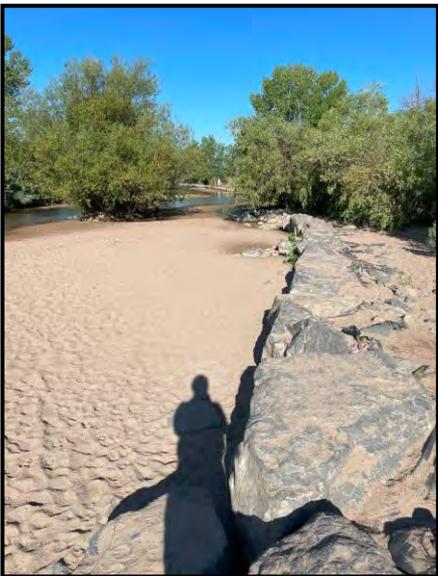
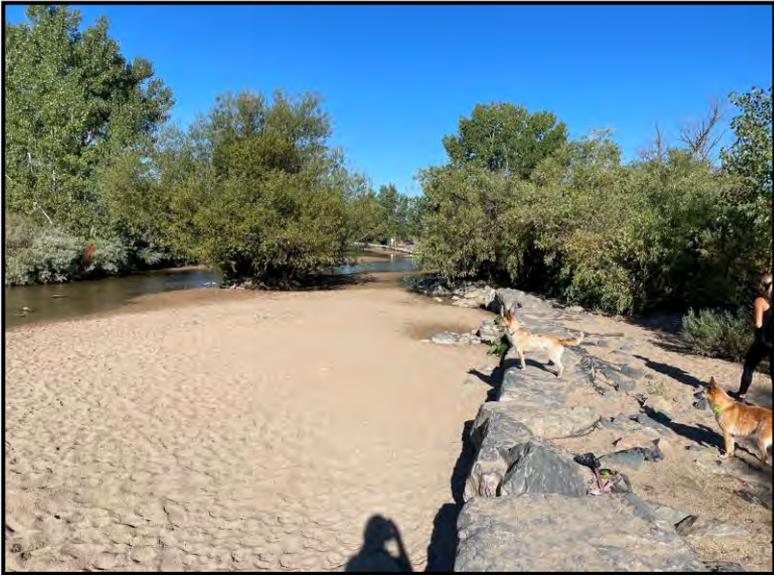
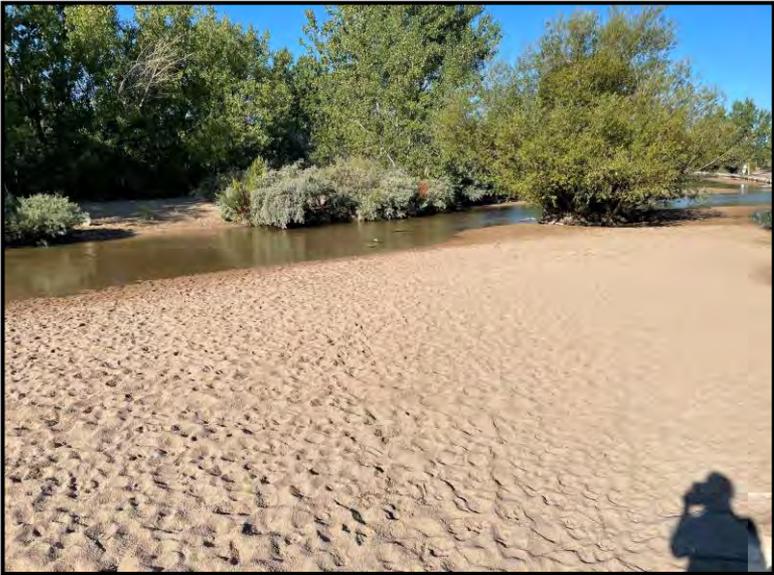
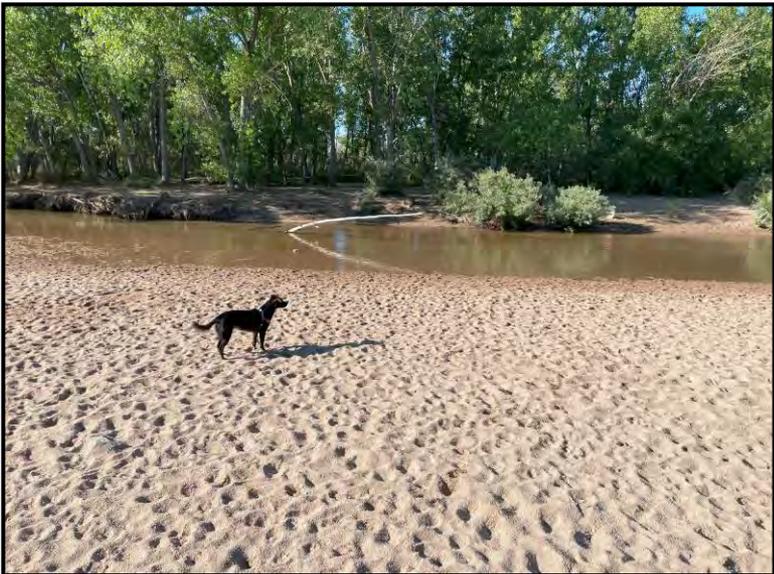
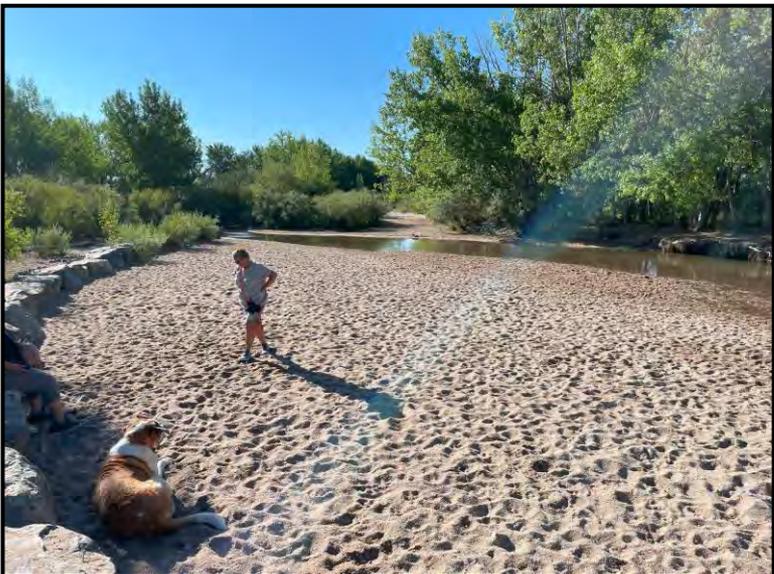
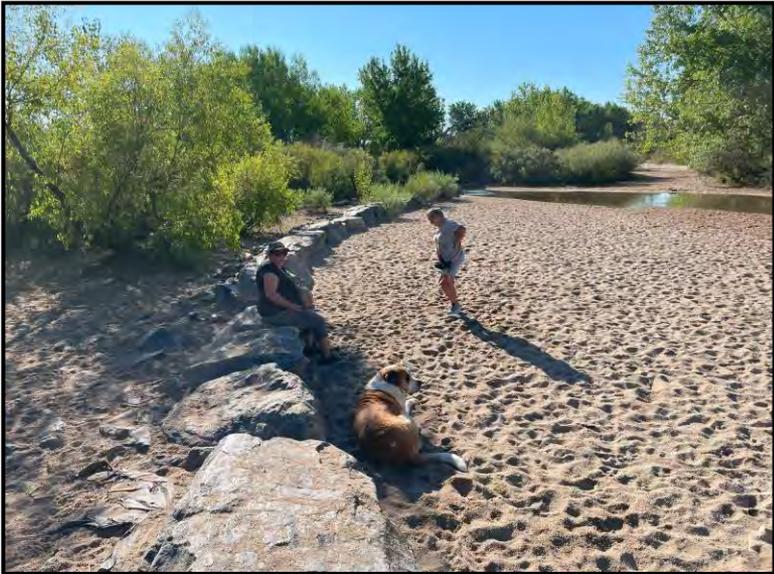
3. The next area visited was a large beach area that is very popular with human and canine users of the area (see photos 14 - 24). This section of creek was lined with large boulders along the outer edge of a bend in the stream alignment, although the low flow channel alignment has since shifted from its initial design alignment in this area now having the outer channel bend on the far bank (south) with sand deposition zones just inside the boulder lining. In recent floods, water got above these boulders and appears to have eroded some of the material in the floodplain bench behind the boulders, leaving some geotextile exposed. Some erosion along the far bank (south) where the outer bend has shifted was also observed. We discussed the potential for stabilizing some of the floodplain bench area with vegetation, which would require soil amendment or importing topsoil. Establish vegetation in this beach area would need to balance the stabilization objectives of revegetation with the active use of this area. Overall, the group felt that this area was a lower priority than others because it clearly serves its recreational objectives as a beach area and there are other areas along the creek with much more substantial erosion. Some erosion protection along the far bank could be considered as a maintenance activity or as part of a capital project.

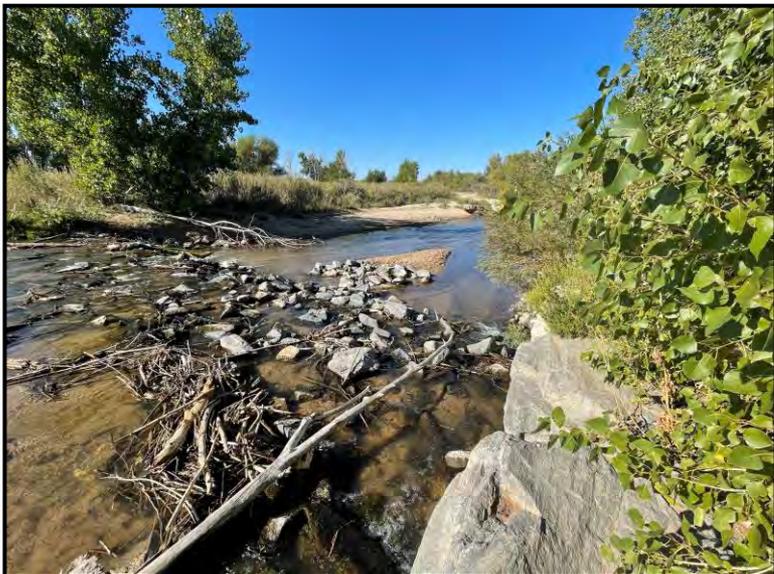
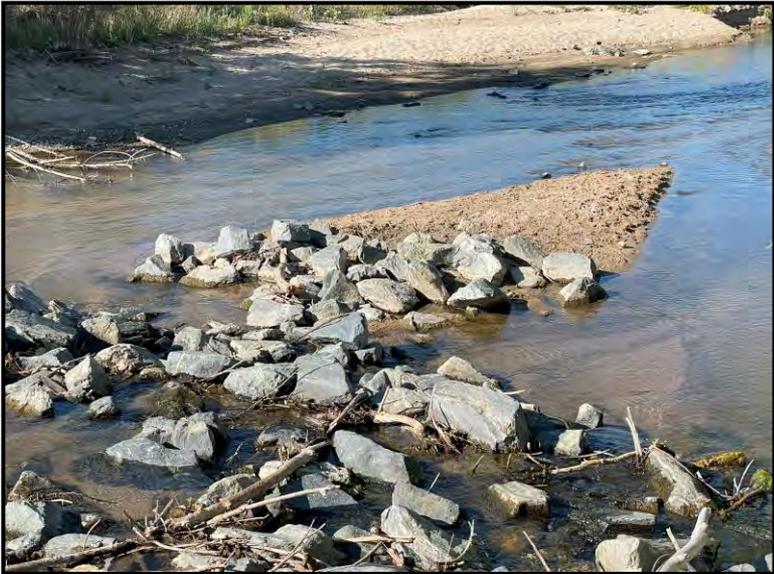
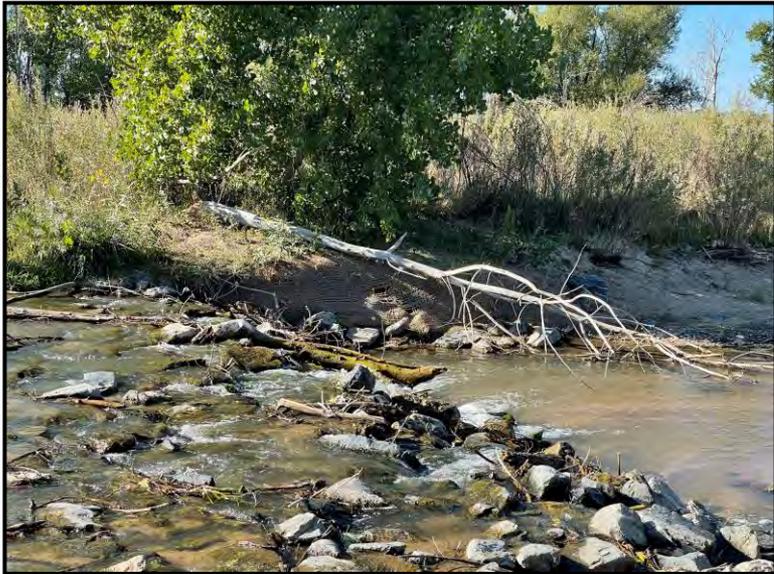
5. The next area visited was the drop structure that was constructed as a part of Phase 3 of the channel improvements in this area (see photos 30 - 33). The drop structure appears to be in good condition, although it appears that some of the Riprap used to construct the drop have been deposited downstream of the structure (see photos 30 and 31). Upstream of the drop structure, the creek appears to flow towards the south bank; Elysa confirmed with record drawings for the Cherry Creek at 12-mile Phase 3 project that the sheet pile for the drop structure does extend approximately 93-ft beyond the south channel bank to protect from the channel eroding around the drop. In addition, it appears that some bank material may have been washed out from the bank on the opposite side of the creek, just downstream of the drop. Replacing the rock that has been dislodged from the drop structure and repairing bank erosion on the far bank could be considered as maintenance projects. The drop structure appears to be performing as intended, so repairing the drop and bank erosion would be good expenditures of O&M funds.

Based on these observations, there are several opportunities for O&M projects that would be beneficial to channel stability and, as a result, water quality. These include replacing rock that has been washed downstream of the Phase 3 drop structure and repair of bank erosion in this area. Backfilling the area between the rock bank and the multi-use path with 2-inch d_{50} material falls in the O&M category, and this project is currently out for bids. Finally, extending the current rock bar (riprap washed out from upstream) in the lower reach across the creek to create a drop structure could be considered as a maintenance project. There is good access to this area. Other needed repairs, such as stabilizing the area where the creek has avulsed to the north, would require heavy equipment and would be more on the scale of a capital project than an O&M activity. It was clear to the group on the site visit that a comprehensive study is needed to better understand the sediment transport dynamics and geomorphology of this reach. With a sand bedded channel and sandy bank materials in many locations, hard armoring of the channel, to the extent this is considered, must be carefully evaluated because the creek is likely to find new areas to erode as other areas are hardened. Such a study should begin downstream of the avulsion reach and extend upstream through the 12 Mile reach. The study team should include a geomorphologist in addition to engineers who can think through the potentially unintended consequences of stabilizing some areas but not others. This area must be studied in a holistic fashion instead of project-by-project.

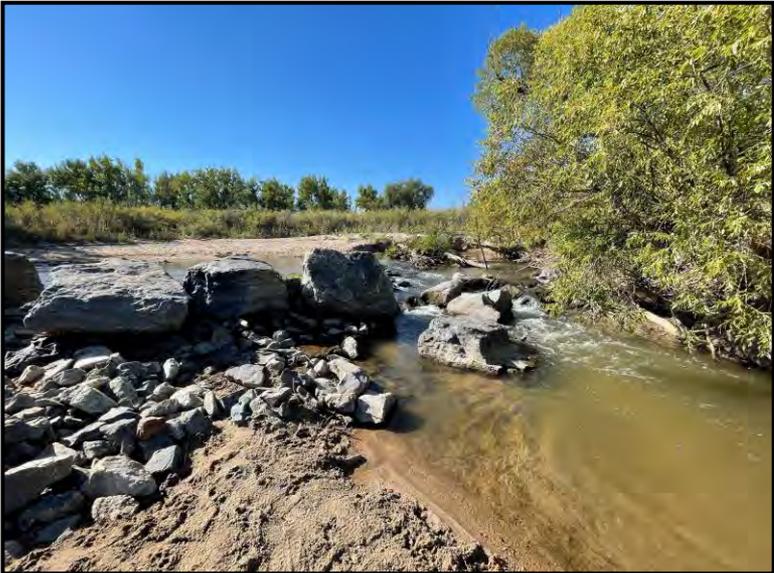
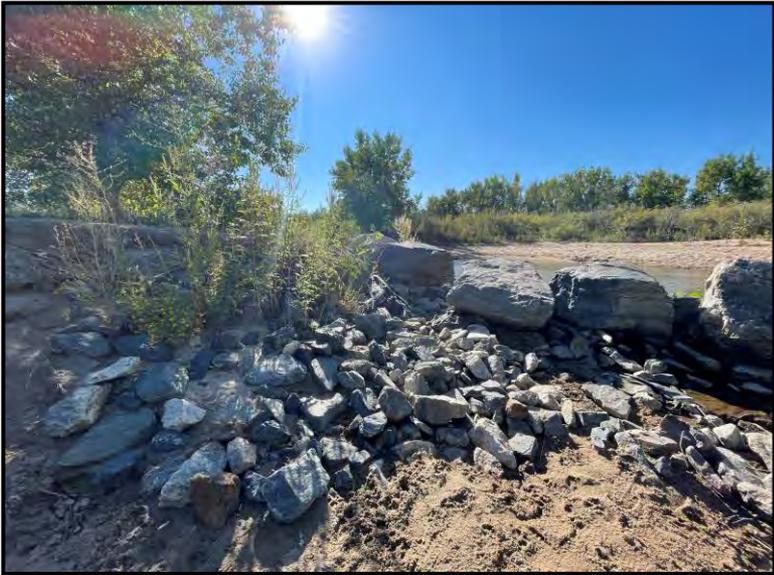
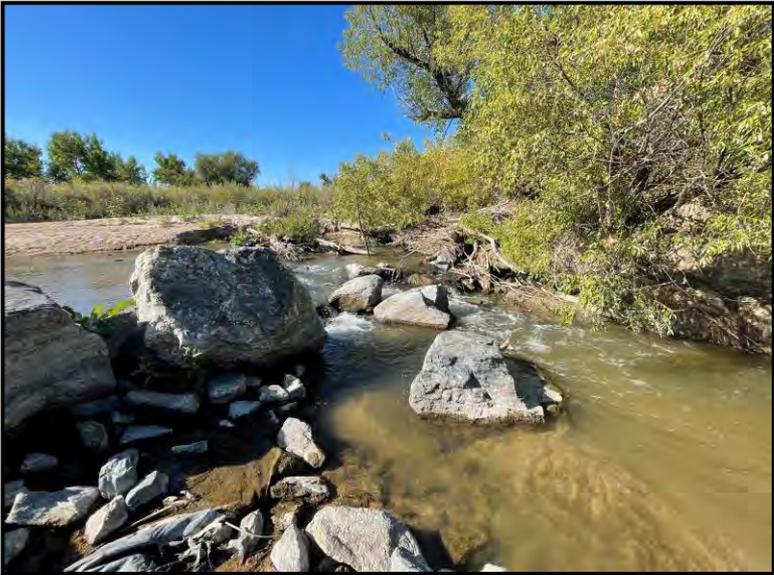
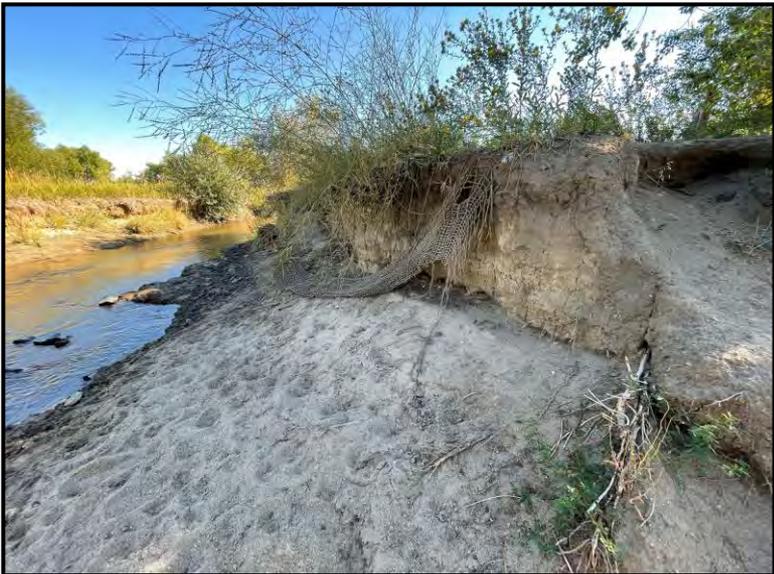
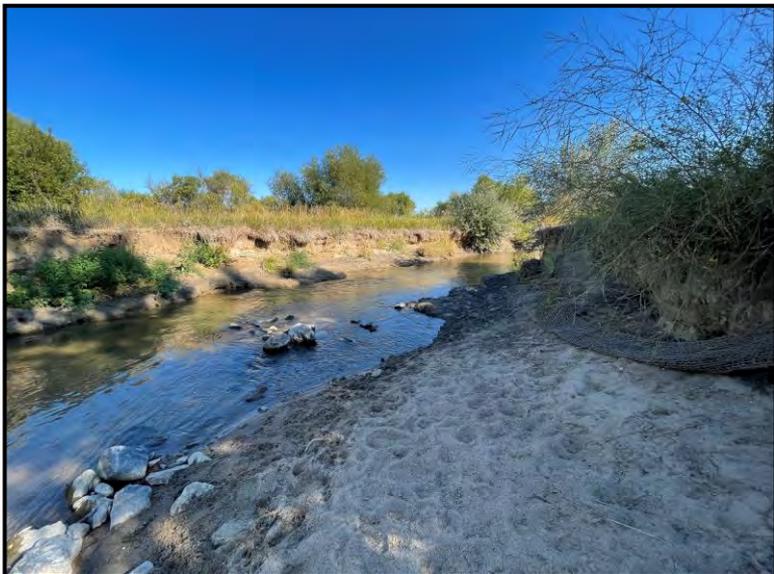
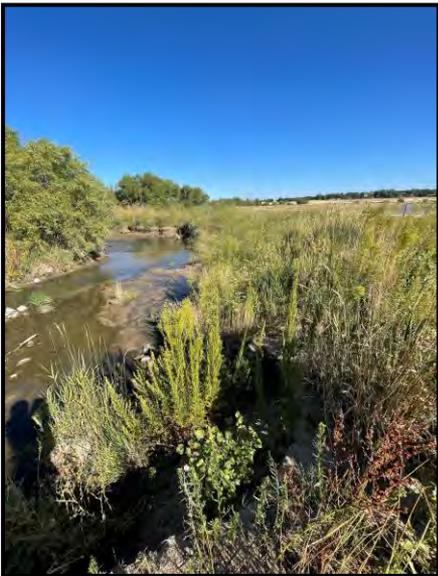
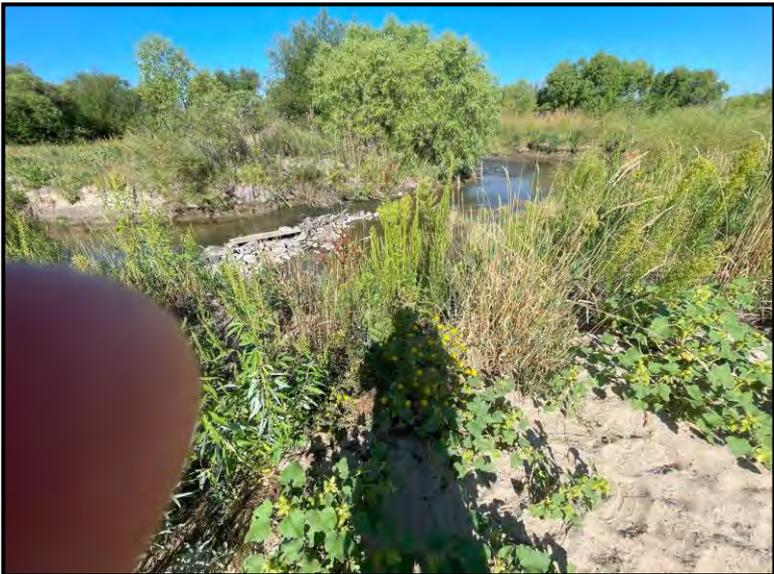
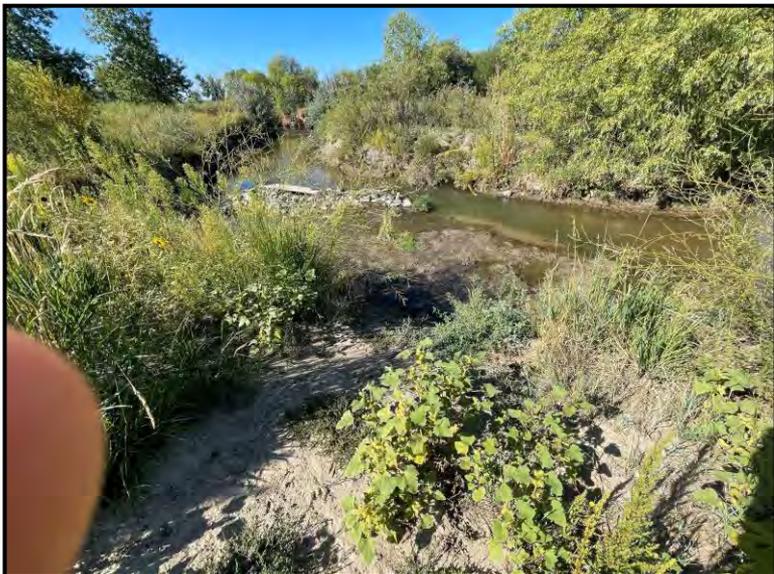
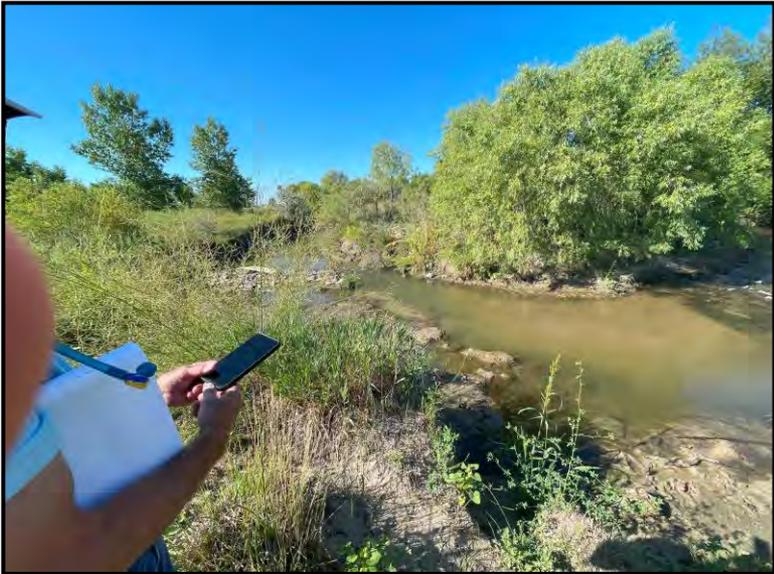
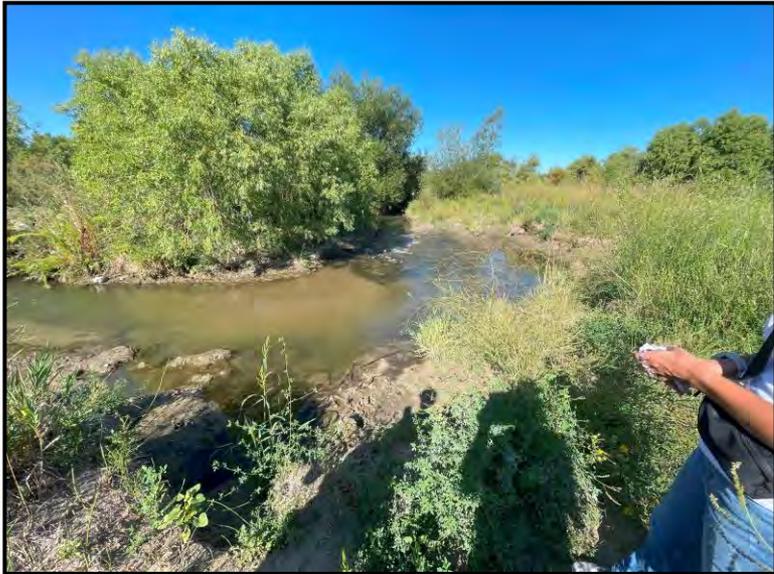
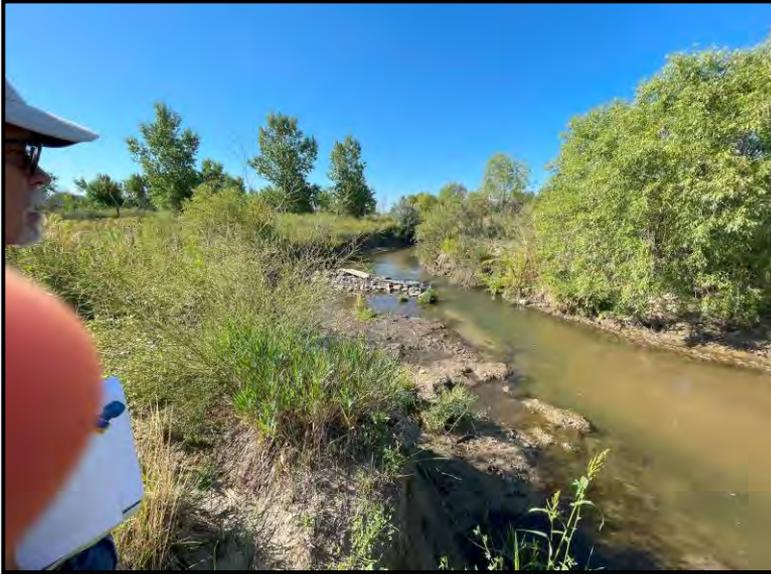
6. Downstream of the drop structure, the channel has avulsed from its historic flow path to the north (see photos 34 - 45). The flow undermined the rock-lined northern bank of the creek, and a new channel has formed. The previous main channel has been filled in with sediment, and the channel that was created by this avulsion is now actively shaping itself. Downstream of avulsion, we observed steep cut banks, as well as a drop naturally forming in the channel bottom due to less erodible claystone bedrock in the channel. The channel flows generally to the north from the avulsion with several sharp eroding bends observed during the site visit. While the old main channel now appears abandoned, it likely would serve as an active flow path in a large flood event in addition to the new channel. Work to repair the breached boulder channel bank and convert this into a formalized grade control structure would require heavy equipment. This may be advisable in the long-term but goes beyond an O&M project. We also noted a rock bar across part of the channel downstream of the avulsion area (see photos 40 – 43 and 45). It appears that this is a deposit of material washed out from upstream. The avulsed channel appears to lose a lot of grade over a short distance, so turning this into a formal grade control structure also could be a good maintenance project. At the point of avulsion and in the channel downstream, there are several locations where the channel significantly narrows as it goes around sharp bends. One alternative to consider in these areas is grading back the banks to lessen the constriction. This would help to reduce velocities through the areas, and high flow path cutting off bends could be evaluated and armored to avoid excessive erosion in flood events. We also discussed collecting samples of exposed claystone bedrock material along the banks of the channel downstream of the avulsion to better assess the phosphorus content and risk of phosphorus loading downstream.
